May 12, 2023

**RE: Roof Condition Assessment Report
Whistler Waste Water Treatment Plant – Primary Building
1135 Cheakamus Lake Road, Whistler, BC**

RJC No. VAN.130859.0002

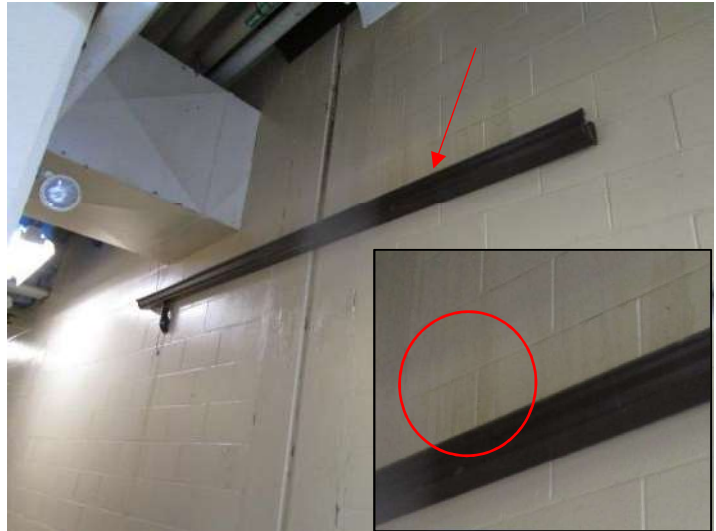
Photo 1

Observed gutters installed at the interior of the building at several locations between room 117 and the thickener room on the 1st floor of the building.

Staining was observed on CMU wall's directly above gutters.

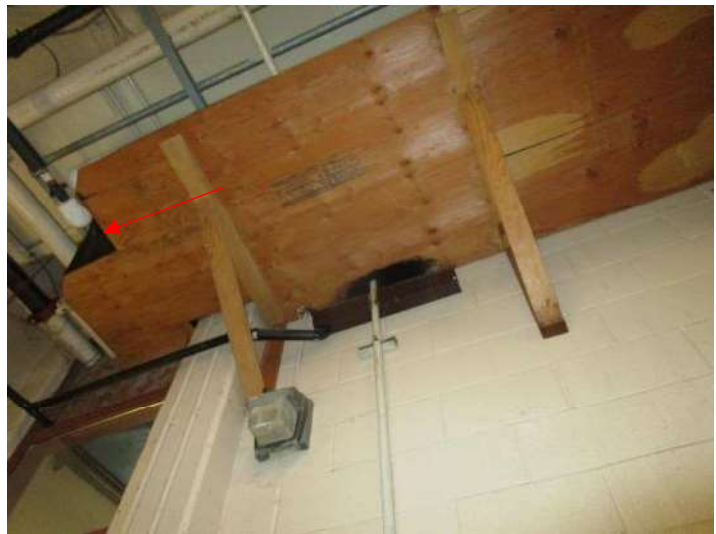
Photo 2

The Owner has constructed a plywood structure with roof membrane at the underside of the concrete deck on the interior of the thickener room. This area of the building is actively leaking.

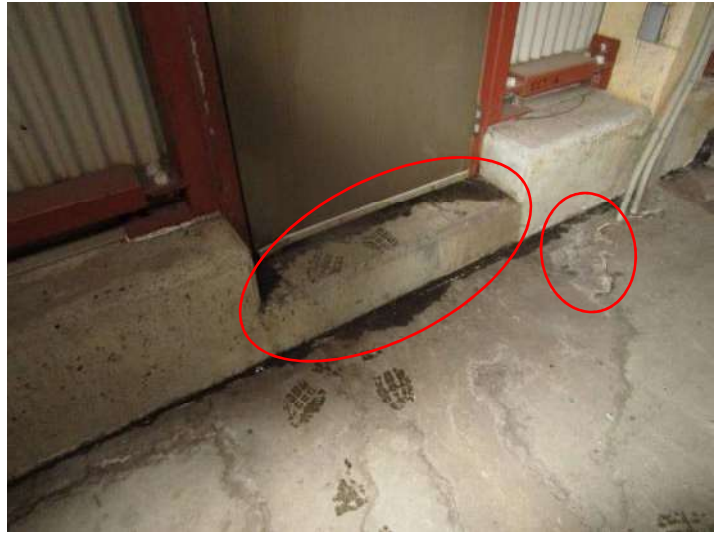
Photo 3

Observed staining and evidence of water ingress at several exterior doors on the 2nd floor of the building.

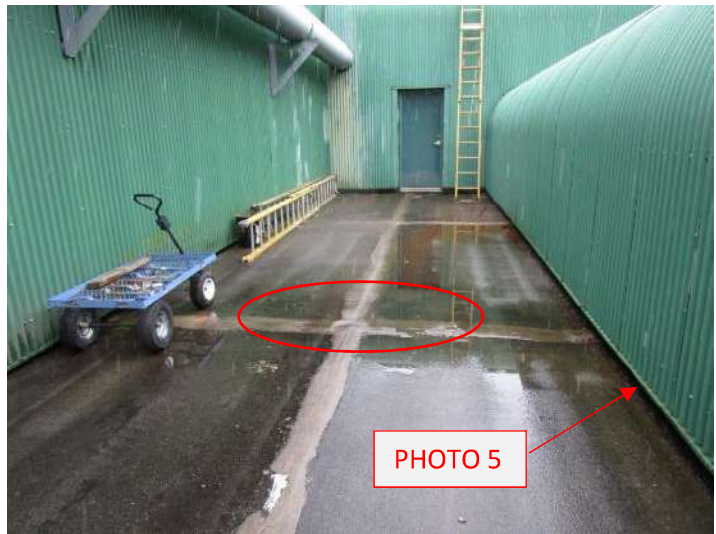
Photo 4

Overview of the 2nd floor exterior walkway above Primary Sedimentation Tank #1. Observed precast concrete hollow-core slabs with concrete patch material between the joints. See Photo 5 for base of wall conditions.

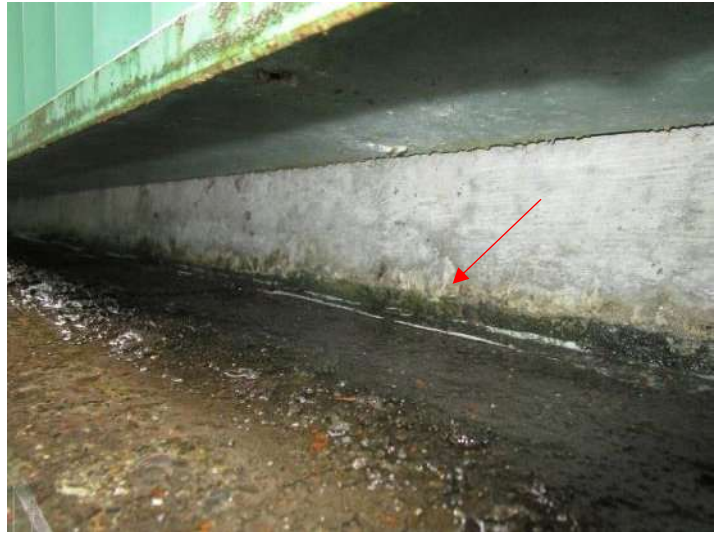
Photo 5

Base of wall beneath corrugated steel cladding system. No waterproofing system was observed. Organic growth was observed along upturn.

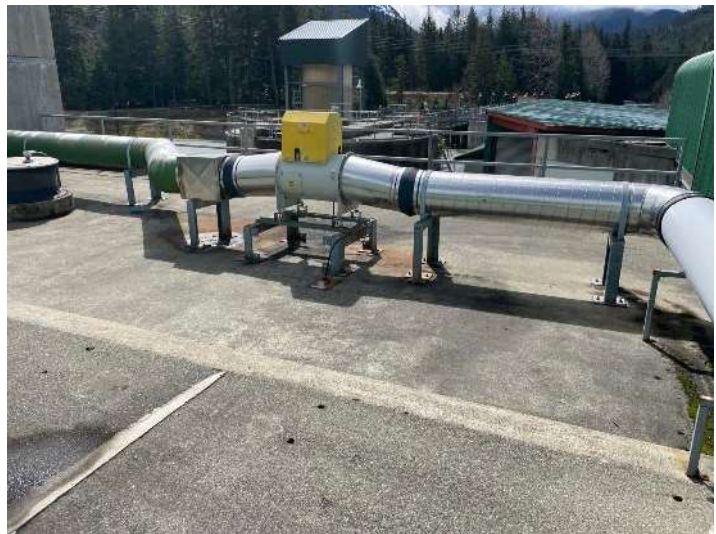
Photo 6

Roof Area #4 is in poor condition and is actively leaking into occupied space. Although we were not able to visually confirm the presence of a waterproofing membrane under the concrete topping, we did not observe evidence of water ingress within the field (centre) of the concrete deck's soffit; however, we did not observe roofing tie-ins at the perimeter of the roof area (base of wall, parapet, etc.). Consequently, several leaks within the interior space below are situated directly beneath areas of visibly wet concrete along the perimeter of this roof area. As such we recommend replacing the roof with a new 2-Ply SBS modified bitumen assembly with proper tie-ins to the perimeter of the roof area. Similar to Roof Area #2, we recommend conducting this work within the next year. As such, the OPC provided in Section 4.0 includes an allowance for this roof area.

Overview of Roof Area #4. Observed concrete topping. This area is above occupied space and the existing waterproofing membrane could not be visually confirmed. No tie-ins were observed at the base of the wall, at the parapet, or at the curb connecting to the hollow core panels above Primary Sedimentation Tank #1.

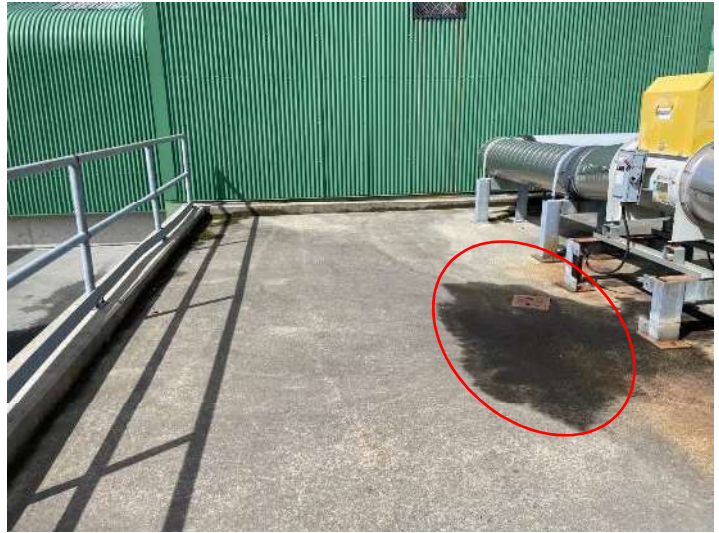
Photo 7

Observed floor drains installed that are not intended for roof areas. Observed ponding water around drains at roof area #4.

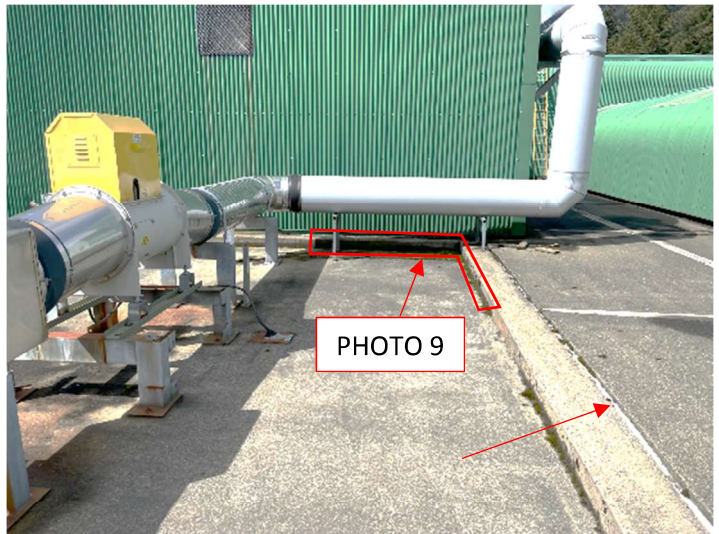
Photo 8

Observed a sealant joint between concrete curb and adjacent hollow-core slabs. Observed wet concrete and localized organic growth around perimeter of roof area. These areas are located above gutter systems in the interior space below. See Photo 9.

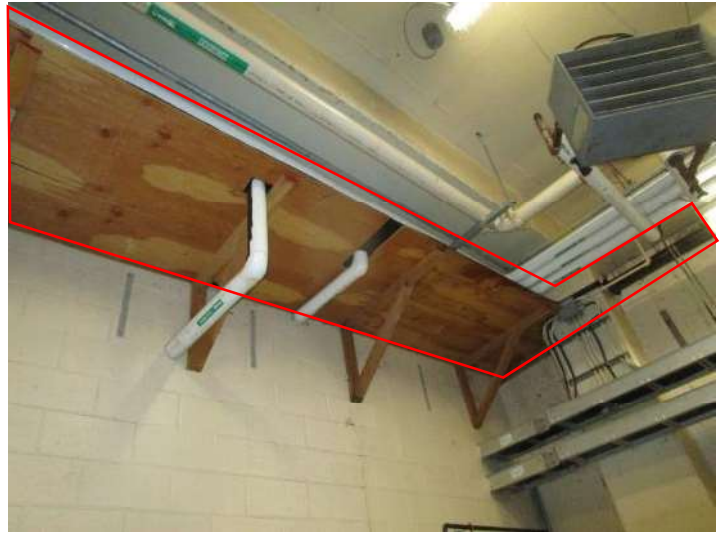
Photo 9

Corresponding gutter and plywood structure located beneath area shown in Photo 8.

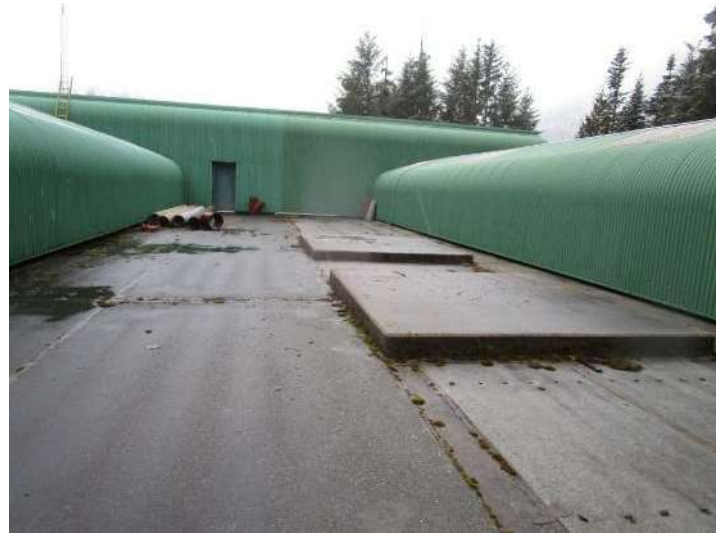
Photo 10

Overview of access walkway above Primary Sedimentation Tank #2 and #3. Observed precast concrete hollow-core slabs with no waterproofing installed over top.

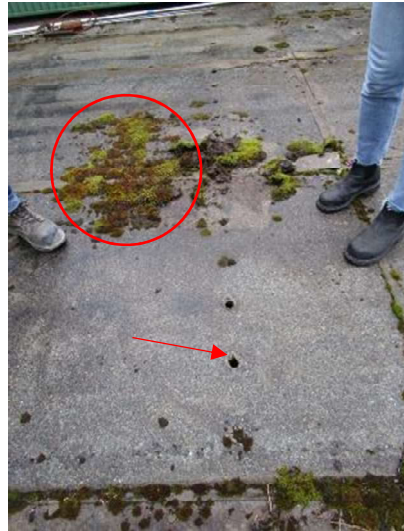
Photo 11

Localized organic growth was observed throughout hollow core slab area. Holes for lift anchors were observed in the slab panels.

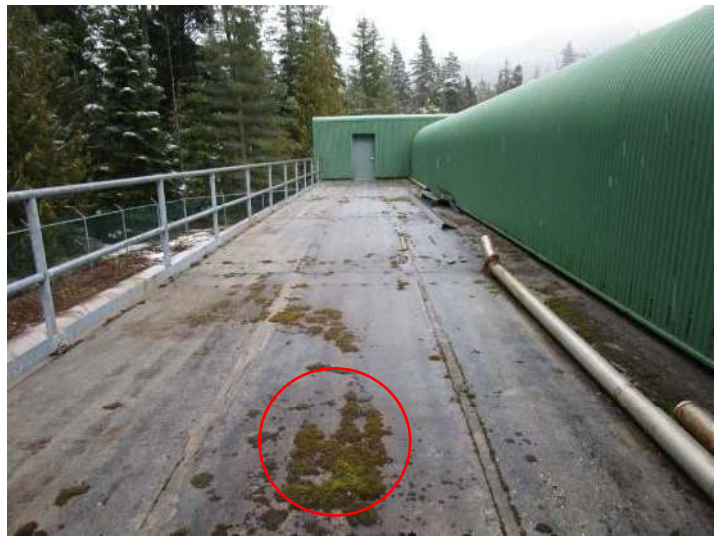
Photo 12

Overview of access walkway above Primary Sedimentation Tank #4. Observed precast concrete hollow-core slabs with no waterproofing installed over top. Localized organic growth was observed throughout the area.

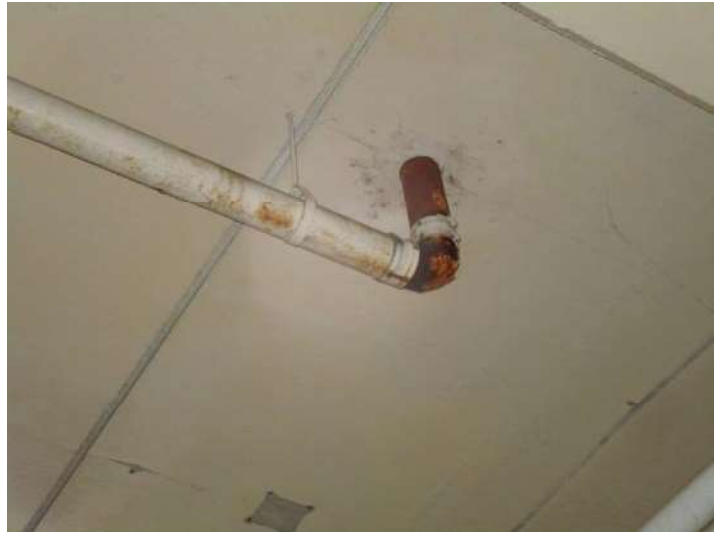
Photo 13

Corrosion and staining was observed at a roof drain pipe penetration

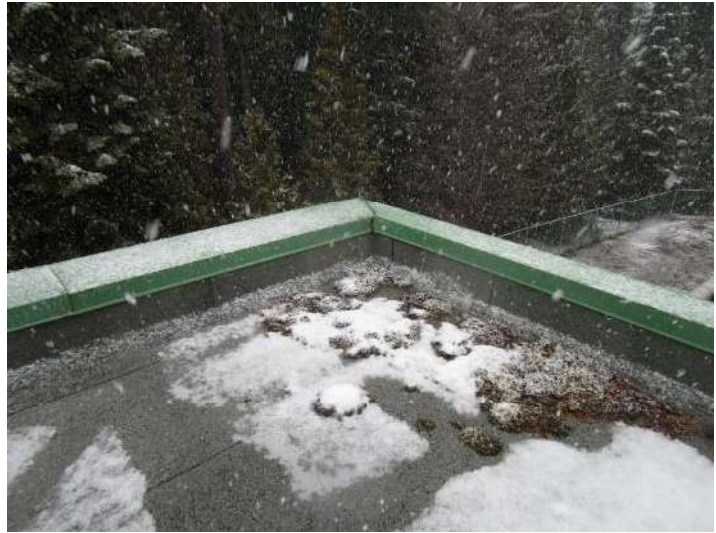
Photo 15

Roof Area #1 appears to have been replaced since the original expansion in circa 2009 and is in good condition with no indications of leaks. The expected service life of a well-maintained 2-Ply modified bitumen roof assembly is 25-30 years. Roof Area #1 has an estimated remaining service life of 11-16 years. We recommend the Owner continue to maintain the roof. If desired by the Owner, Roof Area #1 can be replaced at the same time as Roof Area #2 in order to capitalize on better economies of scale, and one contractor's mobilization cost. As such, the OPC provided for budgetary purposes in Section 4.0 below includes an allowance for this roof area.

Isolated area of organic growth was observed at roof area #1.

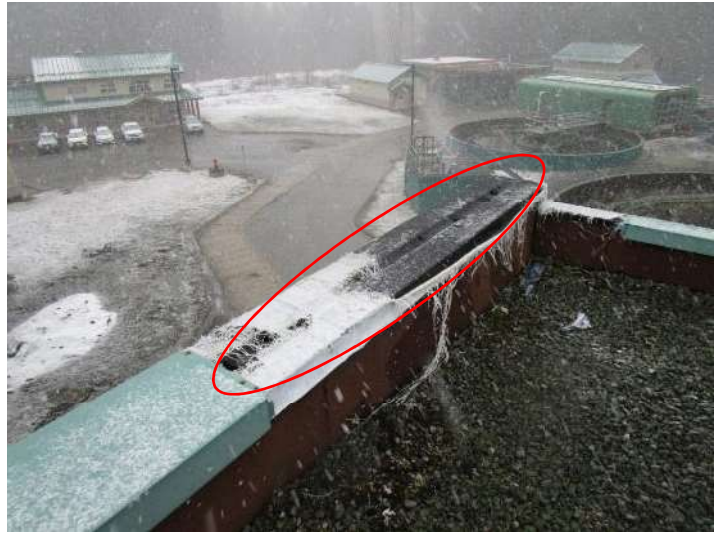
Photo 17

Observed a missing metal flashing and failed membrane stripping at a parapet on the south-west corner of roof area #2. Large holes in the stripping were observed at the top of the parapet

Roof Area #2 has failed in many locations along the parapets on the south end of the roof area and is actively leaking. As such, we recommend the Owner engage a Roofing Contractor to provide repairs to the failed membrane at the parapets surrounding Roof Area #2. Due to the systemic issue observed at Roof Area #2, we recommend the Owner budget for replacement within the next year. The work would involve removing the existing roof down to the structural deck, and installing a new, high performance 2-Ply SBS Modified Bitumen Roof Assembly with new metal flashings, sealants, and skylights (if desired). The expected service life for this type of roof assembly would be 25-30 years. An OPC for this work has been provided in Section 4.0.

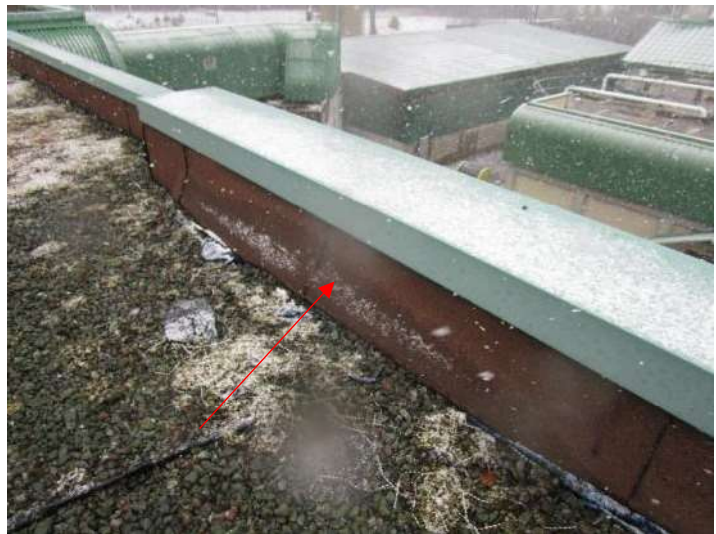
Photo 18

Observed tenting of the cap sheet membrane stripping at several locations along parapets of roof area #2. A small cut was made at the arrow. See Photo 19.

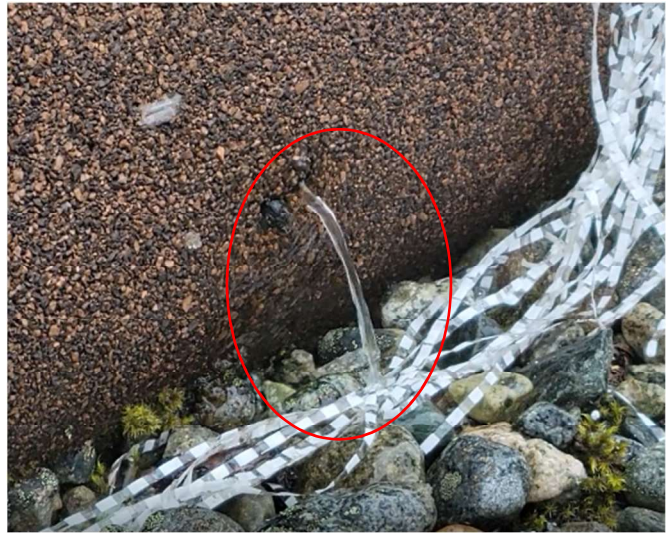
Photo 19

After cutting into the membrane observed in Photo 18, water began to spill out of the membrane.

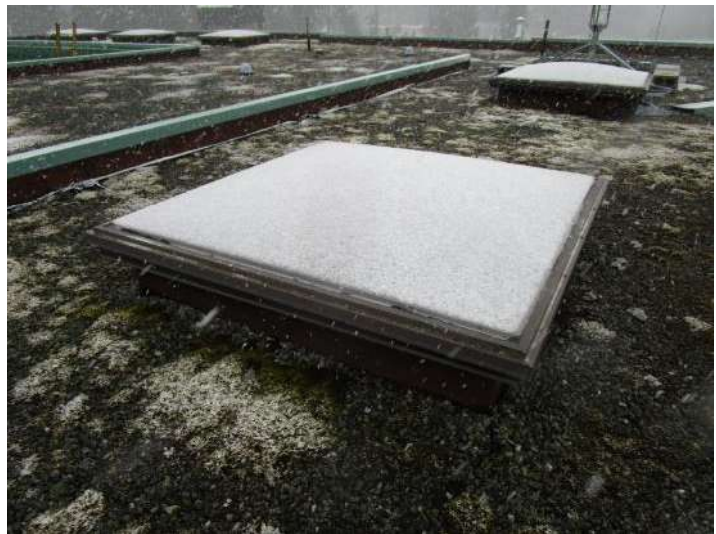
Photo 20

Seven (7) skylights were observed throughout roof area #2. They appeared to be in fair condition and no evidence of leaks were observed from the interior.

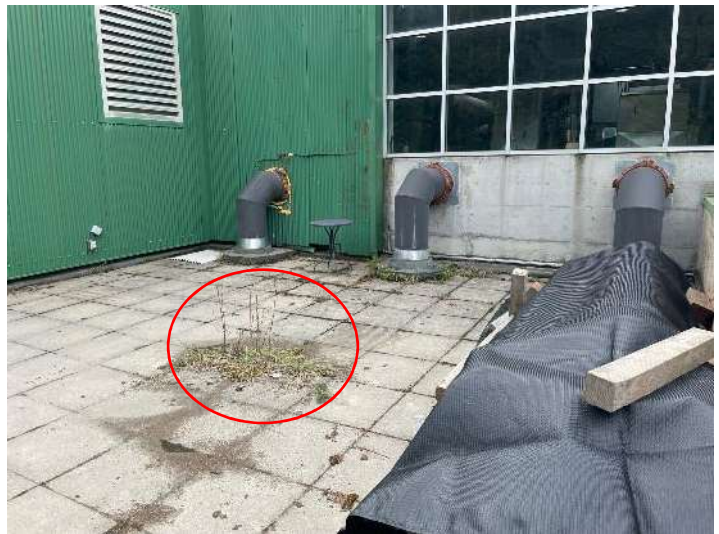
Photo 22

Based on the photos received from the RMOW, Roof Area #3 appears to be in fair condition while experiencing age related defects and excessive organic growth. We do not know the roof's actual age but we do not believe it is original to the building's 1976 construction. Although we were not made aware of issues beneath the roof area, we recommend the client considers replacement this roof area at the same time as Roof Area #2. Similar to the reasons provided above, we recommend this approach due to their proximity to each other, and better economies of scale for a single contractor's mobilization and access cost. We recommend installing a new, protected 2-Ply SBS Modified Bitumen Membrane Assembly. The expected service life of this type of roof is 30-40 years. An OPC for this work has been included in Section 4.0.

Observed localized organic growth throughout roof area #3.

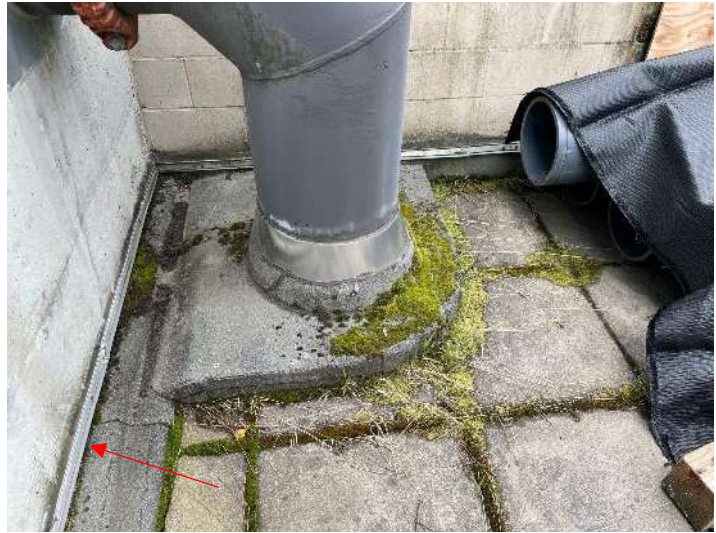
Photo 23

Observed modified bitumen membrane fastened with termination bar to the concrete substrate at roof area #3.

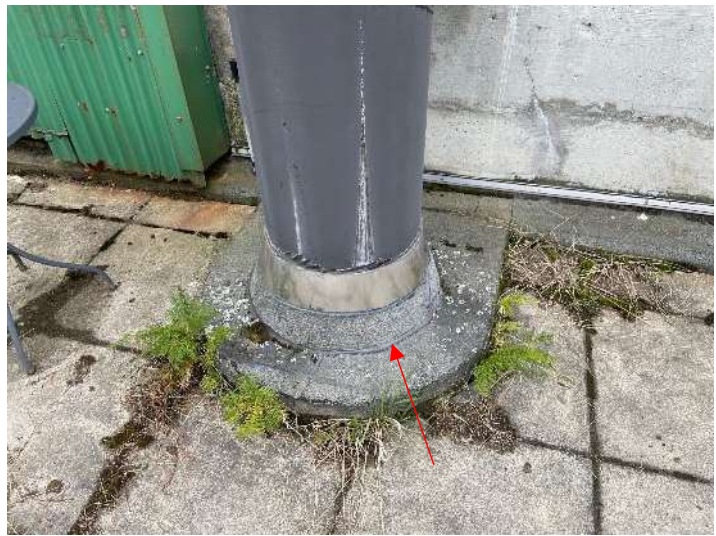
Photo 24

Observed sealant at pipe penetration membrane detailing at roof area #3.

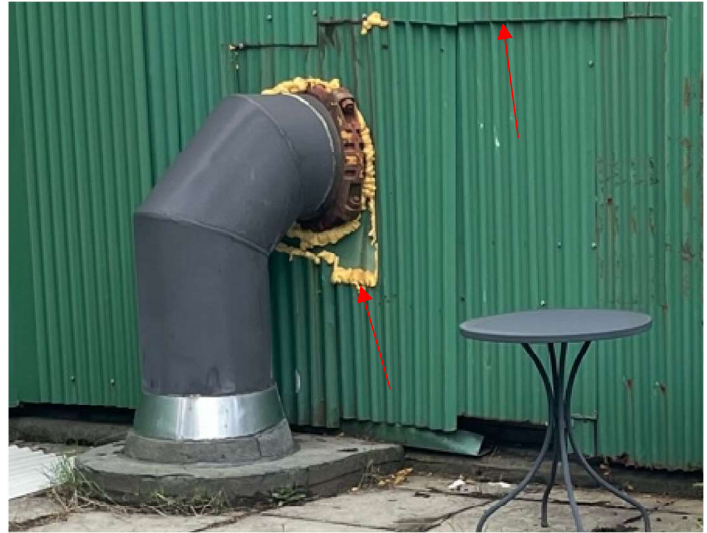
Photo 25

Observed spray foam insulation applied around pipe penetration to wall interface at roof area #3. It appears this may have been installed due to leaks at the wall as the green cladding appears to have been cut to access the area.
