Resort Municipality of Whistler: Wastewater Treatment Plant Primary Sedimentation Tank Assessment Report

Project No. 210505

January 26th, 2022

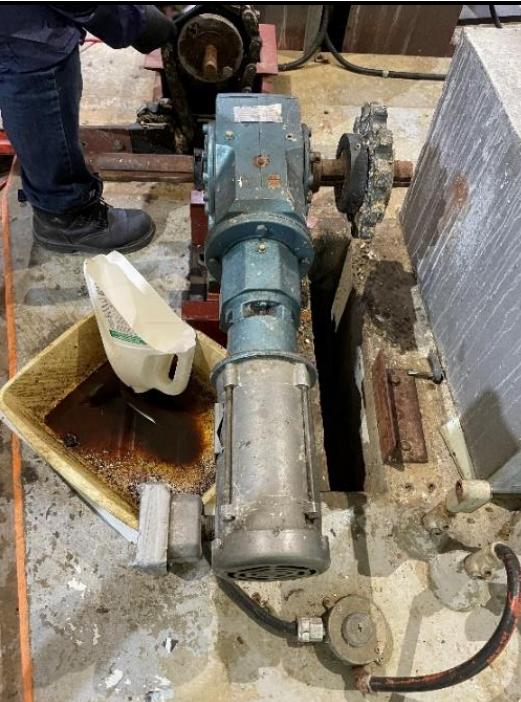
<p>The motor and gearbox were in a fair condition. However, they are in a corrosive environment and is operating continuously. Periodic maintenance plan is required.</p>
	<p>Required Action:</p> <ul style="list-style-type: none"> - All manufacturers' maintenance manuals of drivers and motors shall be followed. - A mechanical/electrical engineering review may be performed. Detailed data logging/reviewing may be conducted to detect potential operational issues by observing the variance in the load/data log results.

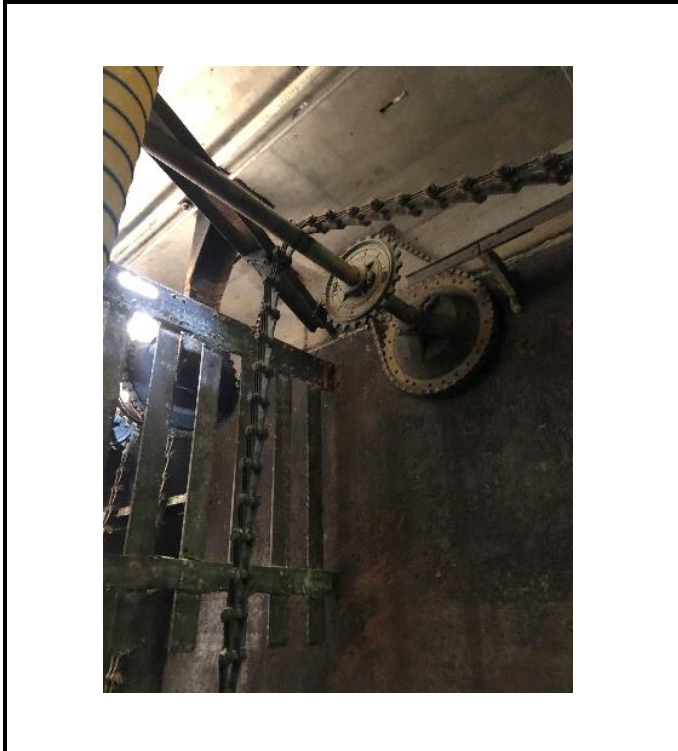
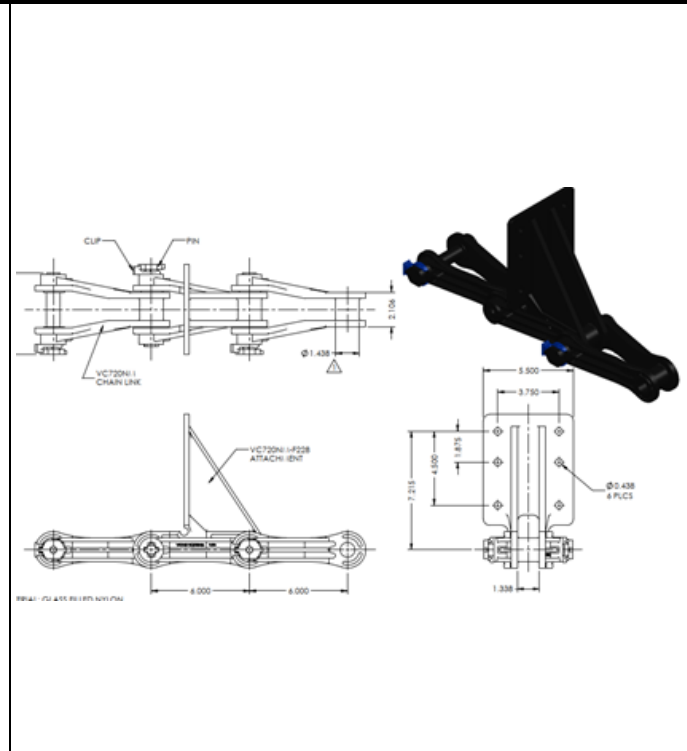
Item No:	M02-1L – Collector Chain
Action Plan & Resolution Timeline Required:	1 year
Repair Priority:	New (has been replaced November 2021)

Location Detail: Tank #1	Description:
	<p>Original Equipment - The collector chains were in fair conditions. However, restrictions on the movement of the wall bearings and sprockets caused increased tension and stresses on the equipment.</p>
	<p>Required Action:</p> <ul style="list-style-type: none"> - All manufacturers' maintenance manuals of moving parts shall be followed. - Alignment of the drivers within the driving sprockets configuration shall be checked periodically ensuring there is no excessive misalignment/friction between chains, sprockets, shafts, and drivers. - Cleaning/removing large scales periodically to reduce the wear and tear.

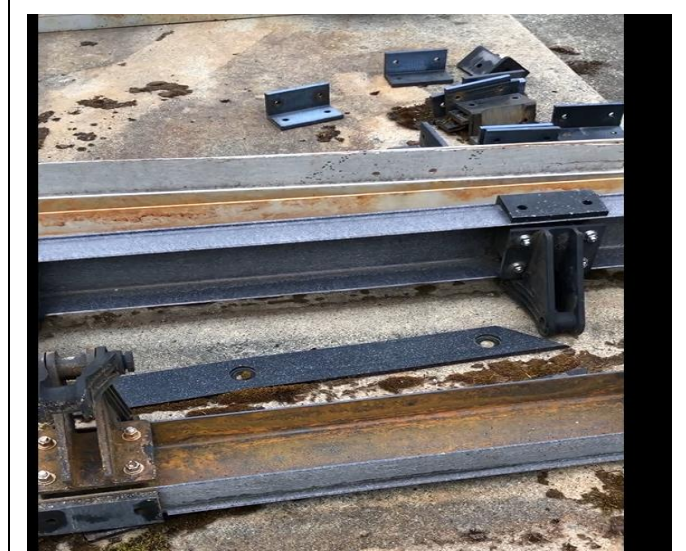
Item No:	M06-1L – C-Channel Fiberglass Flights
Action Plan & Resolution Timeline Required:	1 year
Repair Priority:	New (has been replaced November 2021)
Location Detail: Tank #1	Description:

<p>Original Equipment - The flight assembly were in fair conditions. Damage was observed most likely caused when the system failed.</p>
	<p>Required Action:</p> <ul style="list-style-type: none"> - An engineering investigation shall be performed for a root cause analysis over the malfunctioning of the mechanical system along with the corrosion parameters to determine a maintenance plan/possible design modification. - All manufacturers' maintenance manuals of moving parts shall be followed. - Alignment of the drivers within the driving sprockets configuration shall be checked periodically ensuring there is no excessive misalignment/friction between chains, sprockets, shafts, and drivers. - Cleaning/removing large scales periodically to reduce the wear and tear.

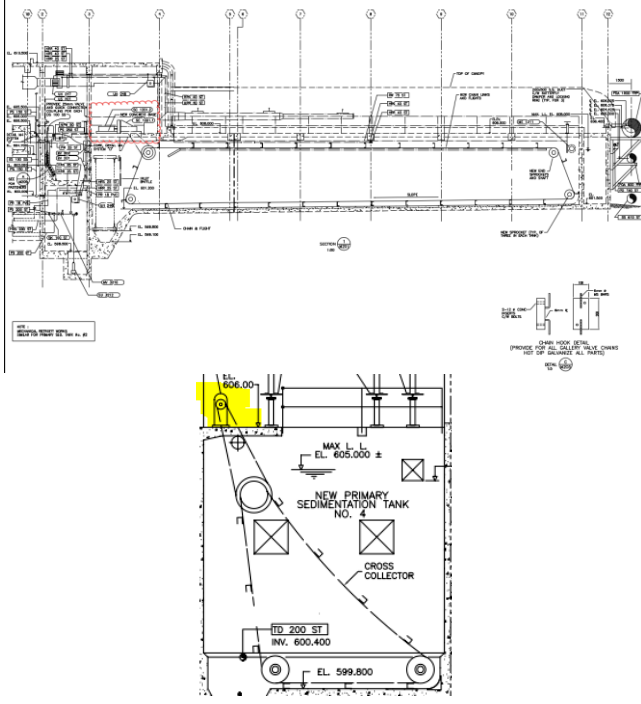
Item No:	M11-1C – Take Up Assembly
Action Plan & Resolution Timeline Required:	1 year
Repair Priority:	New (has been replaced November 2021)
Location Detail: Tank #1	Description:

The Take Up Assemblies were in fair condition.

- All manufacturers' maintenance manuals of moving parts shall be followed.
- Alignment of the drivers within the driving sprockets configuration shall be checked periodically ensuring there is no excessive misalignment/friction between chains, sprockets, shafts, and drivers.
- Cleaning/removing scales periodically to reduce the wear and tear.
- Inspecting driven sprockets periodically, ensuring they are fixed on the shaft and fully synchronized with the driver shaft/sprocket without any slippage.

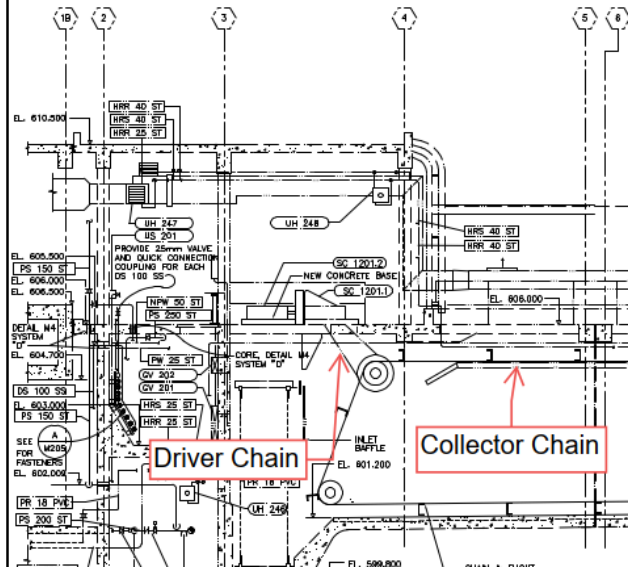
The drive chains were in fair conditions. However, restrictions on the movement of the wall bearings and sprockets caused increased tension and stresses on the equipment.

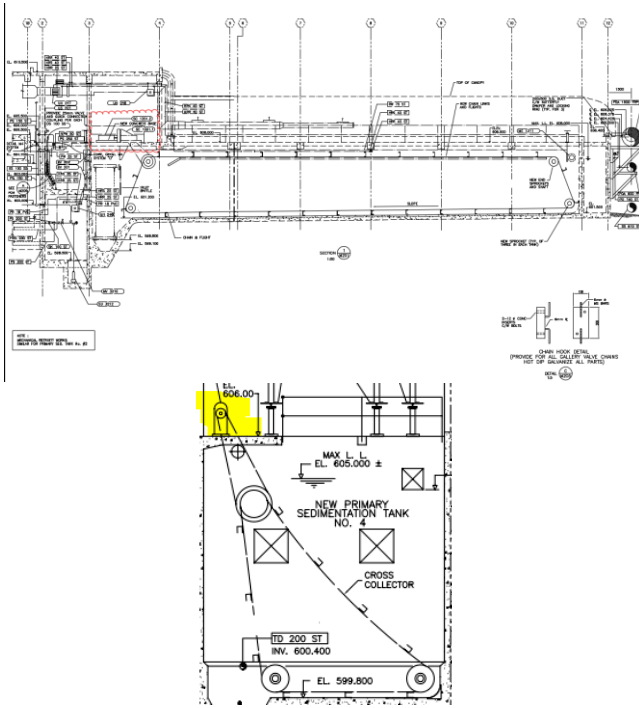
Item No:	M11-2C – Take Up Assembly
Action Plan & Resolution Timeline Required:	1 year
Repair Priority:	P2
Location Detail: Tank #2	Description:

The Take Up Assemblies were in fair condition.

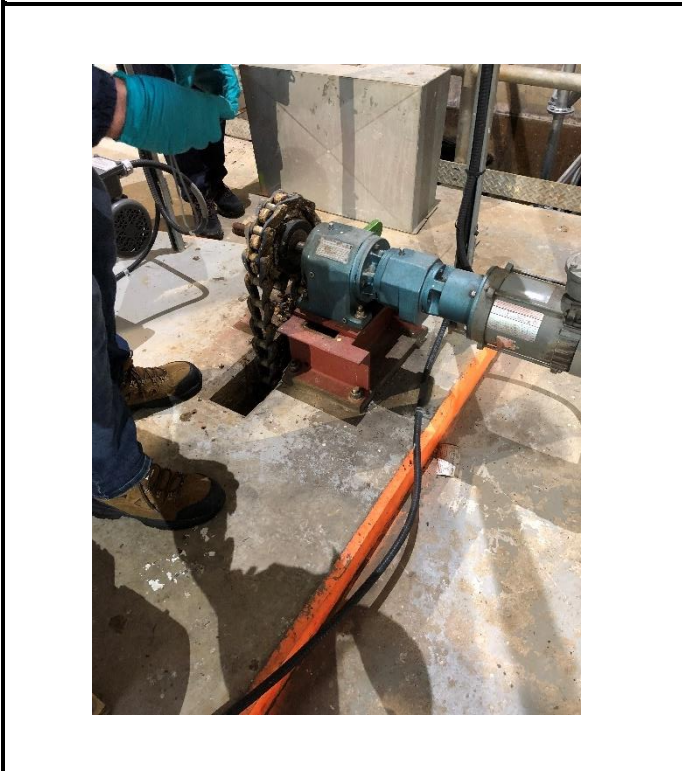
<p>The motor and gearbox were in a fair condition. However, they are in a corrosive environment and is operating continuously. Periodic maintenance plan is required.</p>
	Required Action:

<ul style="list-style-type: none"> - All manufacturers' maintenance manuals of drivers and motors shall be followed. - A mechanical/electrical engineering review may be performed. Detailed data logging/reviewing may be conducted to detect potential operational issues by observing the variance in the load/data log results.

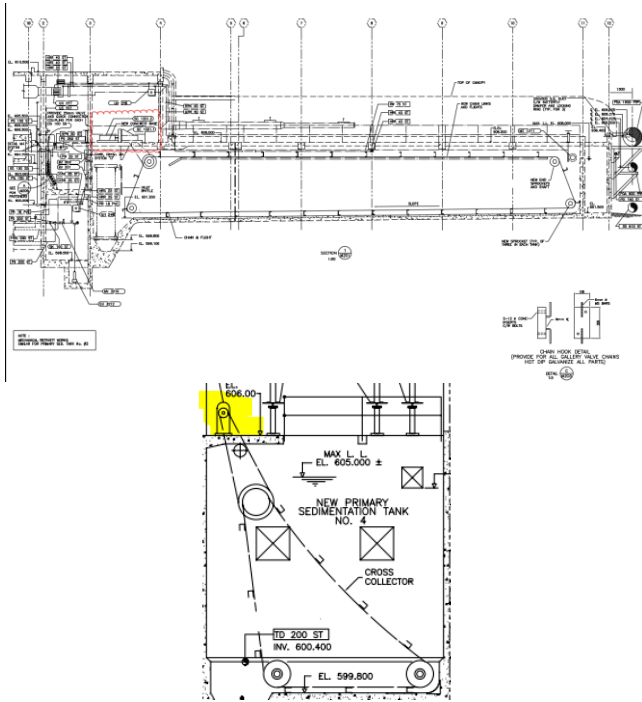
Item No:	M11-3C – Take Up Assembly
Action Plan & Resolution Timeline Required:	1 year
Repair Priority:	P2
Location Detail: Tank #3	Description:

The Take Up Assemblies were in fair condition.

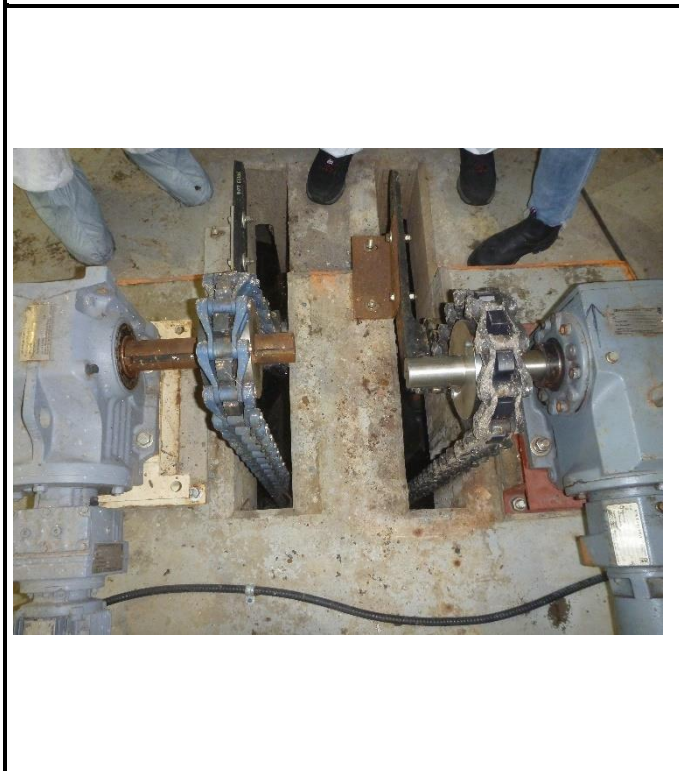
<p>The motor and gearbox were in a fair condition. However, they are in a corrosive environment and is operating continuously. Periodic maintenance plan is required.</p>
	Required Action:

<ul style="list-style-type: none"> - All manufacturers' maintenance manuals of drivers and motors shall be followed. - A mechanical/electrical engineering review may be performed. Detailed data logging/reviewing may be conducted to detect potential operational issues by observing the variance in the load/data log results.

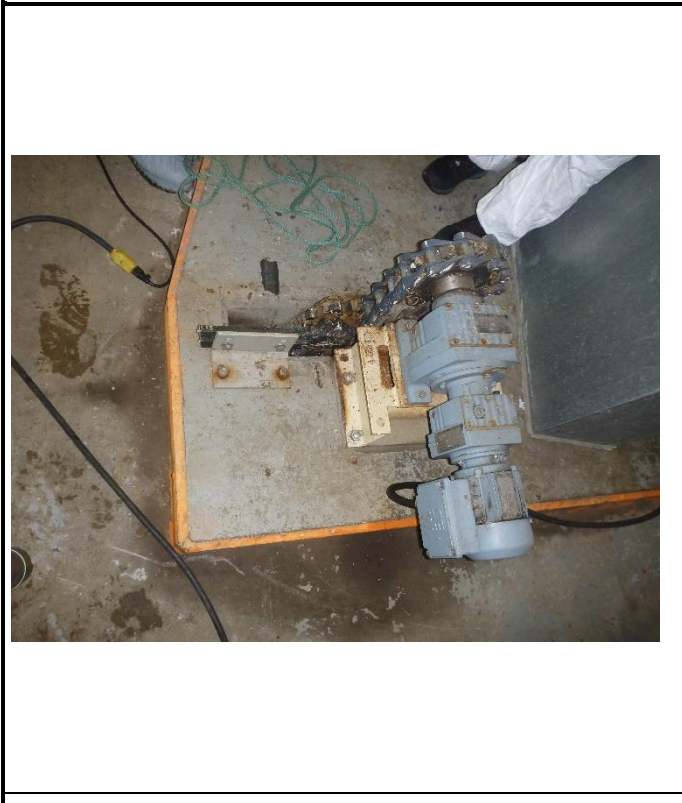
<p>The motor and gearbox were in a fair condition. However, they are in a corrosive environment and is operating continuously. Periodic maintenance plan is required.</p>
	Required Action:

<ul style="list-style-type: none"> - All manufacturers' maintenance manuals of drivers and motors shall be followed. - A mechanical/electrical engineering review may be performed. Detailed data logging/reviewing may be conducted to detect potential operational issues by observing the variance in the load/data log results.

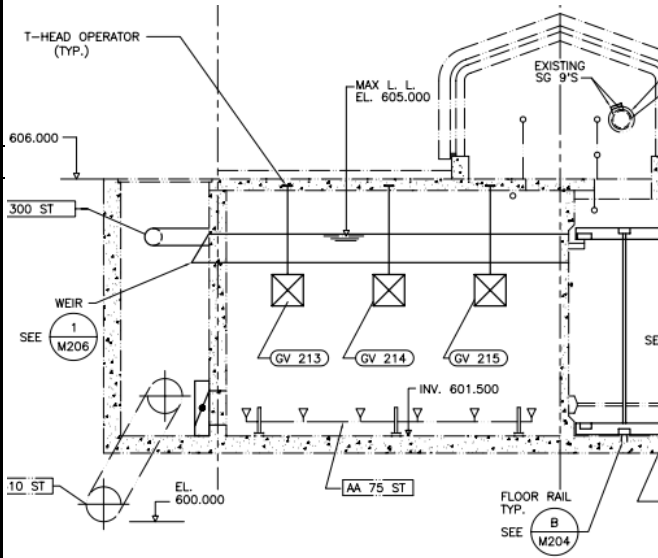
GV 213, GV 214, GV 215
Scales at the gates and the gate valves blades was observed. Actuators are in a fair condition.

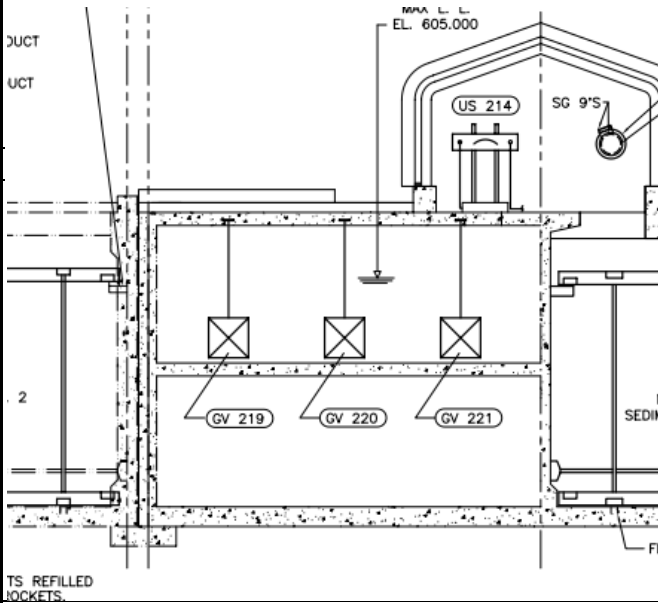
GV 219, GV 220, GV 221
Scales at the gates and the gate valves blades was observed. Actuators are in a fair condition.
