Resort Municipality of Whistler: Wastewater Treatment Plant Primary Sedimentation Tank Assessment Report

Project No. 210505

January 26th, 2022

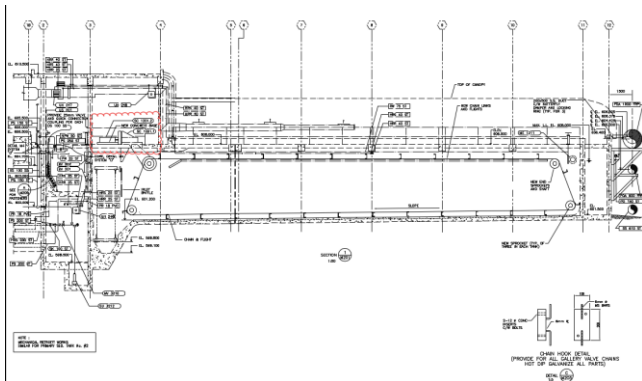
Item No:	M01-1L – Drive Motor / Drive Gearbox
Action Plan & Resolution Timeline Required:	1 year
Repair Priority:	P3
Location Detail: Tank #1	Description:

<p>The motor and gearbox were in a fair condition. However, they are in a corrosive environment and is operating continuously. Periodic maintenance plan is required.</p>
	<p>Required Action:</p> <ul style="list-style-type: none"> - All manufacturers' maintenance manuals of drivers and motors shall be followed. - A mechanical/electrical engineering review may be performed. Detailed data logging/reviewing may be conducted to detect potential operational issues by observing the variance in the load/data log results.

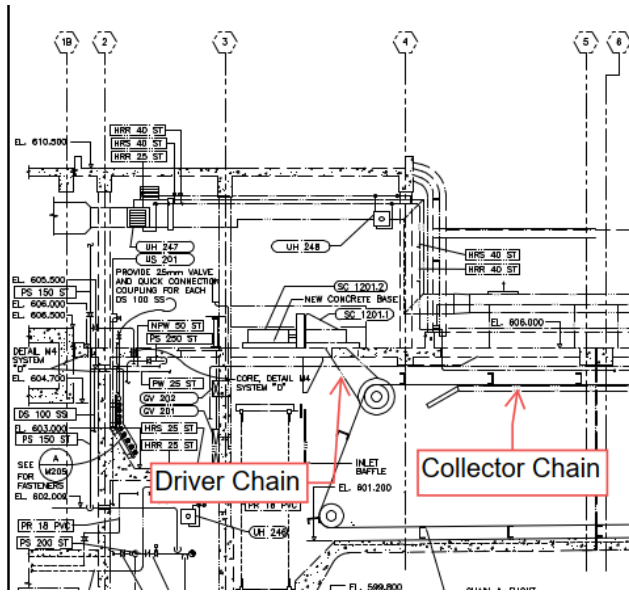
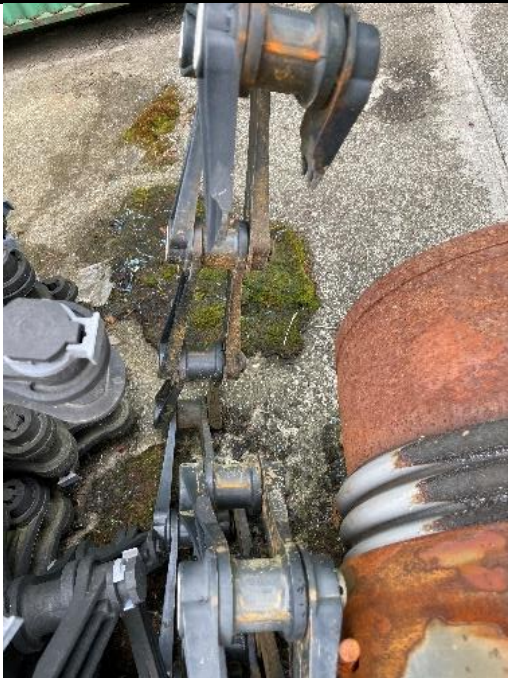
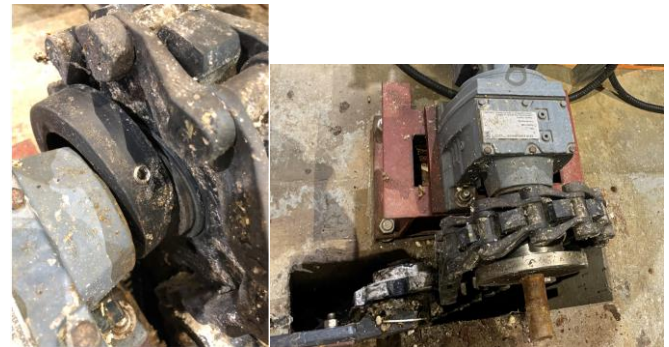
Original Equipment -
The drive chains were in fair conditions. However, restrictions on the movement of the wall bearings and sprockets caused increased tension and stresses on the equipment.

- All manufacturers' maintenance manuals of moving parts shall be followed.
- Alignment of the drivers within the driving sprockets configuration shall be checked periodically ensuring there is no excessive misalignment/friction between chains, sprockets, shafts, and drivers.
- Cleaning/removing large scales periodically to reduce the wear and tear.

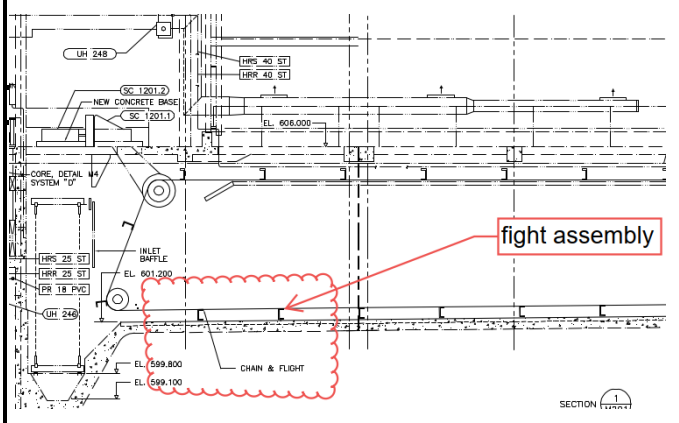
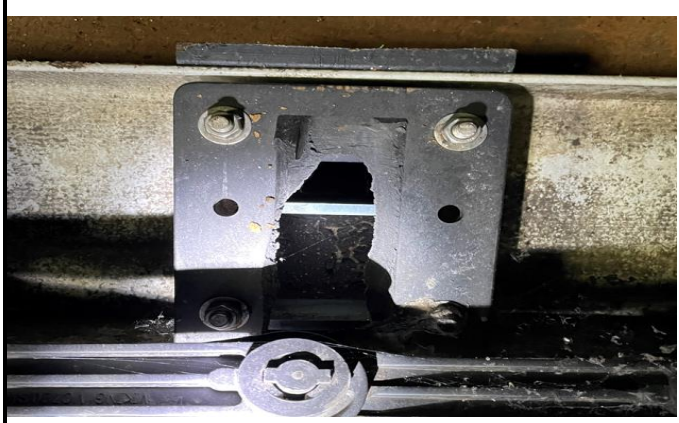
Item No:	M06-1L – C-Channel Fiberglass Flights
Action Plan & Resolution Timeline Required:	1 year
Repair Priority:	New (has been replaced November 2021)
Location Detail: Tank #1	Description:

<p>Original Equipment - The flight assembly were in fair conditions. Damage was observed most likely caused when the system failed.</p>
	<p>Required Action:</p> <ul style="list-style-type: none"> - An engineering investigation shall be performed for a root cause analysis over the malfunctioning of the mechanical system along with the corrosion parameters to determine a maintenance plan/possible design modification. - All manufacturers' maintenance manuals of moving parts shall be followed. - Alignment of the drivers within the driving sprockets configuration shall be checked periodically ensuring there is no excessive misalignment/friction between chains, sprockets, shafts, and drivers. - Cleaning/removing large scales periodically to reduce the wear and tear.

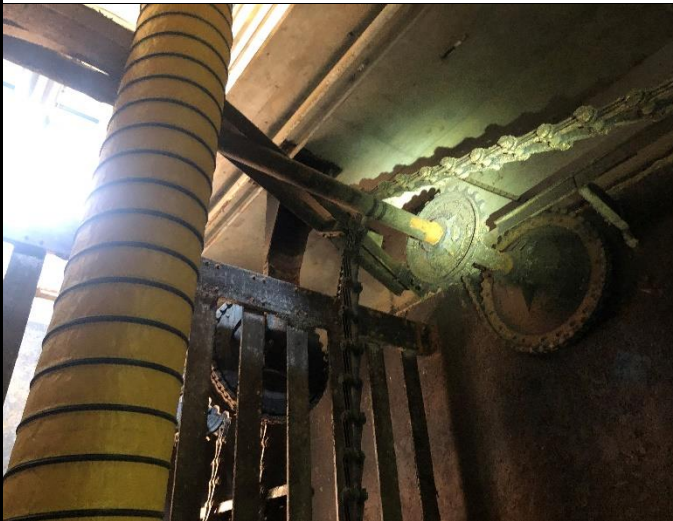
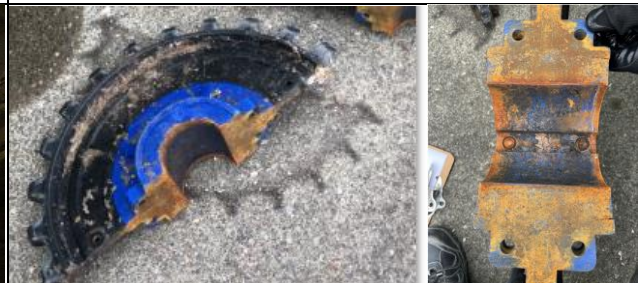
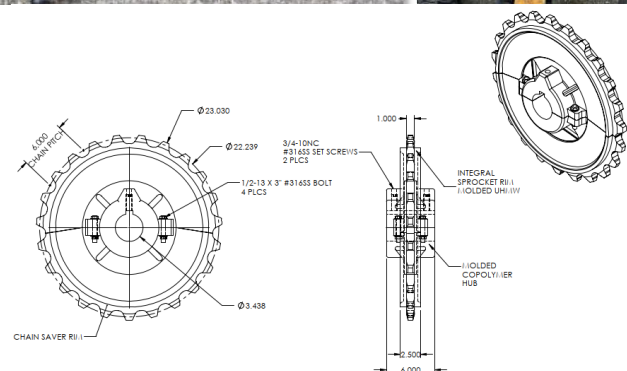
Item No:	M07-1L – Drive Sprocket
Action Plan & Resolution Timeline Required:	1 year
Repair Priority:	New (has been replaced November 2021)
Location Detail: Tank #1	Description:

Original Equipment -
The sprockets on the shaft were in a rusty/scaled condition.

- An engineering investigation should be performed for a root cause analysis over the malfunctioning of the mechanical system along with the corrosion parameters to determine a maintenance plan/possible design modification.
- All manufacturers' maintenance manuals of moving parts shall be followed.
- Alignment of the drivers within the driving sprockets configuration shall be checked periodically ensuring there is no excessive misalignment/friction between chains, sprockets, shafts, and drivers.
- Cleaning/removing scales periodically to reduce the wear and tear.
- Inspecting driven sprockets periodically, ensuring they are fixed on the shaft and fully synchronized with the driver shaft/sprocket without any slippage.

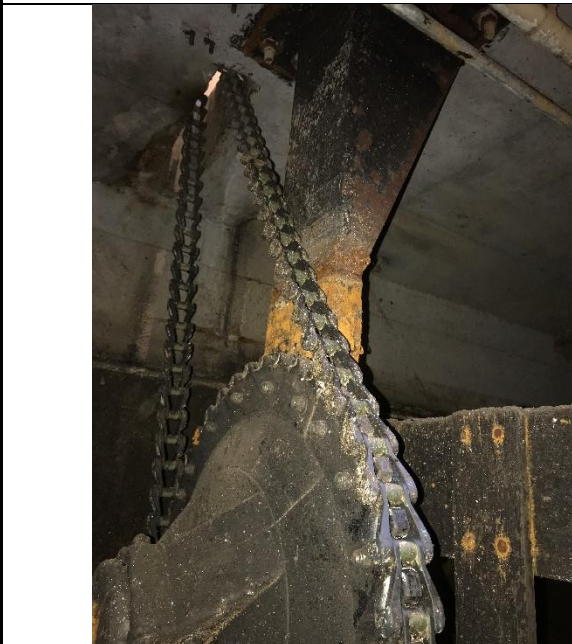
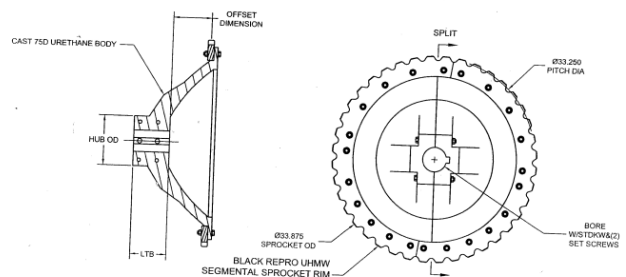
Item No:	M08-1L – Dished Offset Sprocket
Action Plan & Resolution Timeline Required:	1 year
Repair Priority:	New (has been replaced November 2021)
Location Detail: Tank #1	Description:

Original Equipment -
The sprockets on the shaft were in a rusty/scaled condition.

- An engineering investigation should be performed for a root cause analysis over the malfunctioning of the mechanical system along with the corrosion parameters to determine a maintenance plan/possible design modification.
- All manufacturers' maintenance manuals of moving parts shall be followed.
- Alignment of the drivers within the driving sprockets configuration shall be checked periodically ensuring there is no excessive misalignment/friction between chains, sprockets, shafts, and drivers.
- Cleaning/removing scales periodically to reduce the wear and tear.
- Inspecting driven sprockets periodically, ensuring they are fixed on the shaft and fully synchronized with the driver shaft/sprocket without any slippage.

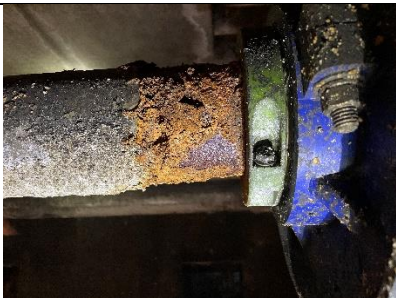
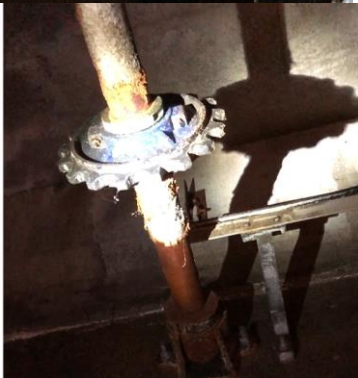
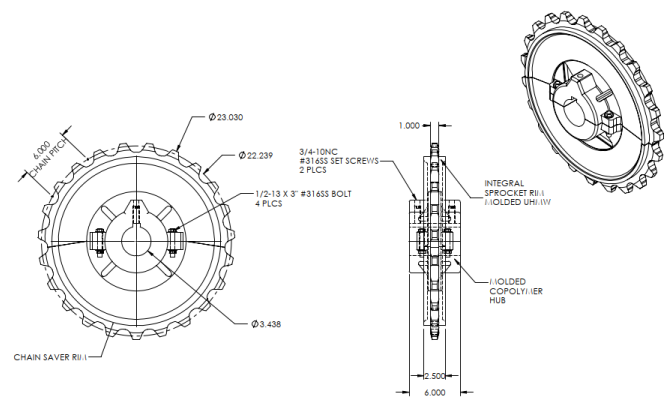
Item No:	M09-1L – Idler Sprocket
Action Plan & Resolution Timeline Required:	1 year
Repair Priority:	New (has been replaced November 2021)
Location Detail: Tank #1	Description:

Original Equipment -
The sprockets on the shaft were in a rusty/scaled condition. The shaft corrosion potentially caused restrictions in the movement of the sprockets.

- An engineering investigation should be performed for a root cause analysis over the malfunctioning of the mechanical system along with the corrosion parameters to determine a maintenance plan/possible design modification.
- All manufacturers' maintenance manuals of moving parts shall be followed.
- Alignment of the drivers within the driving sprockets configuration shall be checked periodically ensuring there is no excessive misalignment/friction between chains, sprockets, shafts, and drivers.
- Cleaning/removing scales periodically to reduce the wear and tear.
- Inspecting driven sprockets periodically, ensuring they are fixed on the shaft and fully synchronized with the driver shaft/sprocket without any slippage.

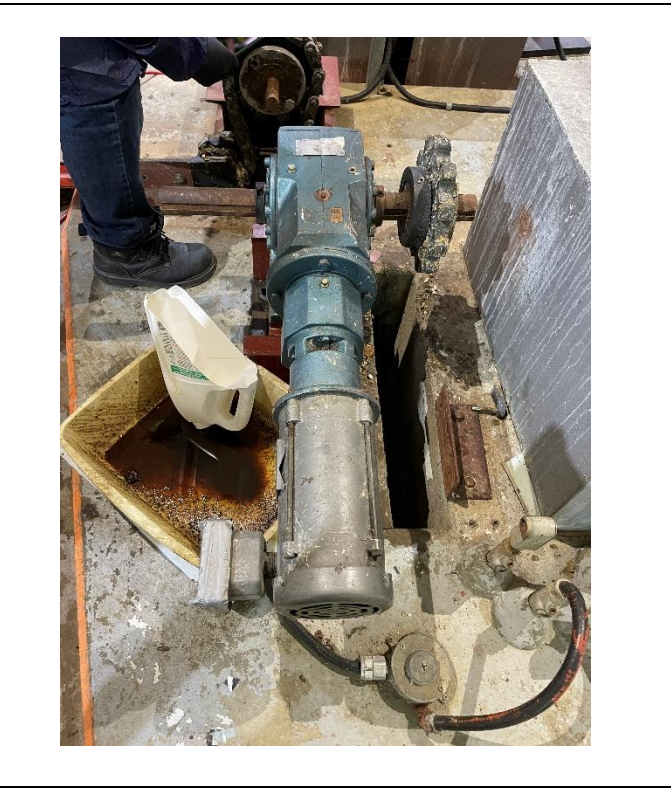
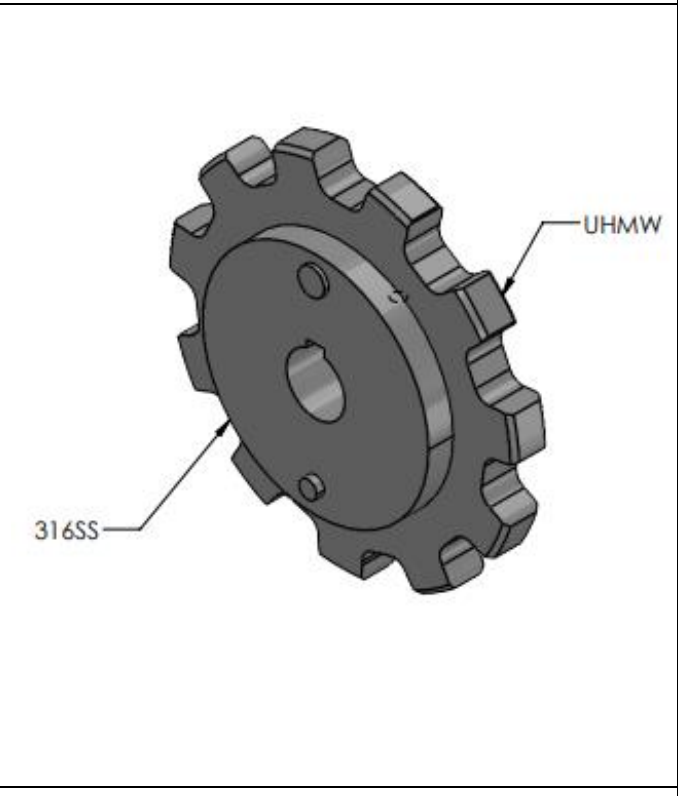
Item No:	M10-1L – Shear Pin Sprocket
Action Plan & Resolution Timeline Required:	1 year
Repair Priority:	New (has been replaced November 2021)
Location Detail: Tank #1	Description:

Original Equipment -
The sprockets on the drive motor shaft were in fair condition.

- All manufacturers' maintenance manuals of moving parts shall be followed.
- Alignment of the drivers within the driving sprockets configuration shall be checked periodically ensuring there is no excessive misalignment/friction between chains, sprockets, shafts, and drivers.
- Cleaning/removing scales periodically to reduce the wear and tear.
- Inspecting driven sprockets periodically, ensuring they are fixed on the shaft and fully synchronized with the driver shaft/sprocket without any slippage.

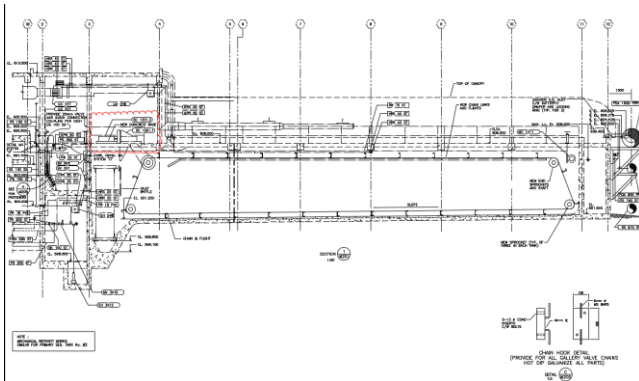
Item No:	M11-1L – Take Up Assembly
Action Plan & Resolution Timeline Required:	1 year
Repair Priority:	New (has been replaced November 2021)
Location Detail: Tank #1	Description:

Original Equipment -
The Take Up Assemblies were in fair condition.

- All manufacturers' maintenance manuals of moving parts shall be followed.
- Alignment of the drivers within the driving sprockets configuration shall be checked periodically ensuring there is no excessive misalignment/friction between chains, sprockets, shafts, and drivers.
- Cleaning/removing scales periodically to reduce the wear and tear.
- Inspecting driven sprockets periodically, ensuring they are fixed on the shaft and fully synchronized with the driver shaft/sprocket without any slippage.

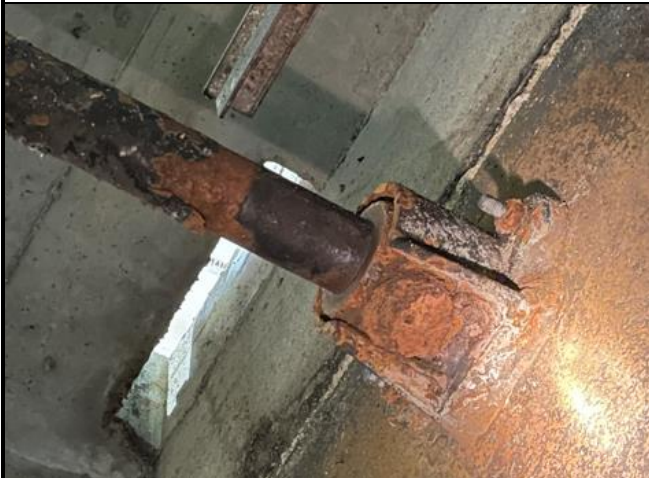
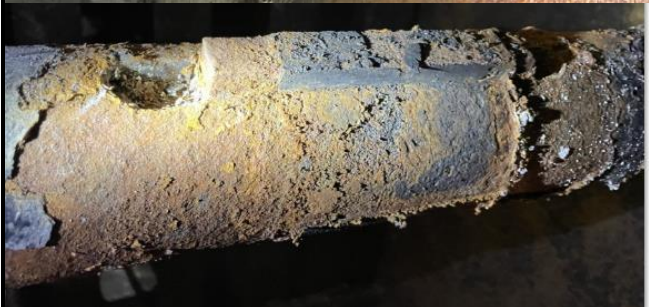
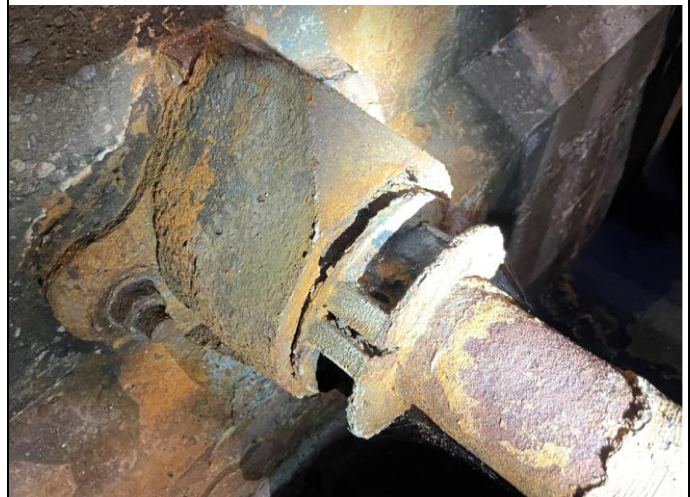
Item No:	M12-1L – Wall Bearings
Action Plan & Resolution Timeline Required:	1 year
Repair Priority:	New (has been replaced November 2021)
Location Detail: Tank #1	Description:

Original Equipment -
The wall bearings were in a rusty/scaled condition.

- An engineering investigation should be performed for a root cause analysis over the malfunctioning of the mechanical system along with the corrosion parameters to determine a maintenance plan/possible design modification.
- All manufacturers' maintenance manuals of moving parts shall be followed.
- Cleaning/removing scales periodically to reduce the wear and tear.
- Inspecting shafts and wall bearings periodically, ensuring they are functioning properly within the whole power transmission system.

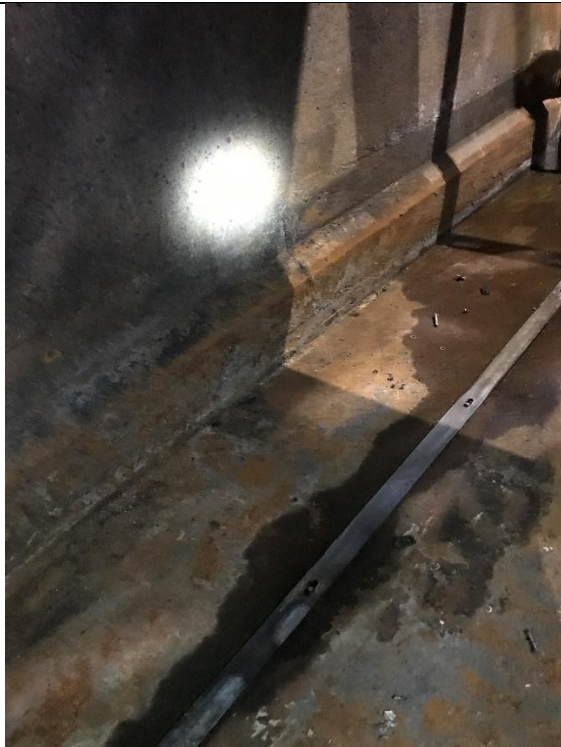
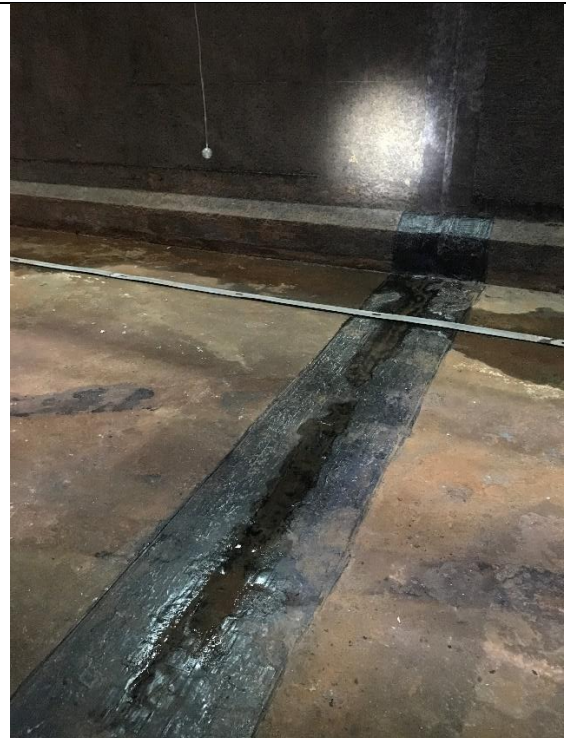
Item No:	M13-1L – Collector Wear Strip
Action Plan & Resolution Timeline Required:	1 year
Repair Priority:	New (has been replaced November 2021)
Location Detail: Tank #1	Description:
	Original Equipment - The wear strips were in fair conditions. No major deficiencies were detected.
	Required Action:
	<ul style="list-style-type: none"> - All manufacturers' maintenance manuals of moving parts shall be followed. - Inspection of wear shall be conducted on a regular basis.

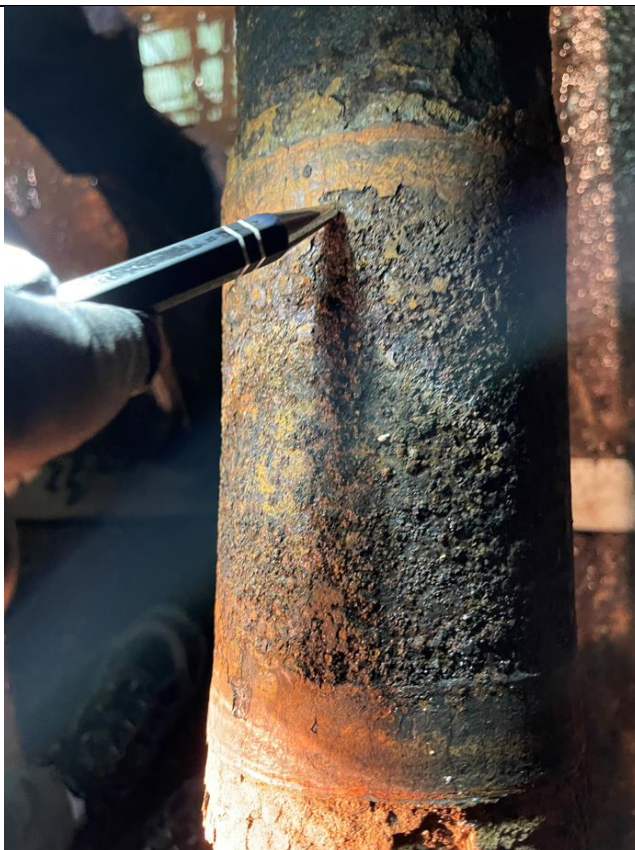
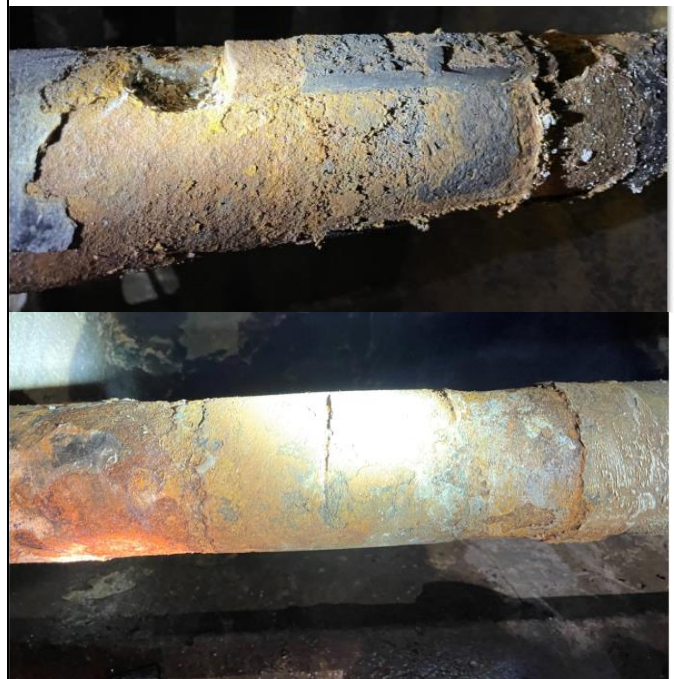
Item No:	M14-1L – Shafts, Pins and set collars
Action Plan & Resolution Timeline Required:	1 year
Repair Priority:	P2
Location Detail: Tank #1	Description:

Original Equipment -
The shafts were in a rusty/scaled condition.

- An engineering investigation should be performed for a root cause analysis over the malfunctioning of the mechanical system along with the corrosion parameters to determine a maintenance plan/possible design modification.
- All manufacturers' maintenance manuals of moving parts shall be followed.
- Cleaning/removing scales periodically to reduce the wear and tear.
- Inspecting shafts and wall bearings periodically, ensuring they are functioning properly within the whole power transmission system.

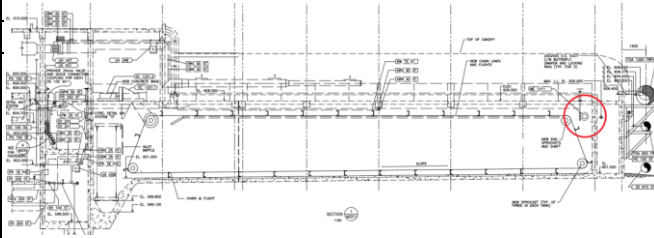
Item No:	M15-1L – Skimmer
Action Plan & Resolution Timeline Required:	1 year
Repair Priority:	P1E
Location Detail: Tank #1	Description:

The skimmer is in a rusty/scaled condition. Operations noted without occasional movement of the skimmer, they are prone to seizing.

Required Action:

- An engineering investigation should be performed for a root cause analysis over the malfunctioning of the mechanical system along with the corrosion parameters.
- Consider a revised design for better reliability. All manufacturers' maintenance manuals of moving parts shall be followed.

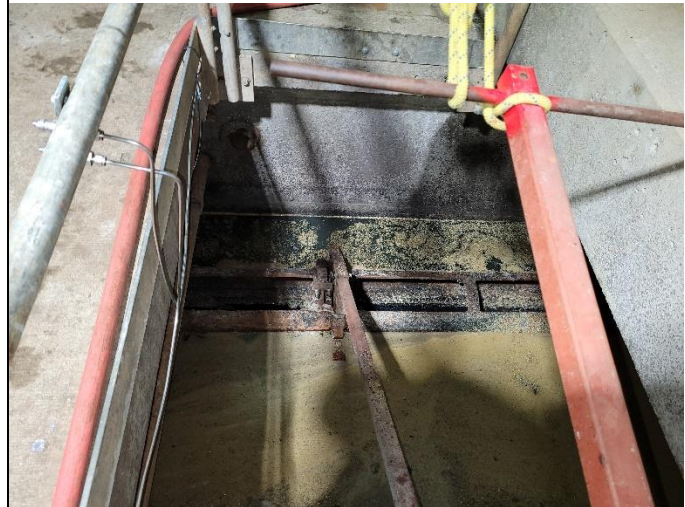
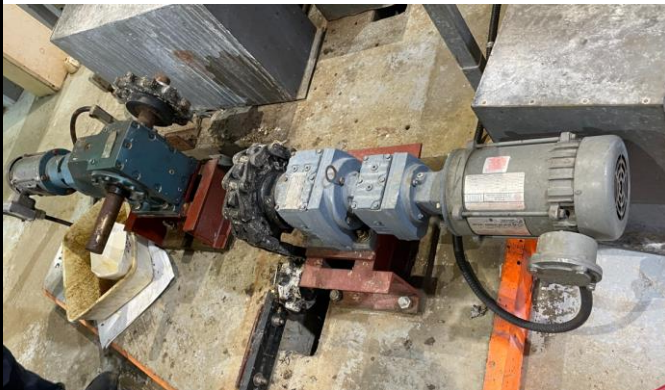
M01-1C – Drive Motor / Drive Gearbox

The motor and gearbox were in a fair condition. However, they are in a corrosive environment and is operating continuously. Periodic maintenance plan is required.

- All manufacturers' maintenance manuals of drivers and motors shall be followed.
- A mechanical/electrical engineering review may be performed. Detailed data logging/reviewing may be conducted to detect potential operational issues by observing the variance in the load/data log results.

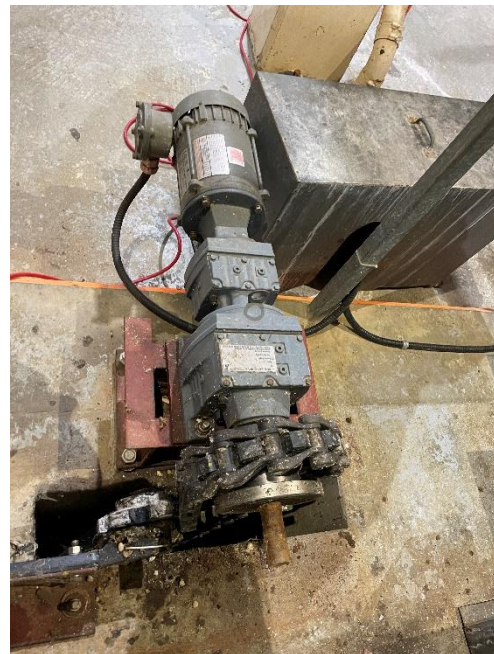
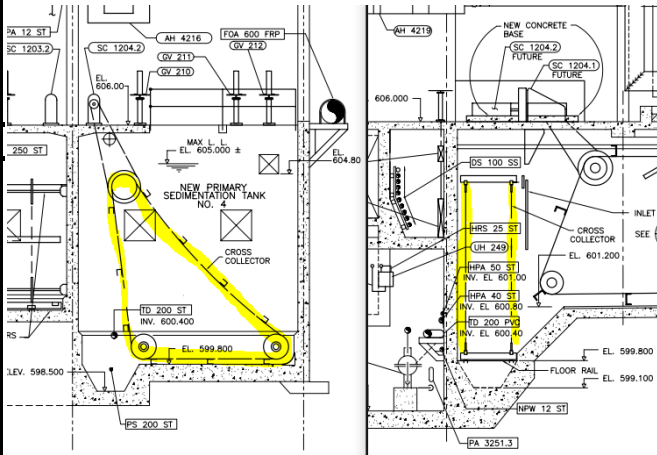
Item No:	M02-1C – Collector Chain
Action Plan & Resolution Timeline Required:	1 year
Repair Priority:	New (has been replaced November 2021)

Location Detail: Tank #1	Description:
	The collector chains were in fair conditions.

Required Action:
<ul style="list-style-type: none"> - All manufacturers' maintenance manuals of moving parts shall be followed. - Alignment of the drivers within the driving sprockets configuration shall be checked periodically ensuring there is no excessive misalignment/friction between chains, sprockets, shafts, and drivers. - Cleaning/removing large scales periodically to reduce the wear and tear.

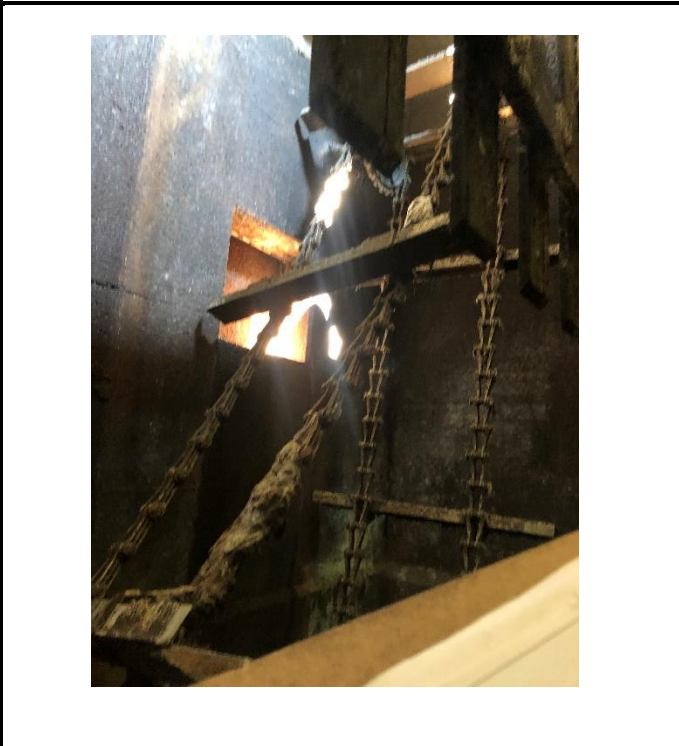
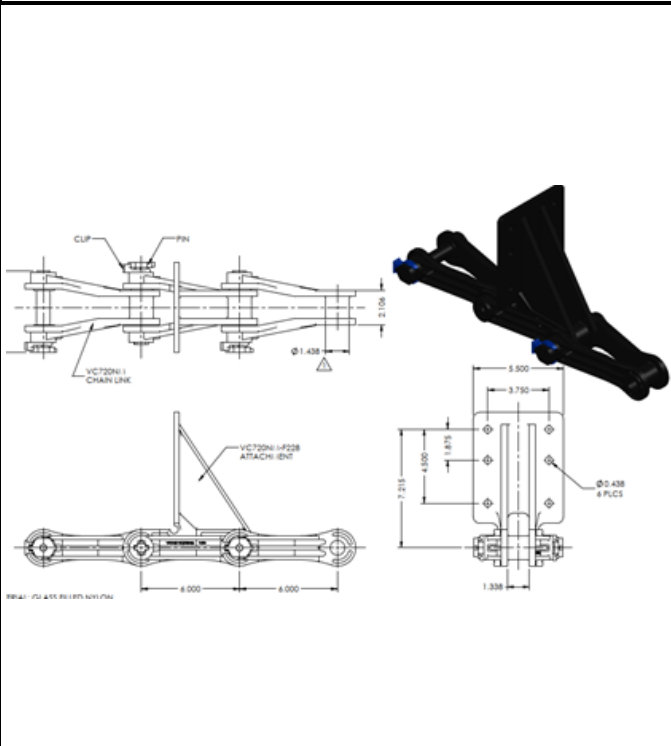
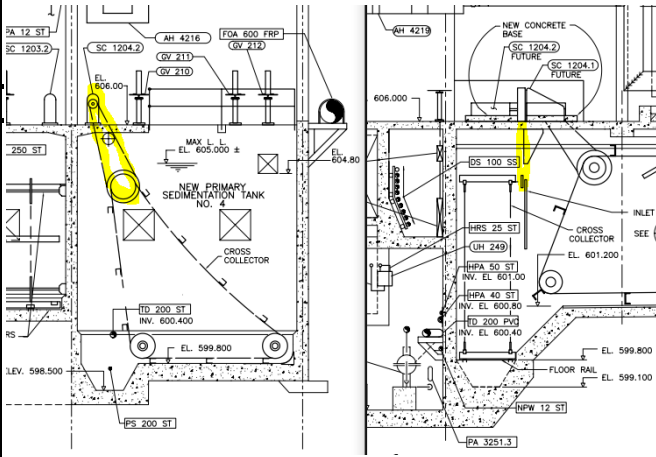
M03-1C – Drive Chain

The drive chains were in fair conditions.

- All manufacturers' maintenance manuals of moving parts shall be followed.
- Alignment of the drivers within the driving sprockets configuration shall be checked periodically ensuring there is no excessive misalignment/friction between chains, sprockets, shafts, and drivers.
- Cleaning/removing large scales periodically to reduce the wear and tear.

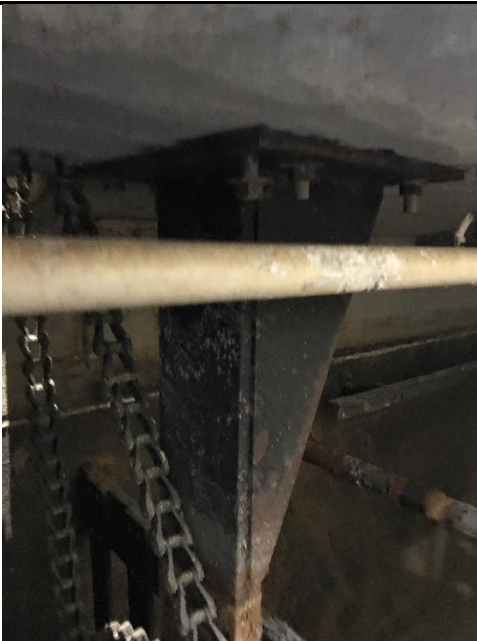
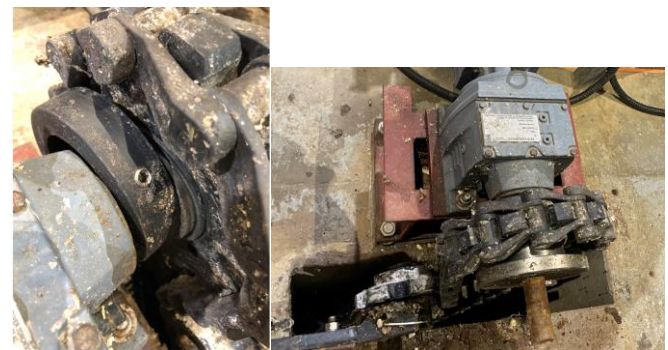
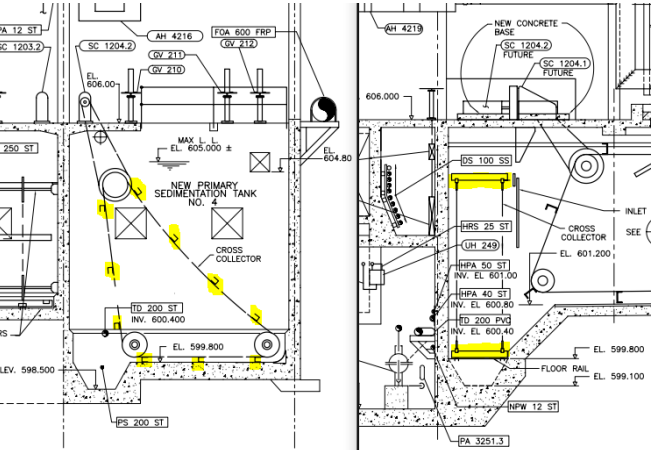
Item No:	M04-1C – Wear Shoes
Action Plan & Resolution Timeline Required:	1 year
Repair Priority:	New (has been replaced November 2021)

The wear shoes were in fair conditions. No major deficiencies were detected.

- All manufacturers' maintenance manuals of moving parts shall be followed.
- Inspection of wear shall be conducted on a regular basis.

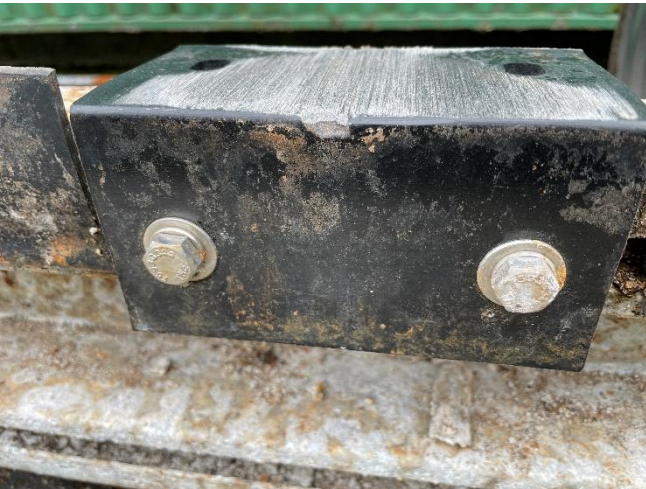
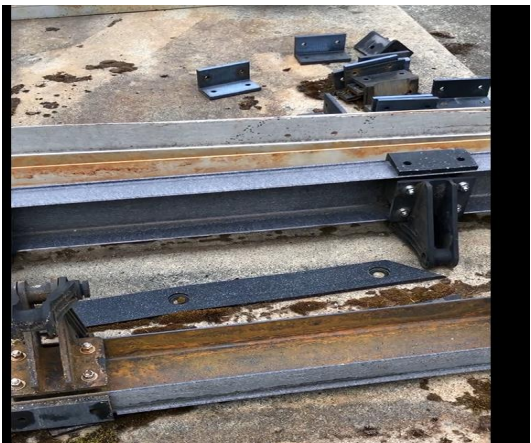
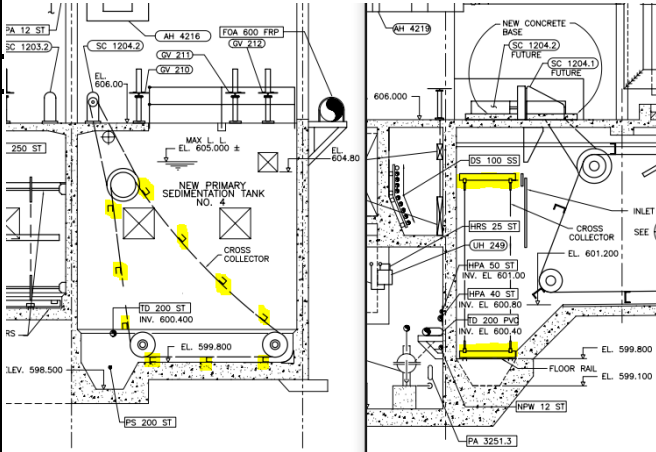
Item No:	M05-1C – Filler Blocks
Action Plan & Resolution Timeline Required:	1 year
Repair Priority:	New (has been replaced November 2021)

The filler blocks were in fair conditions. No major deficiencies were detected.

- Inspection for all the fasteners shall be conducted periodically.

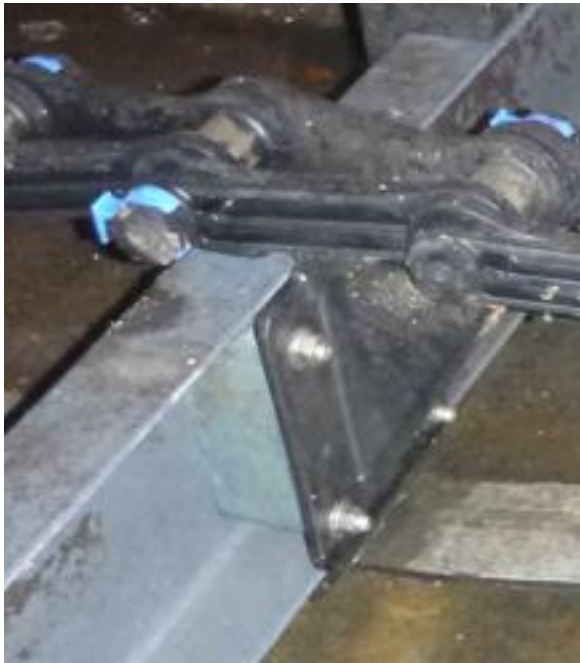
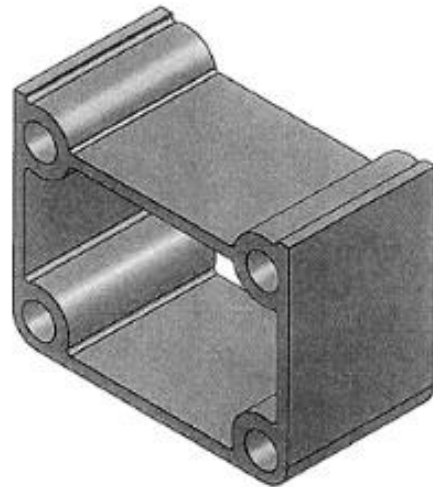
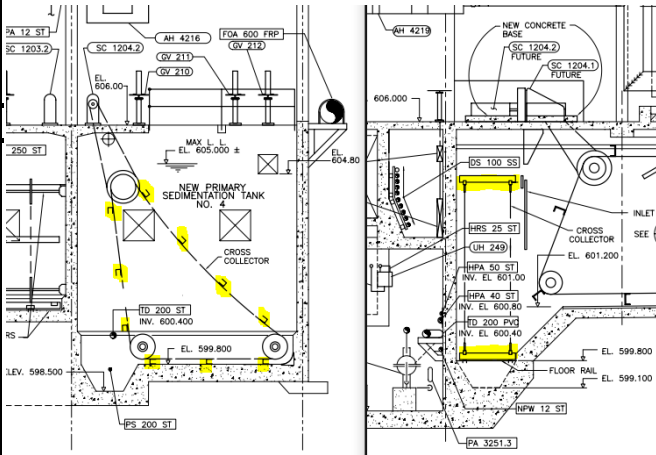
M06-1C – C-Channel Fiberglass Flights

The flight assembly were in fair conditions.

- An engineering investigation shall be performed for a root cause analysis over the malfunctioning of the mechanical system along with the corrosion parameters to determine a maintenance plan/possible design modification.
- All manufacturers' maintenance manuals of moving parts shall be followed.
- Alignment of the drivers within the driving sprockets configuration shall be checked periodically ensuring there is no excessive misalignment/friction between chains, sprockets, shafts, and drivers.
- Cleaning/removing large scales periodically to reduce the wear and tear.

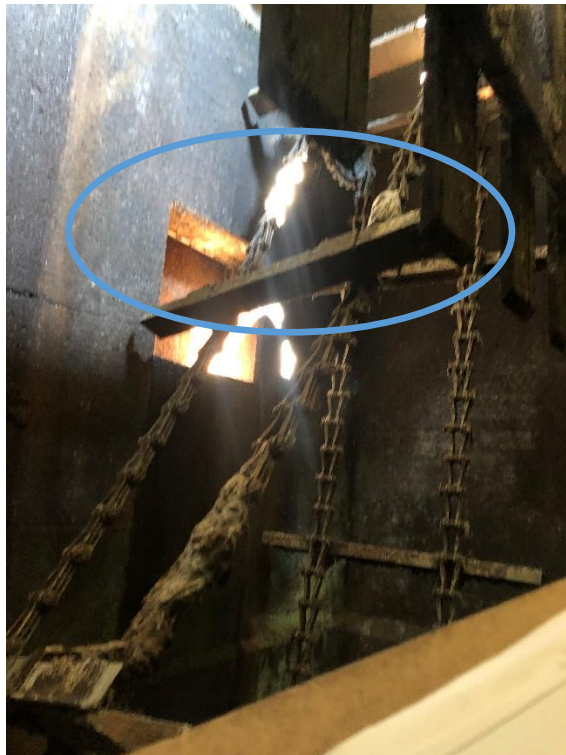
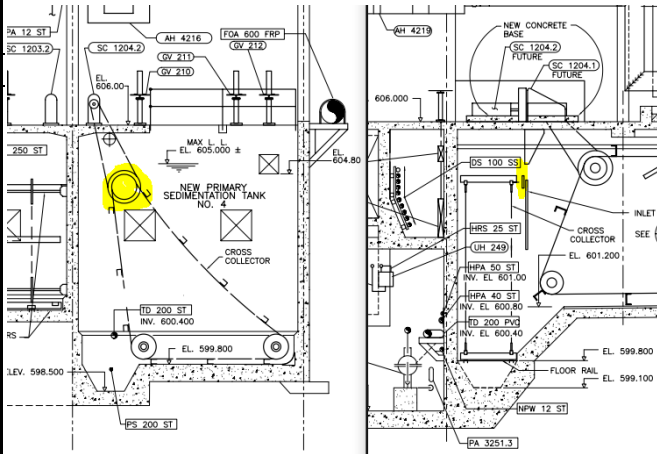
Item No:	M07-1C – Drive Sprocket
Action Plan & Resolution Timeline Required:	1 year
Repair Priority:	New (has been replaced November 2021)
Location Detail: Tank #1	Description:

The sprockets on the shaft were in a rusty/scaled condition.

- An engineering investigation should be performed for a root cause analysis over the malfunctioning of the mechanical system along with the corrosion parameters to determine a maintenance plan/possible design modification.
- All manufacturers' maintenance manuals of moving parts shall be followed.
- Alignment of the drivers within the driving sprockets configuration shall be checked periodically ensuring there is no excessive misalignment/friction between chains, sprockets, shafts, and drivers.
- Cleaning/removing scales periodically to reduce the wear and tear.
- Inspecting driven sprockets periodically, ensuring they are fixed on the shaft and fully synchronized with the driver shaft/sprocket without any slippage.

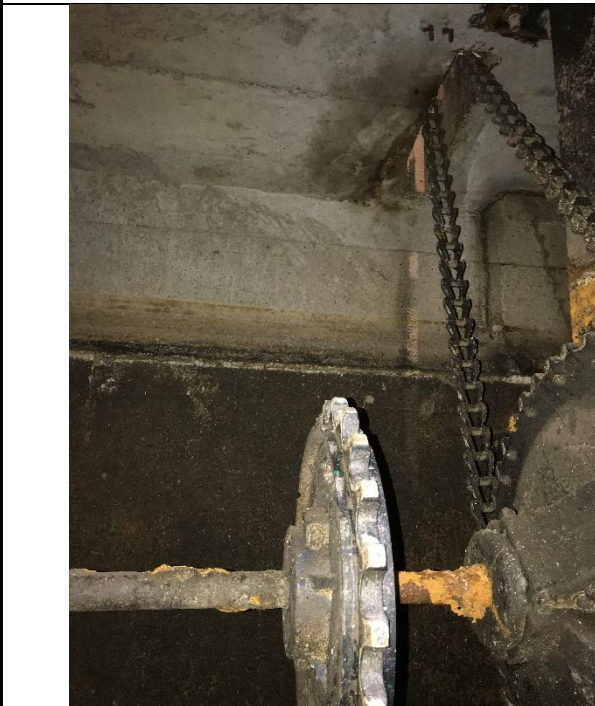
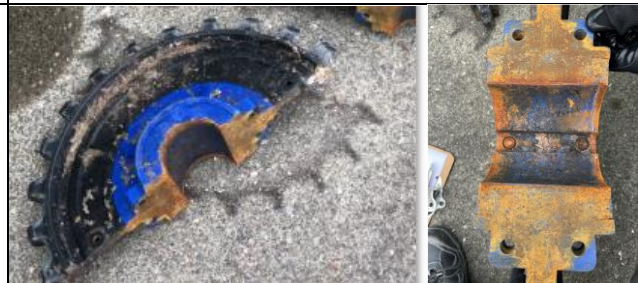
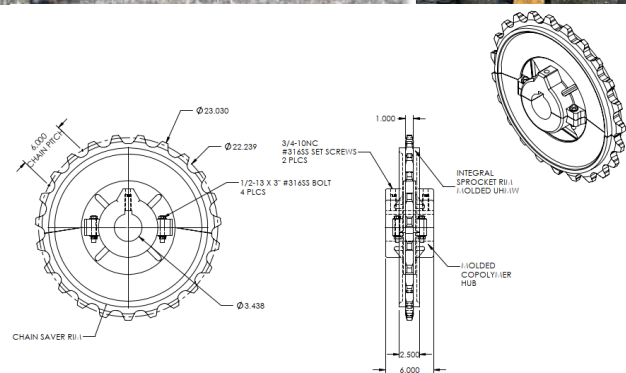
Item No:	M08-1C – Dished Offset Sprocket
Action Plan & Resolution Timeline Required:	1 year
Repair Priority:	New (has been replaced November 2021)
Location Detail: Tank #1	Description:

The sprockets on the shaft were in a rusty/scaled condition.

- An engineering investigation should be performed for a root cause analysis over the malfunctioning of the mechanical system along with the corrosion parameters to determine a maintenance plan/possible design modification.
- All manufacturers' maintenance manuals of moving parts shall be followed.
- Alignment of the drivers within the driving sprockets configuration shall be checked periodically ensuring there is no excessive misalignment/friction between chains, sprockets, shafts, and drivers.
- Cleaning/removing scales periodically to reduce the wear and tear.
- Inspecting driven sprockets periodically, ensuring they are fixed on the shaft and fully synchronized with the driver shaft/sprocket without any slippage.

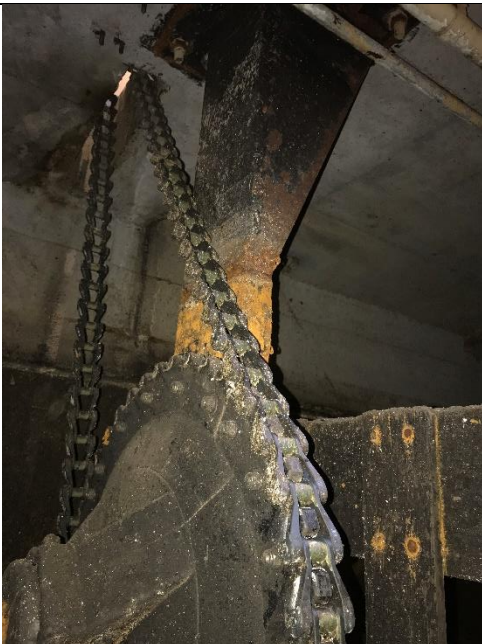
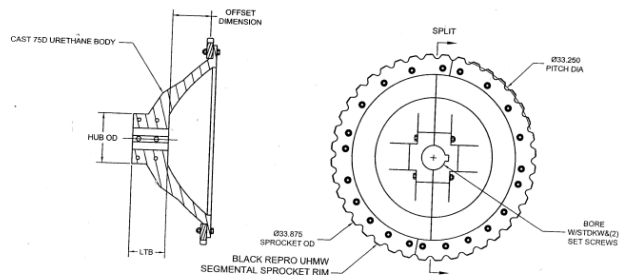
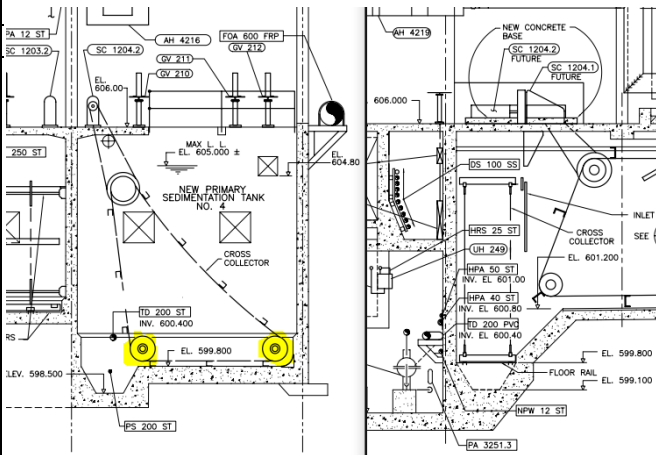
Item No:	M09-1C – Idler Sprocket
Action Plan & Resolution Timeline Required:	1 year
Repair Priority:	New (has been replaced November 2021)
Location Detail: Tank #1	Description:

The sprockets on the shaft were in a rusty/scaled condition. The shaft corrosion potentially caused restrictions in the movement of the sprockets.

- An engineering investigation should be performed for a root cause analysis over the malfunctioning of the mechanical system along with the corrosion parameters to determine a maintenance plan/possible design modification.
- All manufacturers' maintenance manuals of moving parts shall be followed.
- Alignment of the drivers within the driving sprockets configuration shall be checked periodically ensuring there is no excessive misalignment/friction between chains, sprockets, shafts, and drivers.
- Cleaning/removing scales periodically to reduce the wear and tear.
- Inspecting driven sprockets periodically, ensuring they are fixed on the shaft and fully synchronized with the driver shaft/sprocket without any slippage.

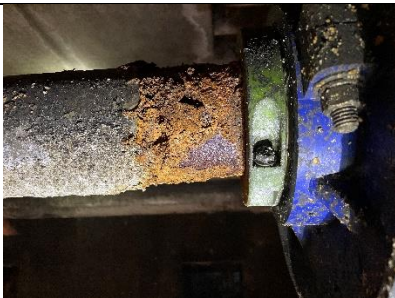
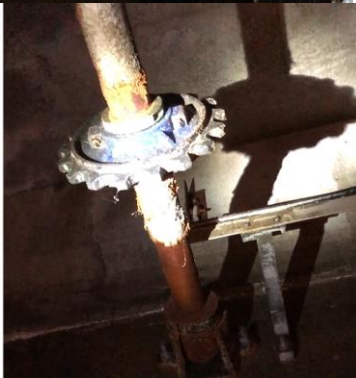
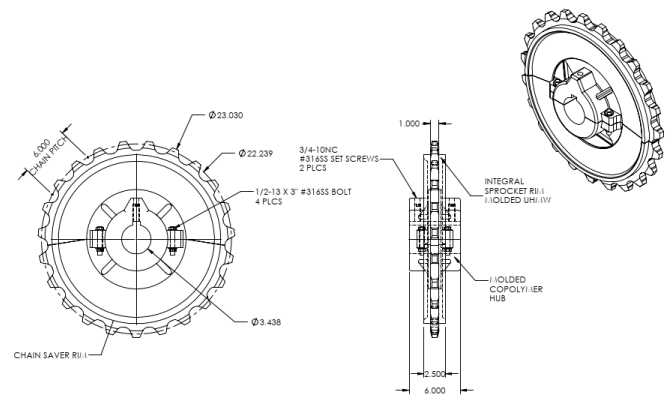
Item No:	M10-1C – Shear Pin Sprocket
Action Plan & Resolution Timeline Required:	1 year
Repair Priority:	New (has been replaced November 2021)
Location Detail: Tank #1	Description:

The sprockets on the drive motor shaft were in fair condition.

- All manufacturers' maintenance manuals of moving parts shall be followed.
- Alignment of the drivers within the driving sprockets configuration shall be checked periodically ensuring there is no excessive misalignment/friction between chains, sprockets, shafts, and drivers.
- Cleaning/removing scales periodically to reduce the wear and tear.
- Inspecting driven sprockets periodically, ensuring they are fixed on the shaft and fully synchronized with the driver shaft/sprocket without any slippage.

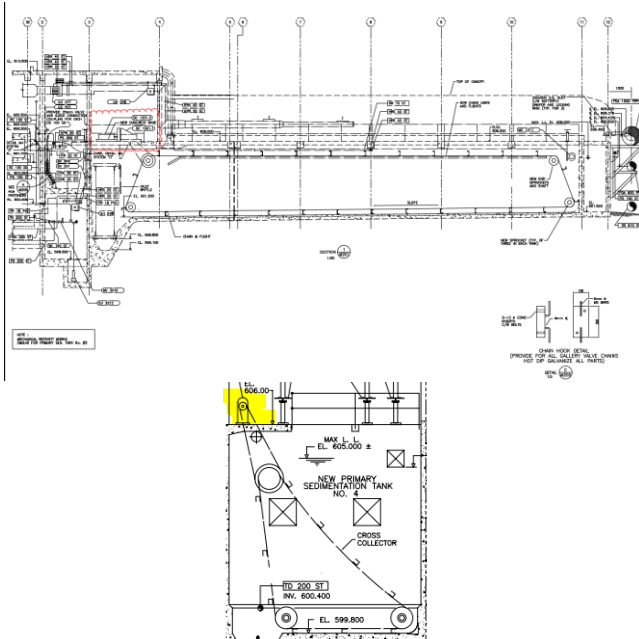
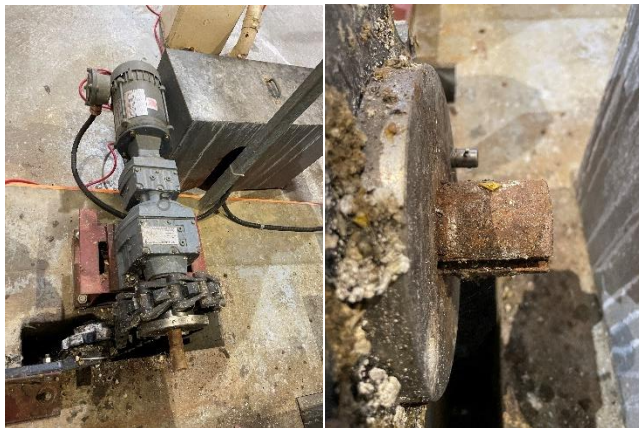
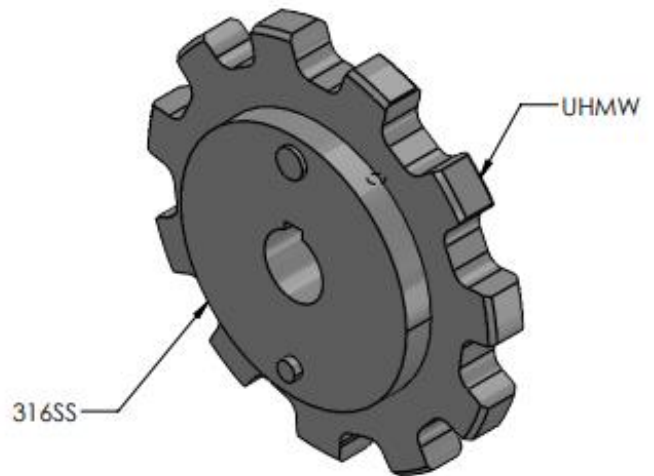
Item No:	M11-1C – Take Up Assembly
Action Plan & Resolution Timeline Required:	1 year
Repair Priority:	New (has been replaced November 2021)
Location Detail: Tank #1	Description:

The Take Up Assemblies were in fair condition.

- All manufacturers' maintenance manuals of moving parts shall be followed.
- Alignment of the drivers within the driving sprockets configuration shall be checked periodically ensuring there is no excessive misalignment/friction between chains, sprockets, shafts, and drivers.
- Cleaning/removing scales periodically to reduce the wear and tear.
- Inspecting driven sprockets periodically, ensuring they are fixed on the shaft and fully synchronized with the driver shaft/sprocket without any slippage.

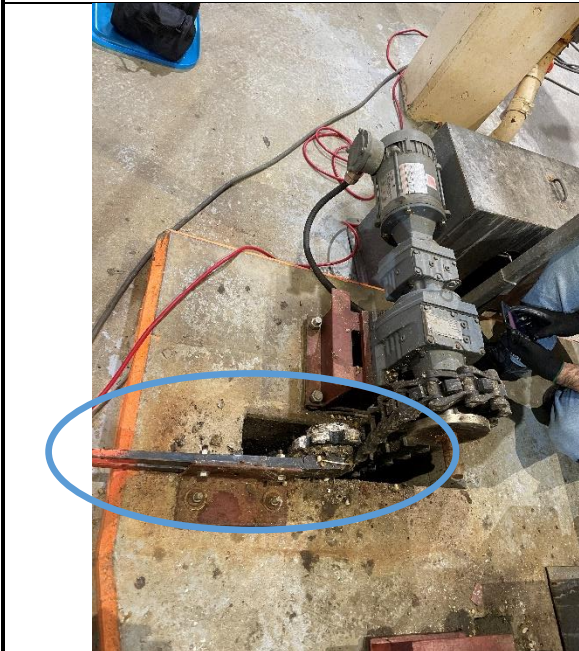
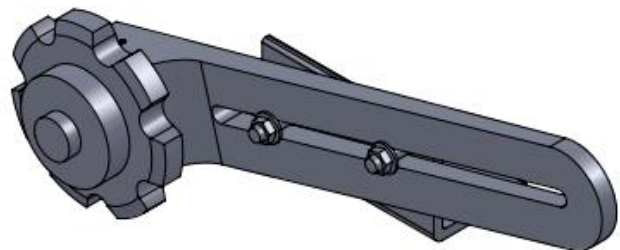
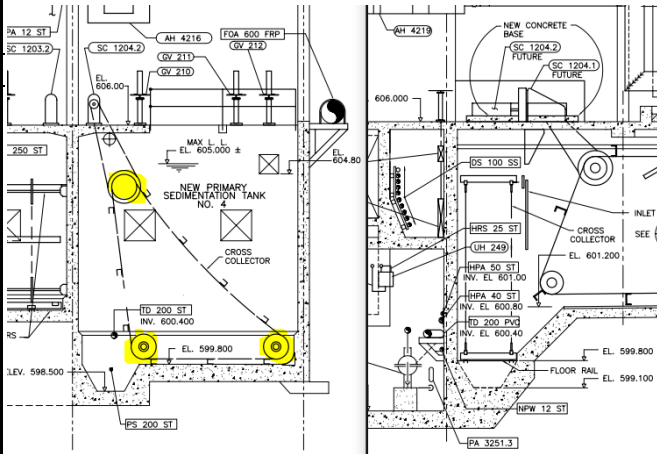
Item No:	M12-1C – Wall Bearings
Action Plan & Resolution Timeline Required:	1 year
Repair Priority:	New (has been replaced November 2021)
Location Detail: Tank #1	Description:

The wall bearings were in a rusty/scaled condition.

- An engineering investigation should be performed for a root cause analysis over the malfunctioning of the mechanical system along with the corrosion parameters to determine a maintenance plan/possible design modification.
- All manufacturers' maintenance manuals of moving parts shall be followed.
- Cleaning/removing scales periodically to reduce the wear and tear.
- Inspecting shafts and wall bearings periodically, ensuring they are functioning properly within the whole power transmission system.
