Resort Municipality of Whistler: Wastewater Treatment Plant Primary Sedimentation Tank Assessment Report

Project No. 210505

January 26th, 2022

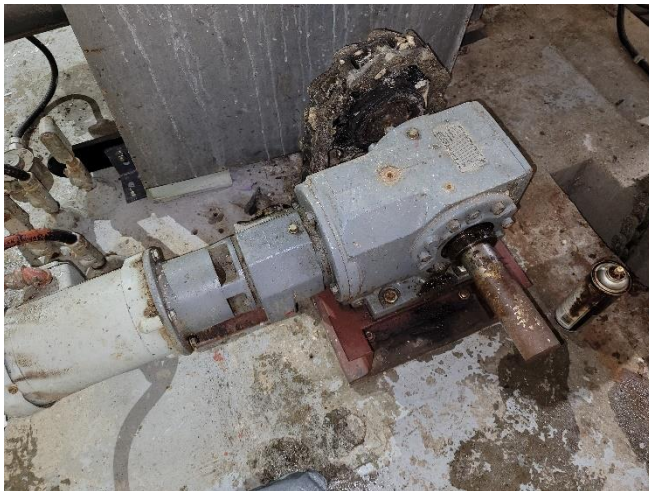
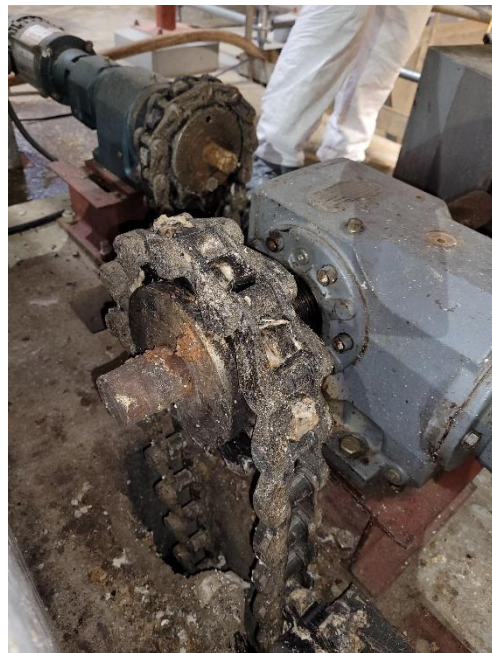
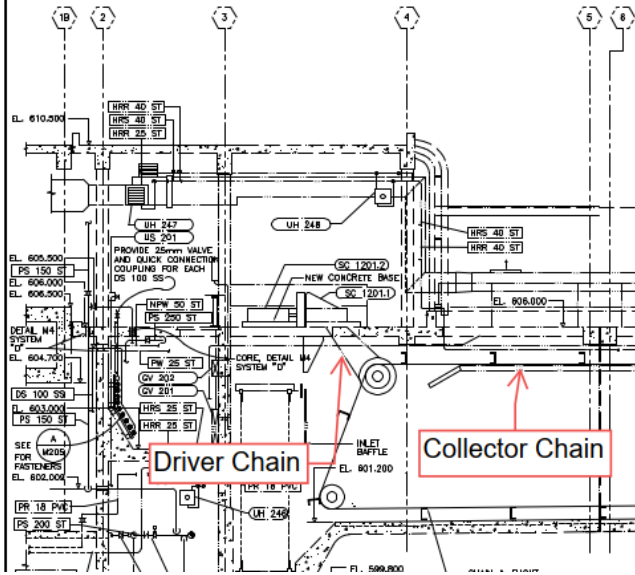
Item No: M02-2L – Collector Chain

Description:
The collector chains were in fair conditions. However, restrictions on the movement of the wall bearings and sprockets caused increased tension and stresses on the equipment.

- All manufacturers' maintenance manuals of moving parts shall be followed.
- Alignment of the drivers within the driving sprockets configuration shall be checked periodically ensuring there is no excessive misalignment/friction between chains, sprockets, shafts, and drivers.
- Cleaning/removing large scales periodically to reduce the wear and tear.

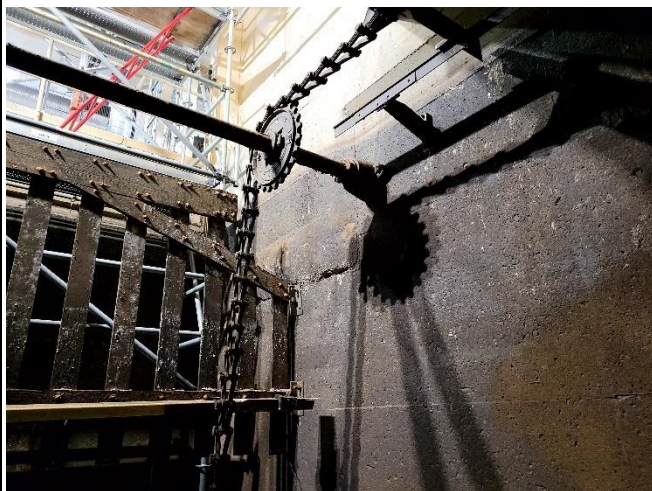
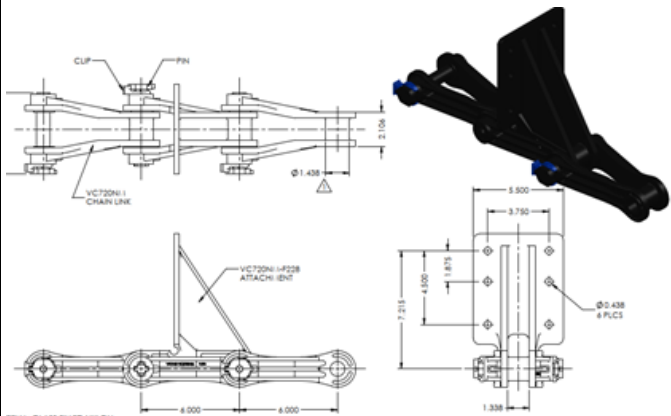
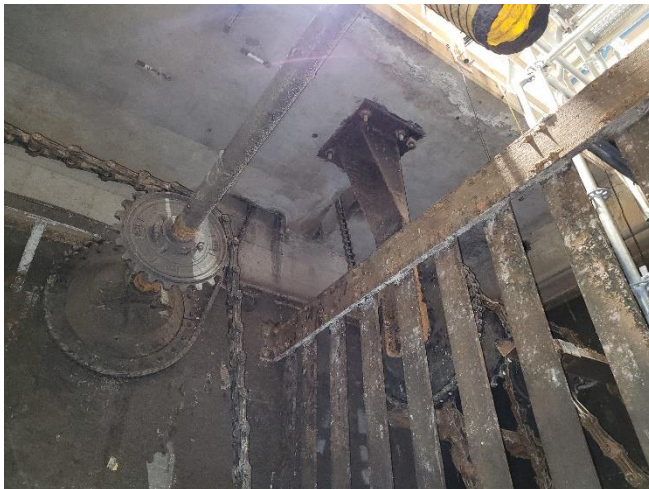
M03-2L – Drive Chain

The drive chains were in fair conditions. However, restrictions on the movement of the wall bearings and sprockets caused increased tension and stresses on the equipment.

- All manufacturers' maintenance manuals of moving parts shall be followed.
- Alignment of the drivers within the driving sprockets configuration shall be checked periodically ensuring there is no excessive misalignment/friction between chains, sprockets, shafts, and drivers.
- Cleaning/removing large scales periodically to reduce the wear and tear.

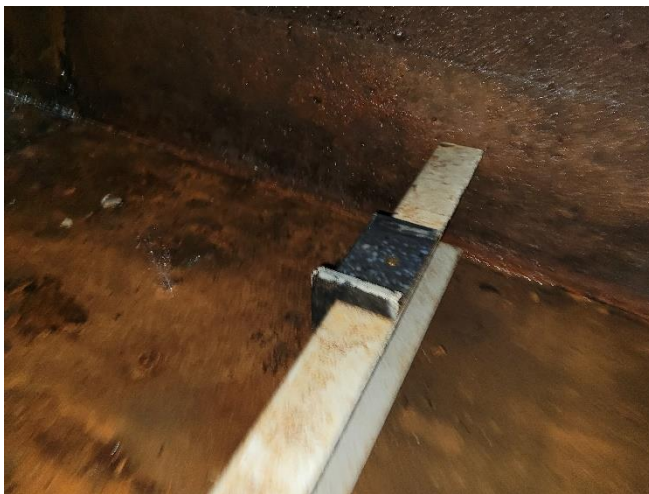
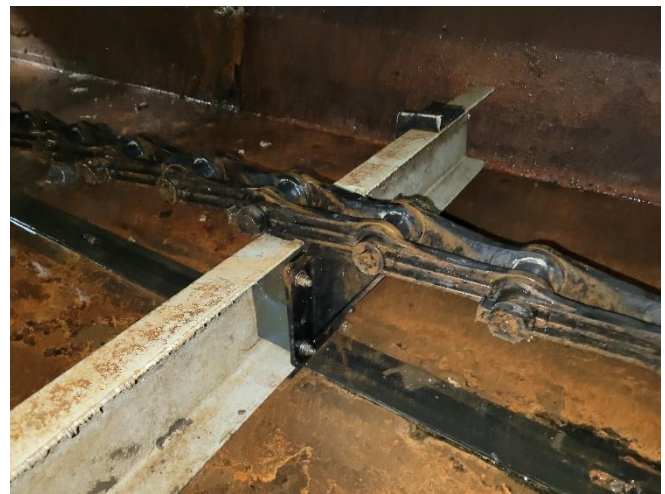
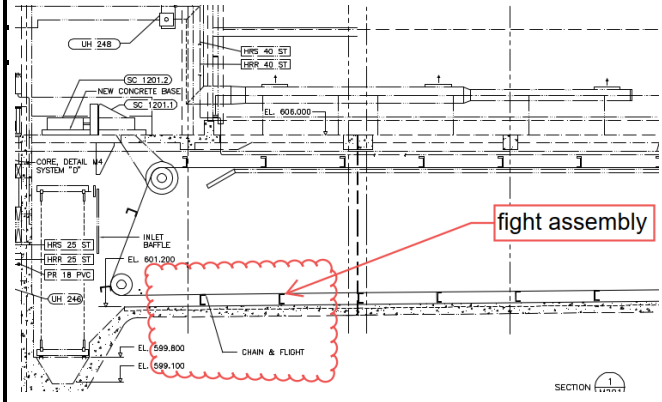
Item No:	M05-2L – Filler Blocks
Action Plan & Resolution Timeline Required:	1 year
Repair Priority:	P2

The filler blocks were in fair conditions. No major deficiencies were detected.

- Inspection for all the fasteners shall be conducted periodically.

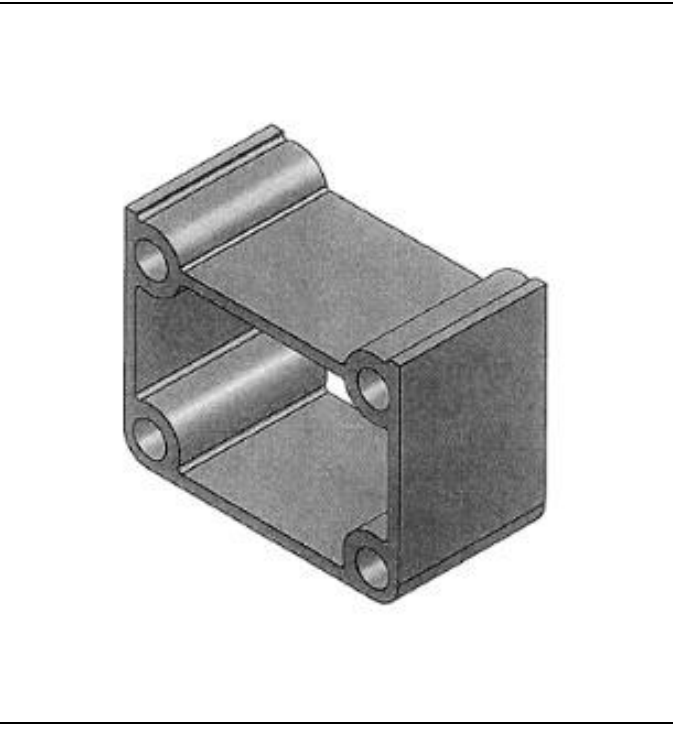
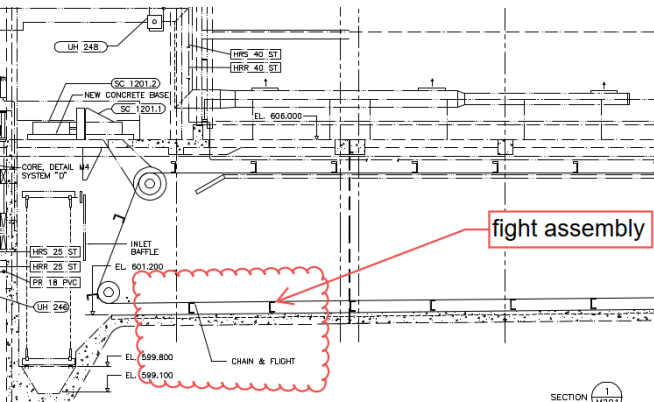
Item No:	M06-2L – C-Channel Fiberglass Flights
Action Plan & Resolution Timeline Required:	1 year
Repair Priority:	P1E
Location Detail: Tank #2	Description:

<p>The flight assembly were in fair conditions.</p>
	<p>Required Action:</p> <ul style="list-style-type: none"> - An engineering investigation shall be performed for a root cause analysis over the malfunctioning of the mechanical system along with the corrosion parameters to determine a maintenance plan/possible design modification. - All manufacturers' maintenance manuals of moving parts shall be followed. - Alignment of the drivers within the driving sprockets configuration shall be checked periodically ensuring there is no excessive misalignment/friction between chains, sprockets, shafts, and drivers. - Cleaning/removing large scales periodically to reduce the wear and tear.

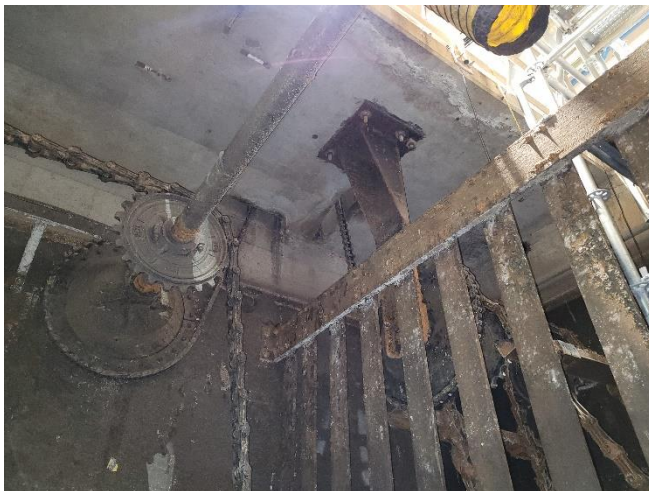
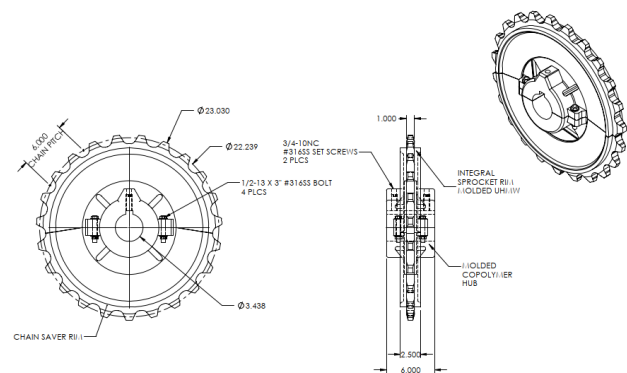
Item No:	M08-2L – Dished Offset Sprocket
Action Plan & Resolution Timeline Required:	1 year
Repair Priority:	P2
Location Detail: Tank #2	Description:

The sprockets on the shaft were in a rusty/scaled condition.

- An engineering investigation should be performed for a root cause analysis over the malfunctioning of the mechanical system along with the corrosion parameters to determine a maintenance plan/possible design modification.
- All manufacturers' maintenance manuals of moving parts shall be followed.
- Alignment of the drivers within the driving sprockets configuration shall be checked periodically ensuring there is no excessive misalignment/friction between chains, sprockets, shafts, and drivers.
- Cleaning/removing scales periodically to reduce the wear and tear.
- Inspecting driven sprockets periodically, ensuring they are fixed on the shaft and fully synchronized with the driver shaft/sprocket without any slippage.

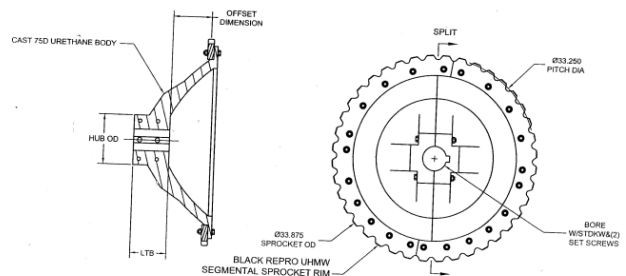
Item No: M09-2L – Idler Sprocket

The sprockets on the shaft were in a rusty/scaled condition. The shaft corrosion potentially caused restrictions in the movement of the sprockets.

- An engineering investigation should be performed for a root cause analysis over the malfunctioning of the mechanical system along with the corrosion parameters to determine a maintenance plan/possible design modification.
- All manufacturers' maintenance manuals of moving parts shall be followed.
- Alignment of the drivers within the driving sprockets configuration shall be checked periodically ensuring there is no excessive misalignment/friction between chains, sprockets, shafts, and drivers.
- Cleaning/removing scales periodically to reduce the wear and tear.
- Inspecting driven sprockets periodically, ensuring they are fixed on the shaft and fully synchronized with the driver shaft/sprocket without any slippage.

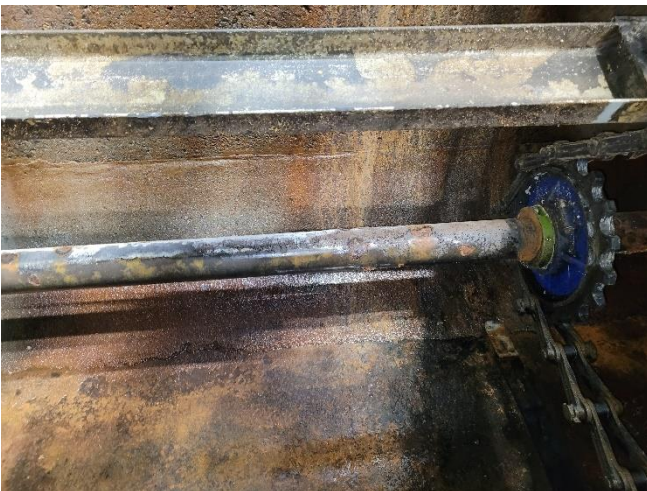
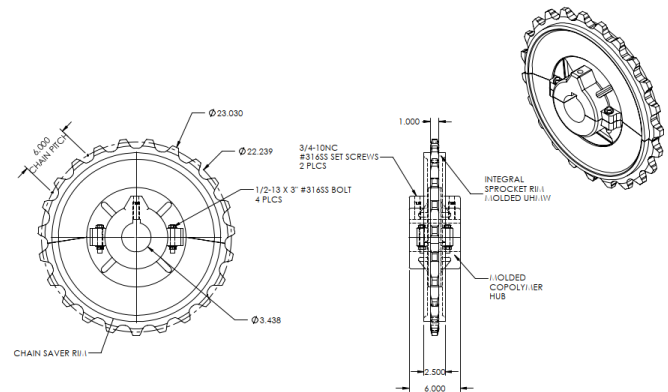
Item No:	M10-2L – Shear Pin Sprocket
Action Plan & Resolution Timeline Required:	1 year
Repair Priority:	P2
Location Detail: Tank #2	Description:

The sprockets on the drive motor shaft were in fair condition.

- All manufacturers' maintenance manuals of moving parts shall be followed.
- Alignment of the drivers within the driving sprockets configuration shall be checked periodically ensuring there is no excessive misalignment/friction between chains, sprockets, shafts, and drivers.
- Cleaning/removing scales periodically to reduce the wear and tear.
- Inspecting driven sprockets periodically, ensuring they are fixed on the shaft and fully synchronized with the driver shaft/sprocket without any slippage.

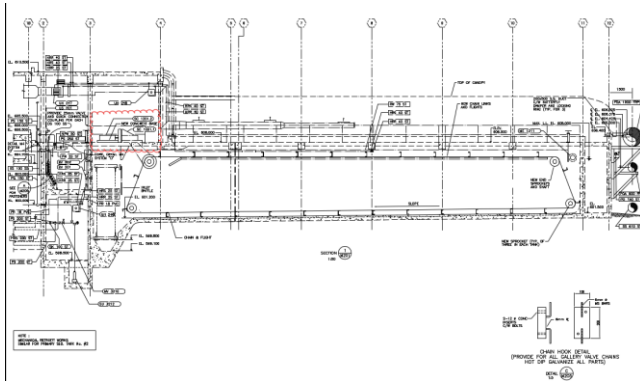
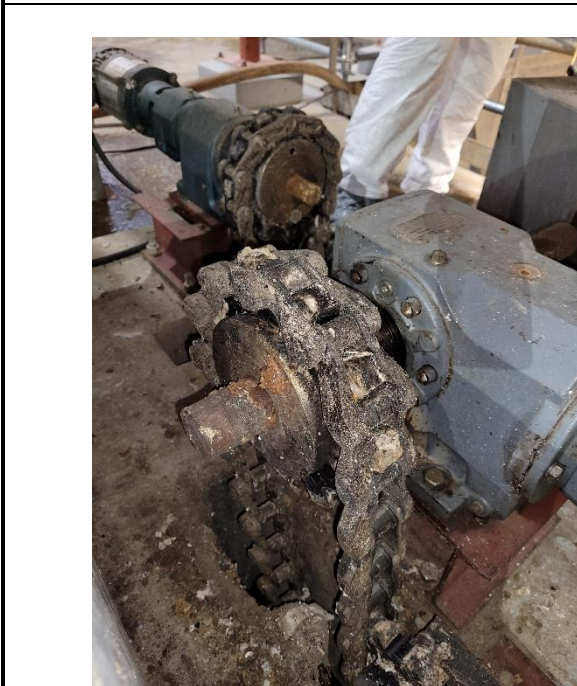
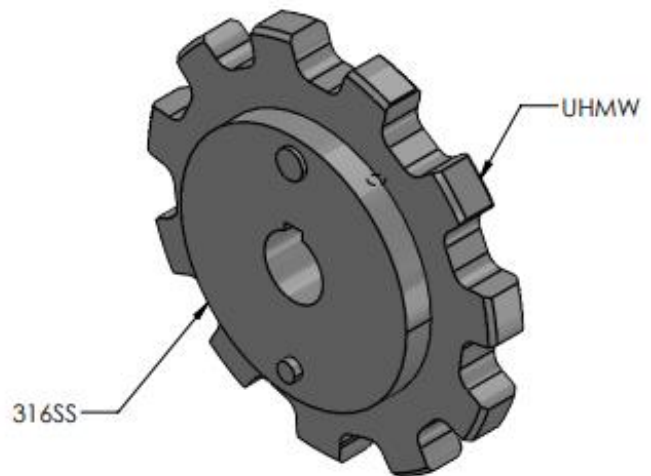
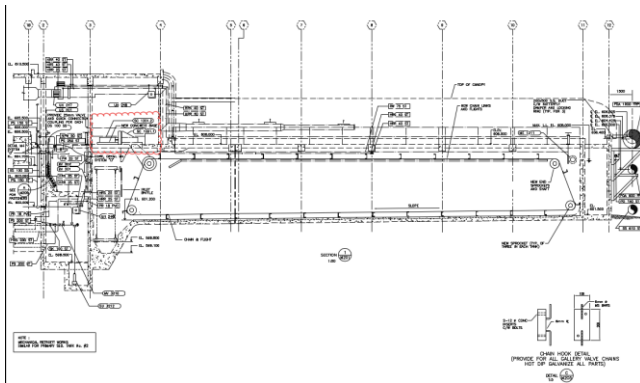
Item No:	M11-2L – Take Up Assembly
Action Plan & Resolution Timeline Required:	1 year
Repair Priority:	P2
Location Detail: Tank #2	Description:

The Take Up Assemblies were in fair condition.

- All manufacturers' maintenance manuals of moving parts shall be followed.
- Alignment of the drivers within the driving sprockets configuration shall be checked periodically ensuring there is no excessive misalignment/friction between chains, sprockets, shafts, and drivers.
- Cleaning/removing scales periodically to reduce the wear and tear.
- Inspecting driven sprockets periodically, ensuring they are fixed on the shaft and fully synchronized with the driver shaft/sprocket without any slippage.

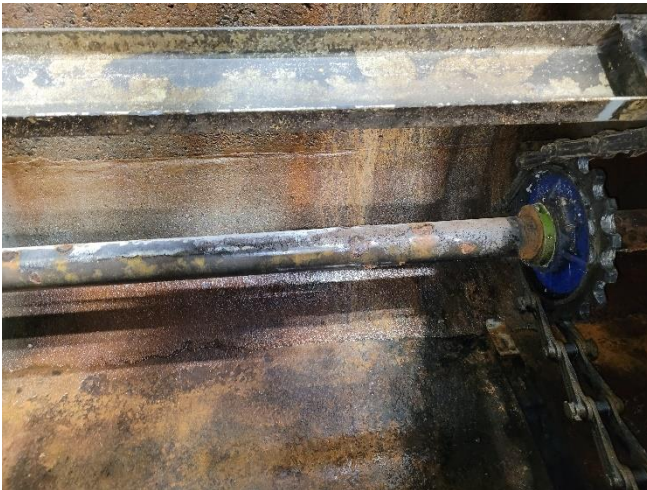
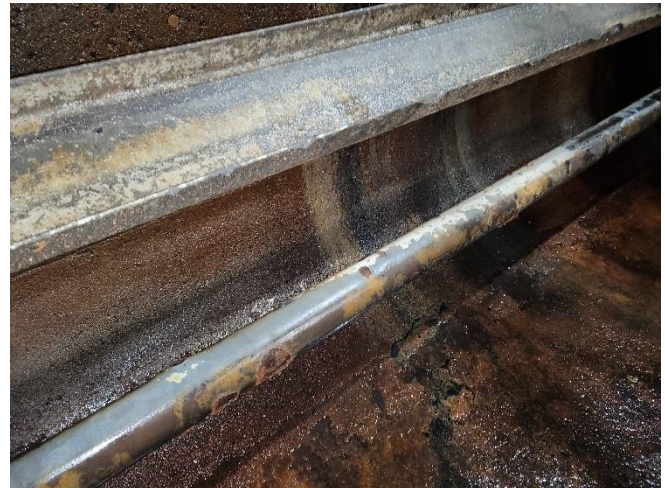
Item No:	M15-2L – Skimmer
Action Plan & Resolution Timeline Required:	1 year
Repair Priority:	P1E
Location Detail: Tank #2	Description:

The skimmer is in a rusty/scaled condition. Operations noted without occasional movement of the skimmer, they are prone to seizing.

- An engineering investigation should be performed for a root cause analysis over the malfunctioning of the mechanical system along with the corrosion parameters.
- Consider a revised design for better reliability. All manufacturers' maintenance manuals of moving parts shall be followed.

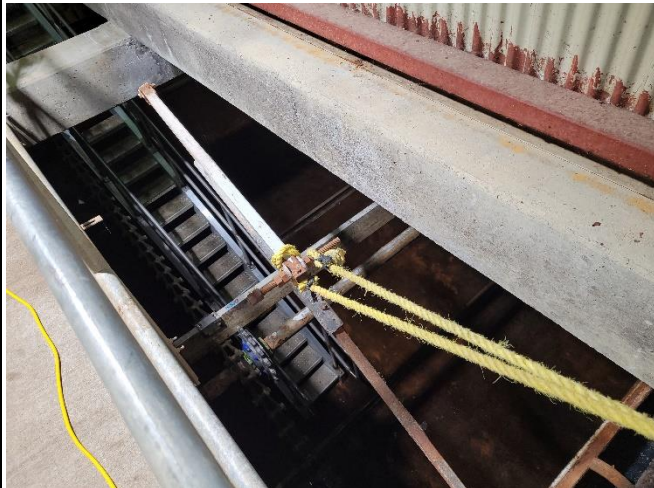
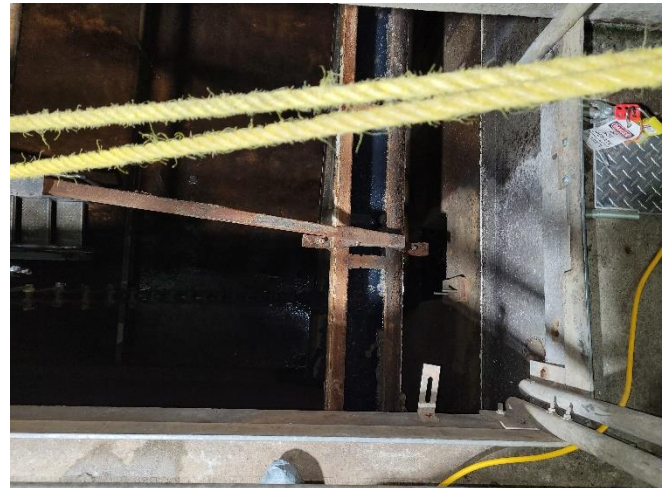
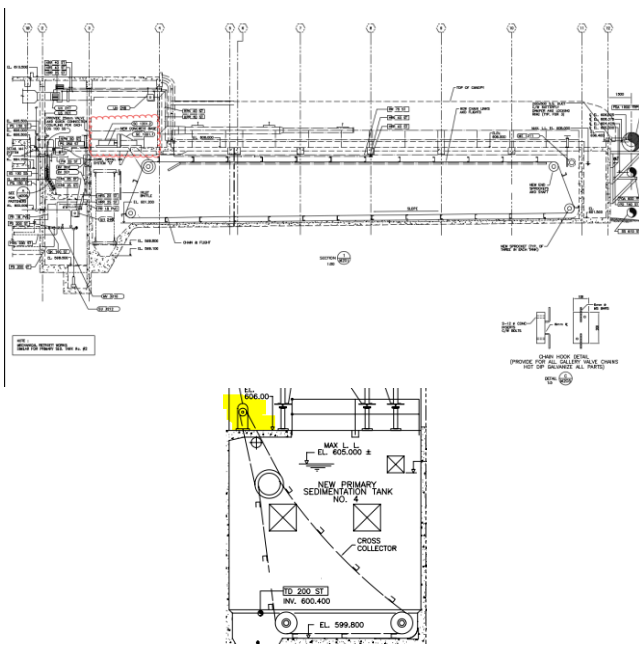
M01-2C – Drive Motor / Drive Gearbox

The motor and gearbox were in a fair condition.

- All manufacturers' maintenance manuals of drivers and motors shall be followed.
- A mechanical/electrical engineering review may be performed. Detailed data logging/reviewing may be conducted to detect potential operational issues by observing the variance in the load/data log results.

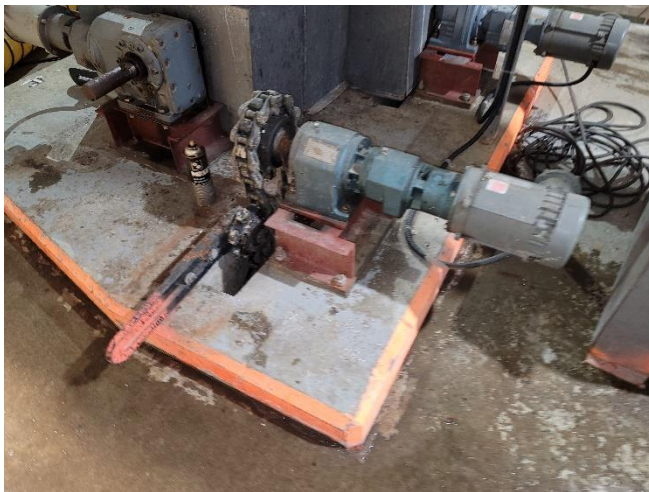
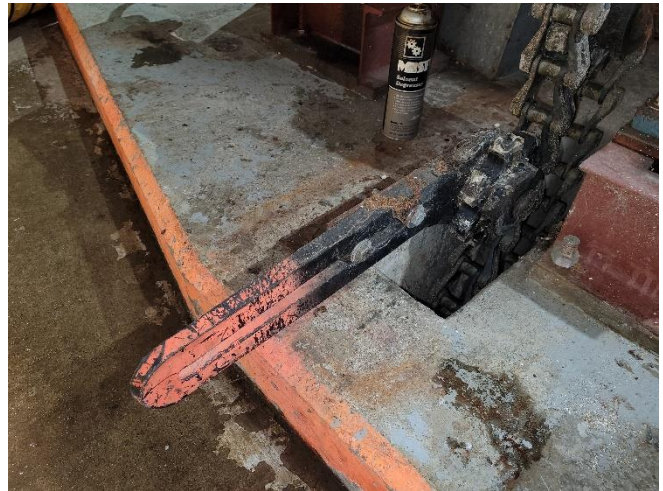
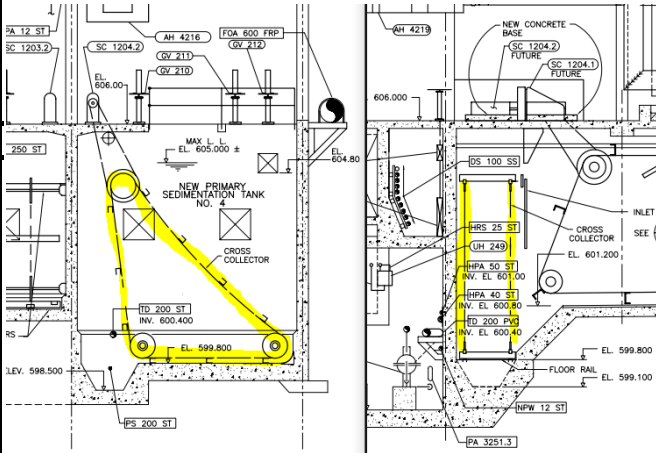
M02-2C – Collector Chain

The collector chains were in fair conditions.

- All manufacturers' maintenance manuals of moving parts shall be followed.
- Alignment of the drivers within the driving sprockets configuration shall be checked periodically ensuring there is no excessive misalignment/friction between chains, sprockets, shafts, and drivers.
- Cleaning/removing large scales periodically to reduce the wear and tear.

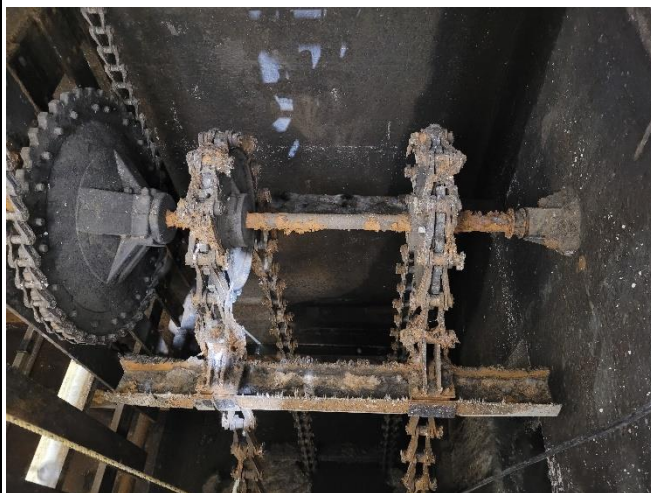
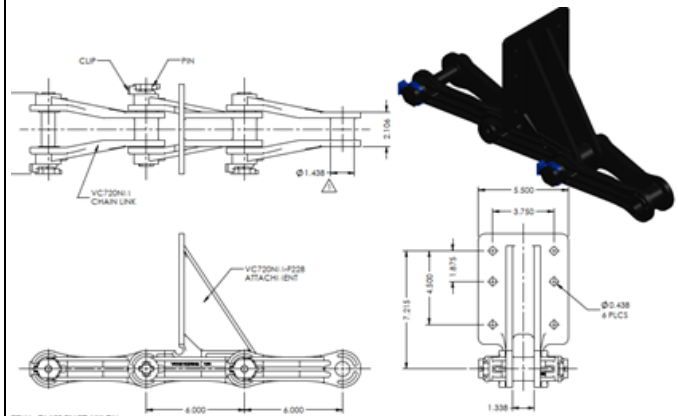
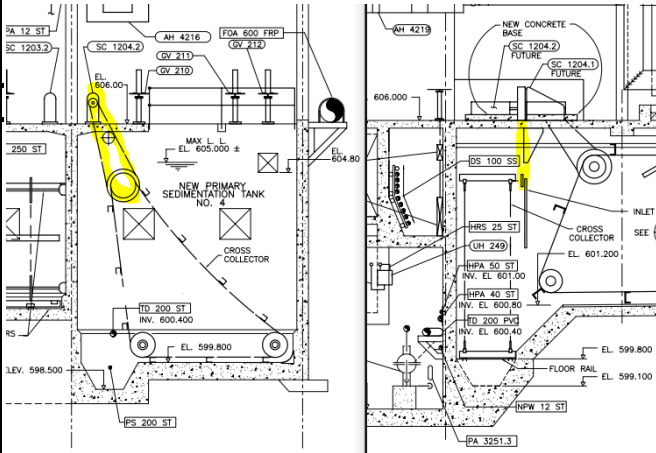
Item No: M03-2C – Drive Chain

The drive chains were in fair conditions.

- All manufacturers' maintenance manuals of moving parts shall be followed.
- Alignment of the drivers within the driving sprockets configuration shall be checked periodically ensuring there is no excessive misalignment/friction between chains, sprockets, shafts, and drivers.
- Cleaning/removing large scales periodically to reduce the wear and tear.

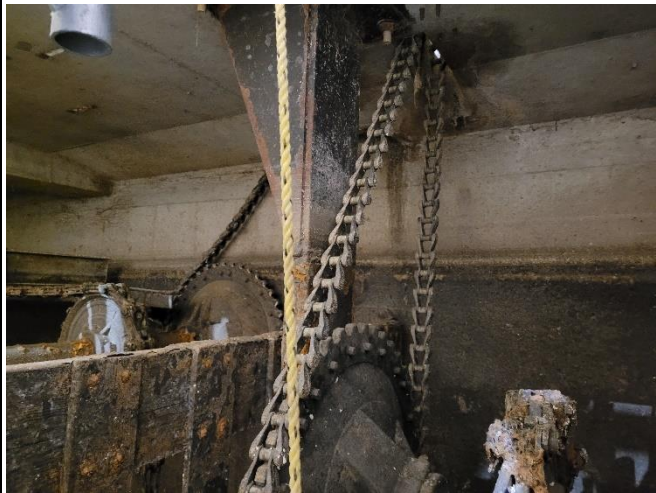
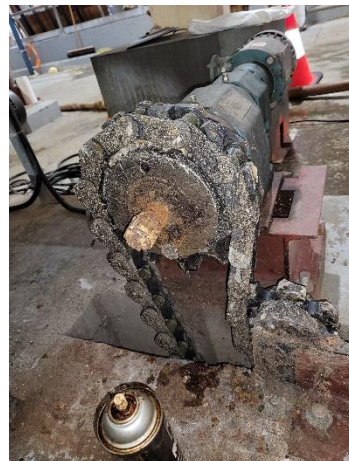
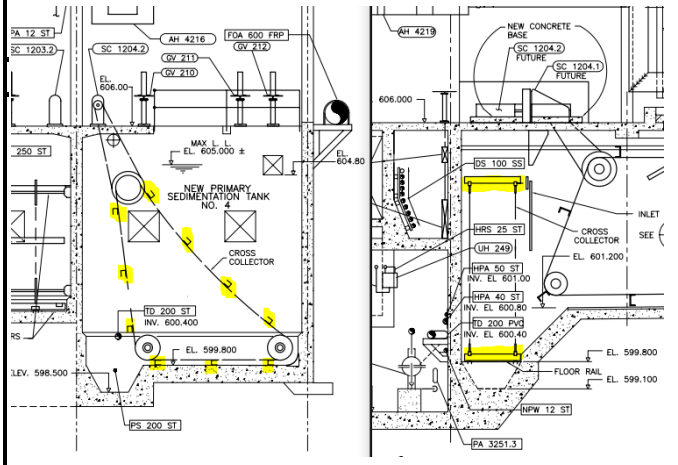
Item No:	M04-2C – Wear Shoes
Action Plan & Resolution Timeline Required:	1 year
Repair Priority:	P2

The wear shoes were in fair conditions. No major deficiencies were detected.

- All manufacturers' maintenance manuals of moving parts shall be followed.
- Inspection of wear shall be conducted on a regular basis.

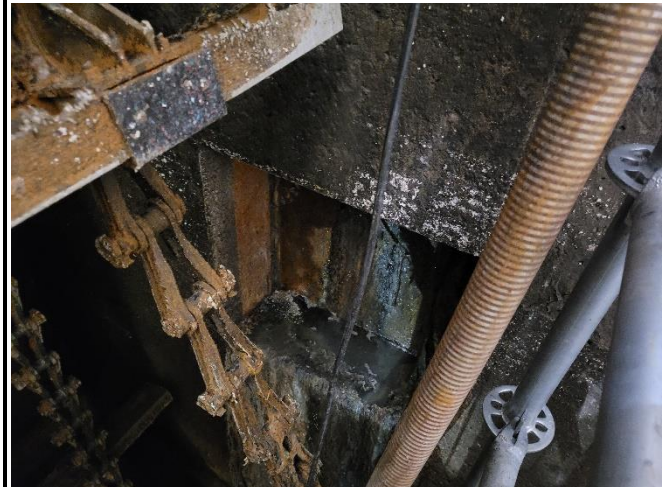
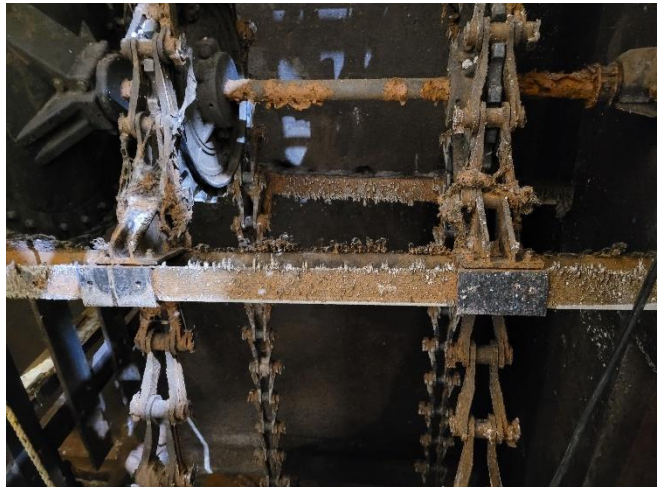
Item No:	M05-2C – Filler Blocks
Action Plan & Resolution Timeline Required:	1 year
Repair Priority:	P2

The filler blocks were in fair conditions. No major deficiencies were detected.

- Inspection for all the fasteners shall be conducted periodically.

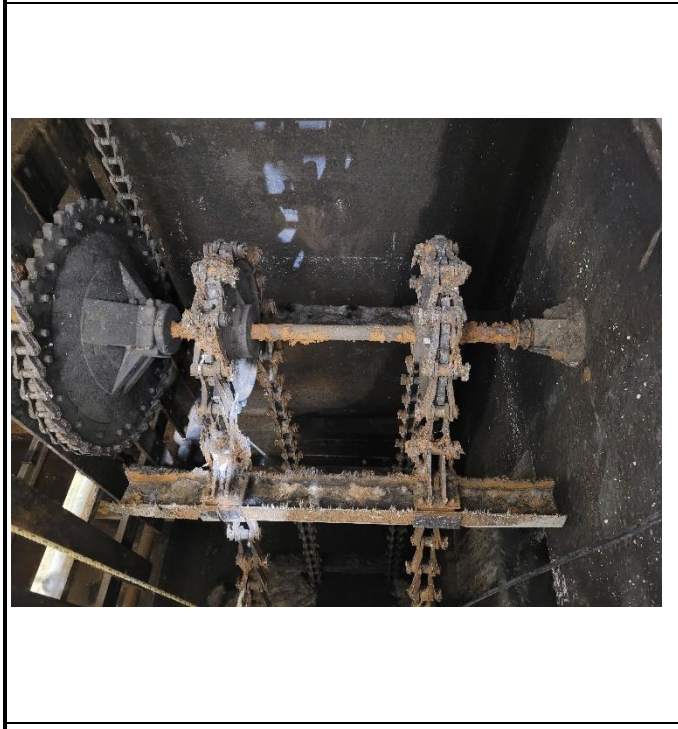
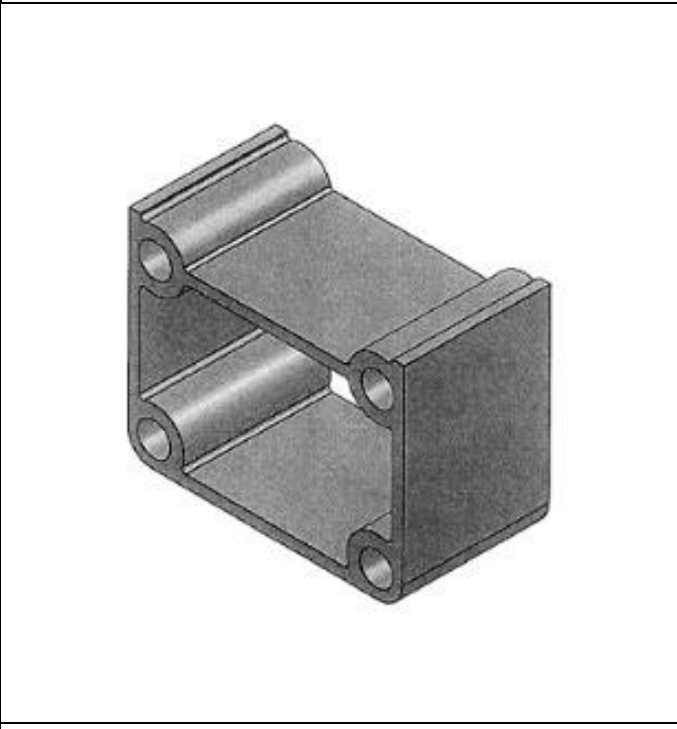
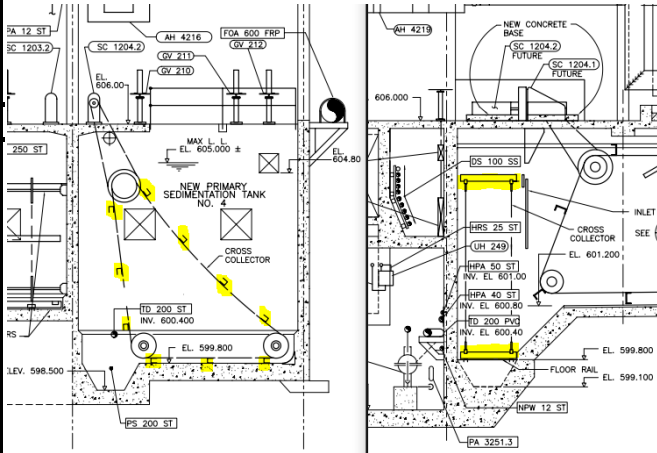
M06-2C – C-Channel Fiberglass Flights

The flight assembly were in fair conditions.

- An engineering investigation shall be performed for a root cause analysis over the malfunctioning of the mechanical system along with the corrosion parameters to determine a maintenance plan/possible design modification.
- All manufacturers' maintenance manuals of moving parts shall be followed.
- Alignment of the drivers within the driving sprockets configuration shall be checked periodically ensuring there is no excessive misalignment/friction between chains, sprockets, shafts, and drivers.
- Cleaning/removing large scales periodically to reduce the wear and tear.

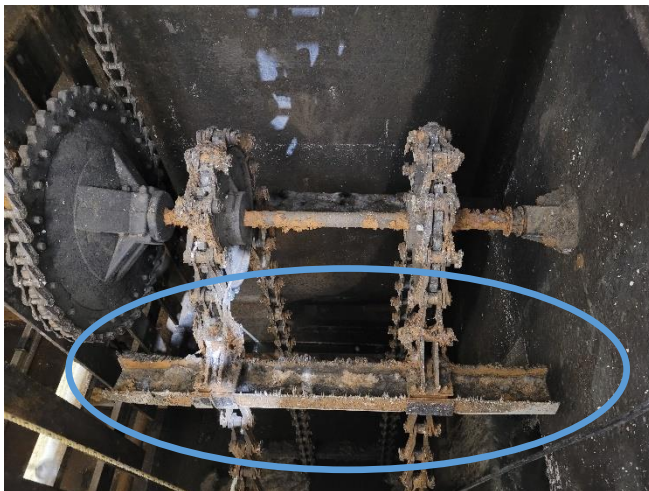
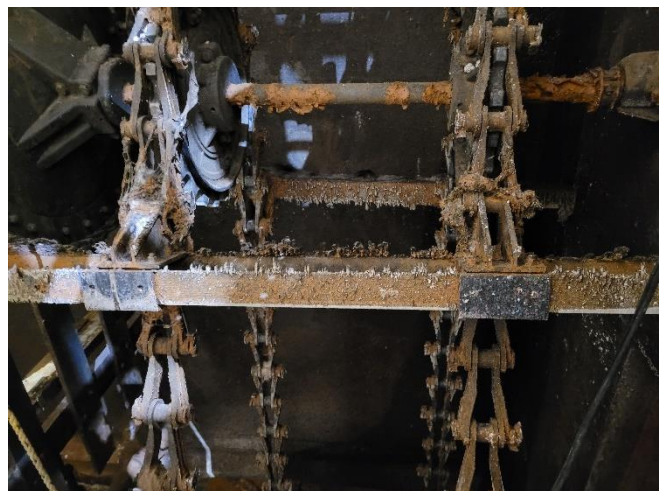
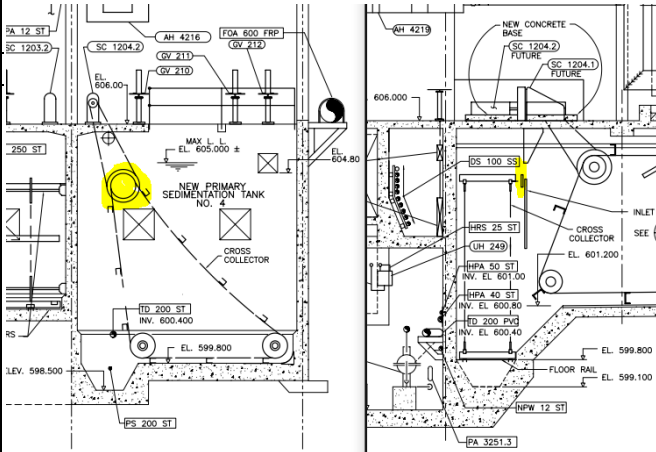
Item No: M07-2C – Drive Sprocket

The sprockets on the shaft were in a rusty/scaled condition.

- An engineering investigation should be performed for a root cause analysis over the malfunctioning of the mechanical system along with the corrosion parameters to determine a maintenance plan/possible design modification.
- All manufacturers' maintenance manuals of moving parts shall be followed.
- Alignment of the drivers within the driving sprockets configuration shall be checked periodically ensuring there is no excessive misalignment/friction between chains, sprockets, shafts, and drivers.
- Cleaning/removing scales periodically to reduce the wear and tear.
- Inspecting driven sprockets periodically, ensuring they are fixed on the shaft and fully synchronized with the driver shaft/sprocket without any slippage.

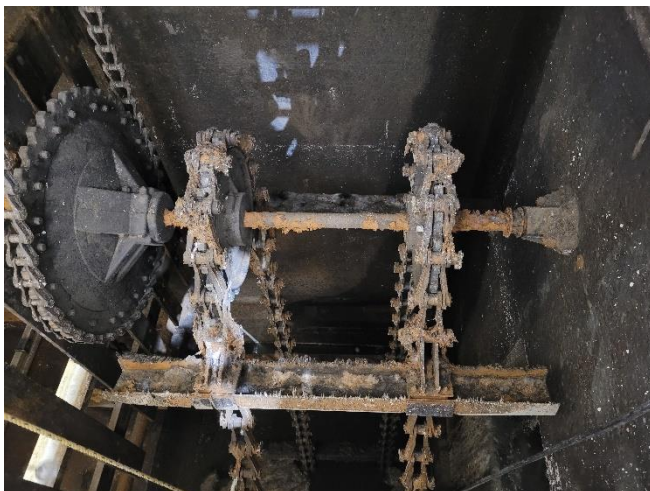
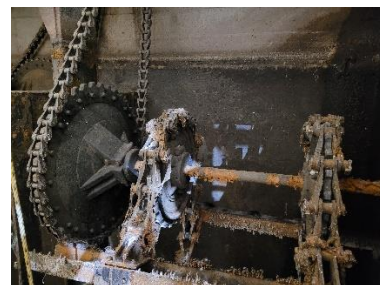
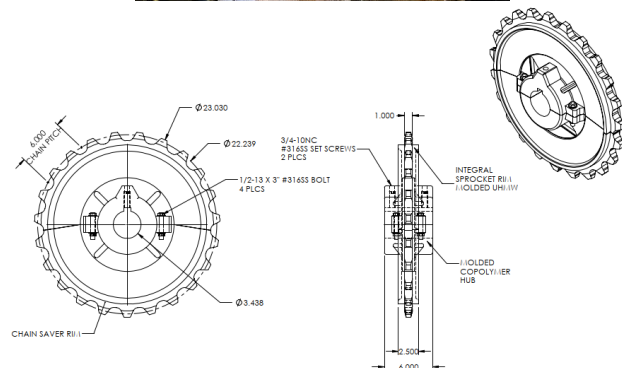
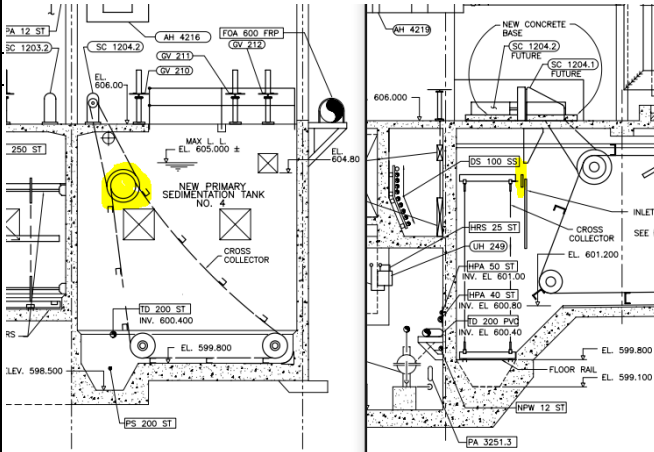
Item No:	M08-2C – Dished Offset Sprocket
Action Plan & Resolution Timeline Required:	1 year
Repair Priority:	P1E
Location Detail: Tank #2	Description:

The sprockets on the shaft were in a rusty/scaled condition.

- An engineering investigation should be performed for a root cause analysis over the malfunctioning of the mechanical system along with the corrosion parameters to determine a maintenance plan/possible design modification.
- All manufacturers' maintenance manuals of moving parts shall be followed.
- Alignment of the drivers within the driving sprockets configuration shall be checked periodically ensuring there is no excessive misalignment/friction between chains, sprockets, shafts, and drivers.
- Cleaning/removing scales periodically to reduce the wear and tear.
- Inspecting driven sprockets periodically, ensuring they are fixed on the shaft and fully synchronized with the driver shaft/sprocket without any slippage.

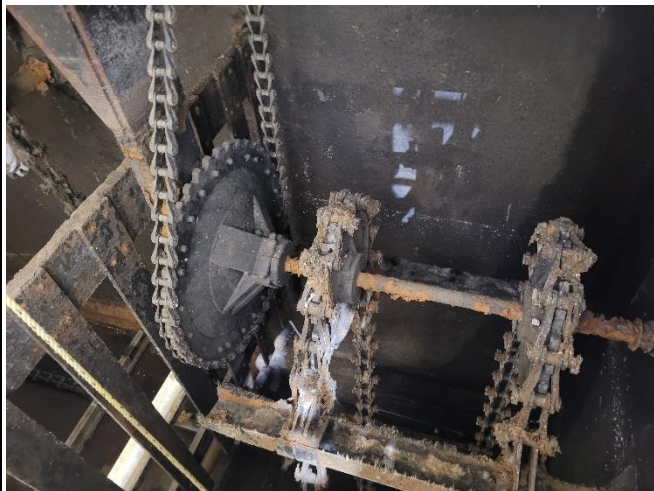
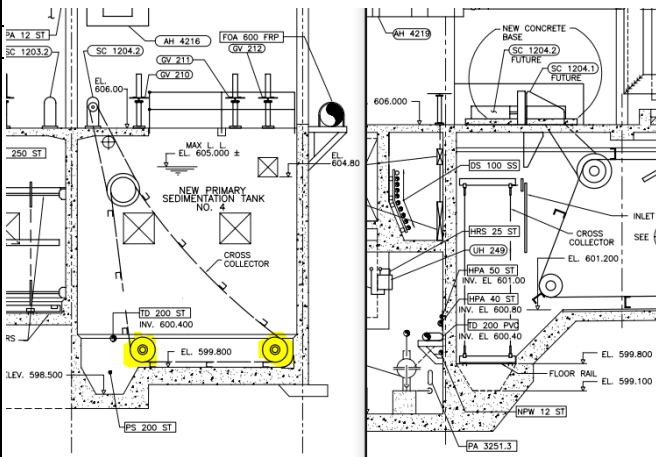
Item No: M09-2C – Idler Sprocket

The sprockets on the shaft were in a rusty/scaled condition. The shaft corrosion potentially caused restrictions in the movement of the sprockets.

- An engineering investigation should be performed for a root cause analysis over the malfunctioning of the mechanical system along with the corrosion parameters to determine a maintenance plan/possible design modification.
- All manufacturers' maintenance manuals of moving parts shall be followed.
- Alignment of the drivers within the driving sprockets configuration shall be checked periodically ensuring there is no excessive misalignment/friction between chains, sprockets, shafts, and drivers.
- Cleaning/removing scales periodically to reduce the wear and tear.
- Inspecting driven sprockets periodically, ensuring they are fixed on the shaft and fully synchronized with the driver shaft/sprocket without any slippage.

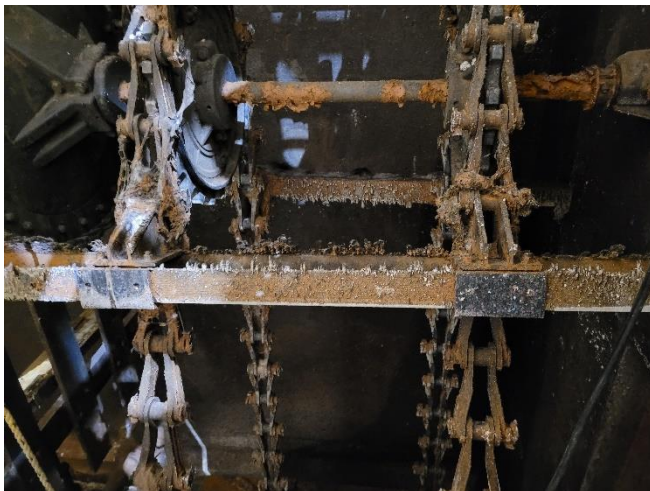
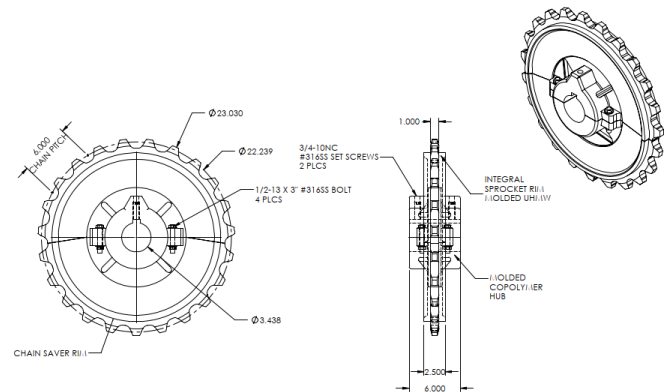
Item No: M10-2C – Shear Pin Sprocket

The sprockets on the drive motor shaft were in fair condition.

- All manufacturers' maintenance manuals of moving parts shall be followed.
- Alignment of the drivers within the driving sprockets configuration shall be checked periodically ensuring there is no excessive misalignment/friction between chains, sprockets, shafts, and drivers.
- Cleaning/removing scales periodically to reduce the wear and tear.
- Inspecting driven sprockets periodically, ensuring they are fixed on the shaft and fully synchronized with the driver shaft/sprocket without any slippage.

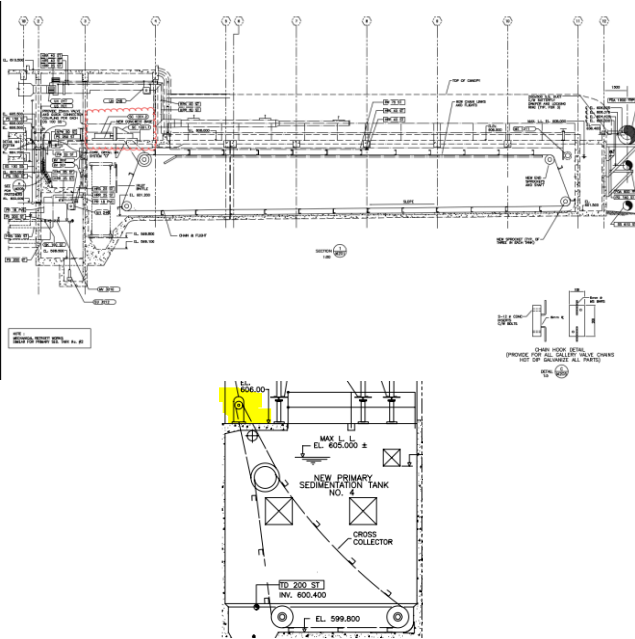
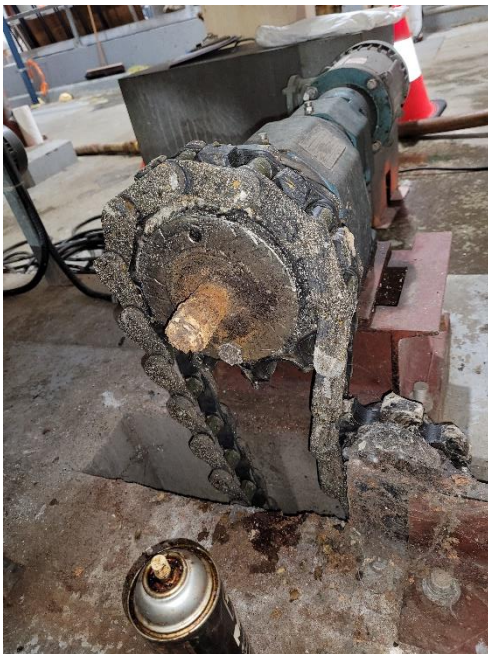
Item No:	M11-2C – Take Up Assembly
Action Plan & Resolution Timeline Required:	1 year
Repair Priority:	P2
Location Detail: Tank #2	Description:

The Take Up Assemblies were in fair condition.

- All manufacturers' maintenance manuals of moving parts shall be followed.
- Alignment of the drivers within the driving sprockets configuration shall be checked periodically ensuring there is no excessive misalignment/friction between chains, sprockets, shafts, and drivers.
- Cleaning/removing scales periodically to reduce the wear and tear.
- Inspecting driven sprockets periodically, ensuring they are fixed on the shaft and fully synchronized with the driver shaft/sprocket without any slippage.

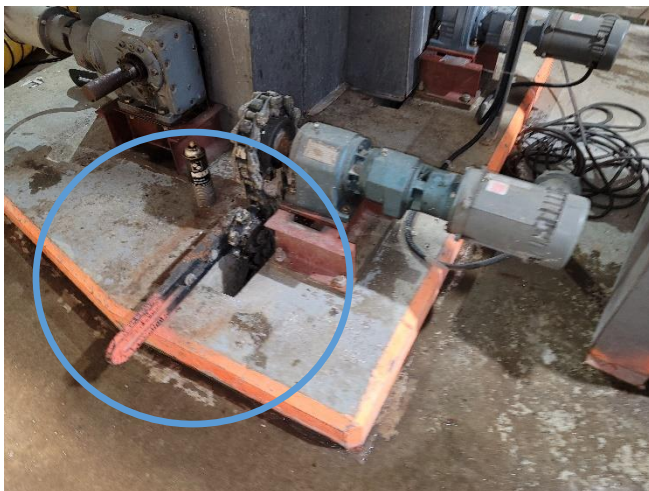
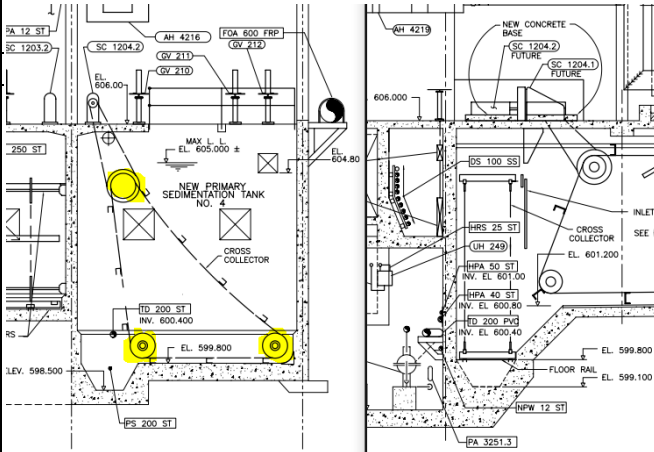
Item No:	M12-2C – Wall Bearings
Action Plan & Resolution Timeline Required:	1 year
Repair Priority:	P1E
Location Detail: Tank #2	Description:

The wall bearings were in a rusty/scaled condition.

- An engineering investigation should be performed for a root cause analysis over the malfunctioning of the mechanical system along with the corrosion parameters to determine a maintenance plan/possible design modification.
- All manufacturers' maintenance manuals of moving parts shall be followed.
- Cleaning/removing scales periodically to reduce the wear and tear.
- Inspecting shafts and wall bearings periodically, ensuring they are functioning properly within the whole power transmission system.

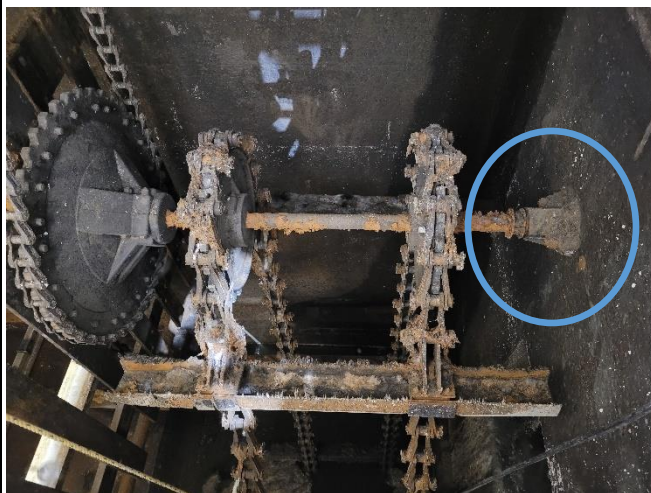
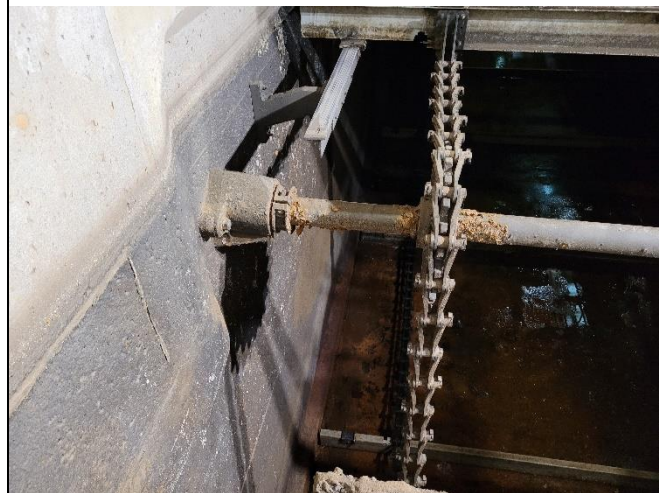
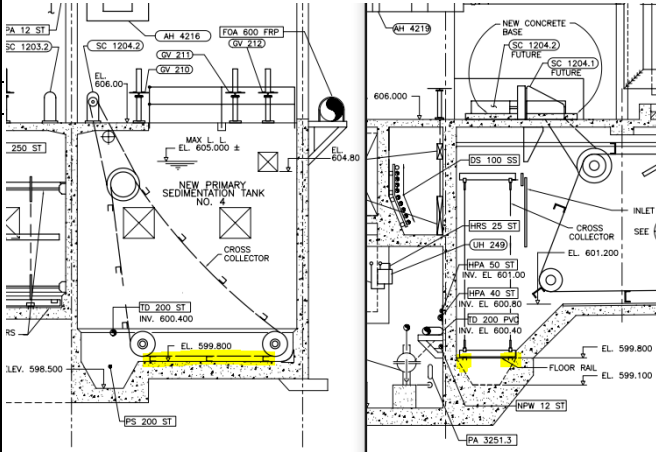
Item No: M13-2C – Collector Wear Strip

Not accessible.

- All manufacturers' maintenance manuals of moving parts shall be followed.
- Inspection of wear shall be conducted on a regular basis.

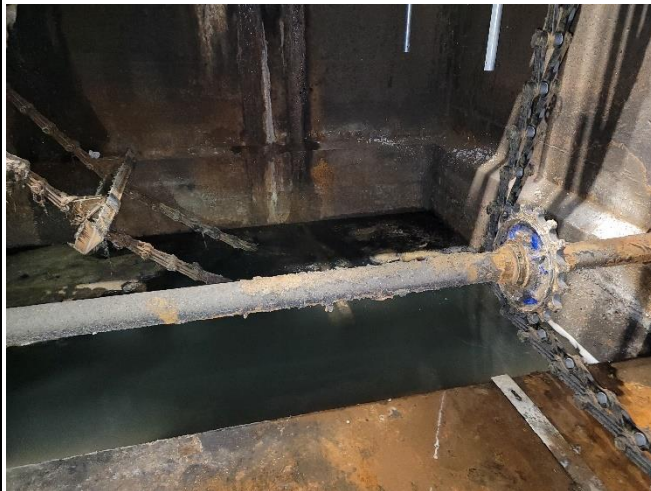
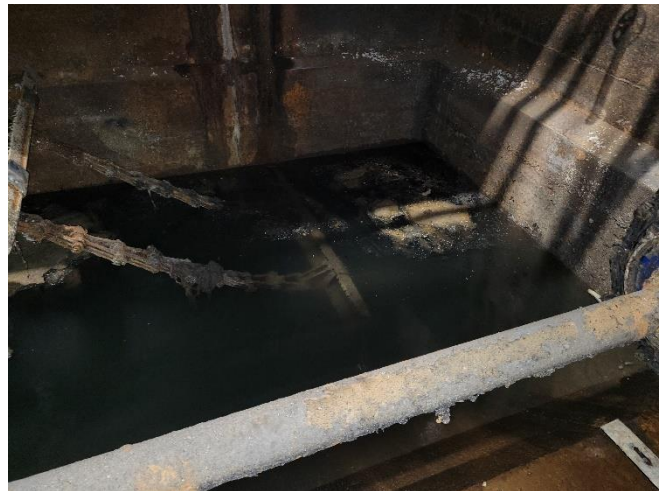
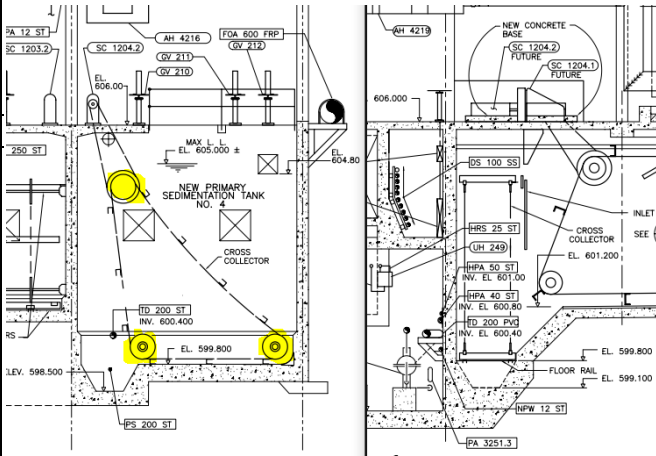
Item No:	M14-2C – Shafts, Pins and set collars
Action Plan & Resolution Timeline Required:	1 year
Repair Priority:	P2
Location Detail: Tank #2	Description:

The shafts were in a rusty/scaled condition.

- An engineering investigation should be performed for a root cause analysis over the malfunctioning of the mechanical system along with the corrosion parameters to determine a maintenance plan/possible design modification.
- All manufacturers' maintenance manuals of moving parts shall be followed.
- Cleaning/removing scales periodically to reduce the wear and tear.
- Inspecting shafts and wall bearings periodically, ensuring they are functioning properly within the whole power transmission system.
