Resort Municipality of Whistler: Wastewater Treatment Plant Primary Sedimentation Tank Assessment Report

Project No. 210505

January 26th, 2022

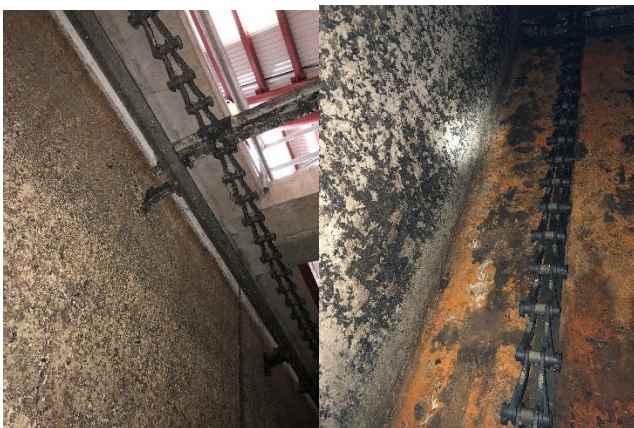
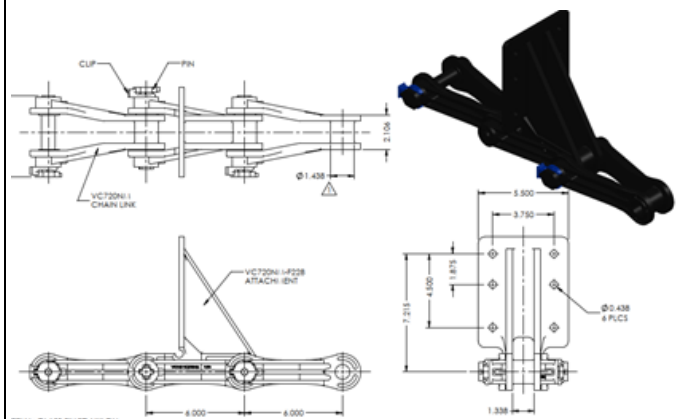
Item No: M03-3L – Drive Chain

The drive chains were in fair conditions. However, restrictions on the movement of the wall bearings and sprockets caused increased tension and stresses on the equipment.

- All manufacturers' maintenance manuals of moving parts shall be followed.
- Alignment of the drivers within the driving sprockets configuration shall be checked periodically ensuring there is no excessive misalignment/friction between chains, sprockets, shafts, and drivers.
- Cleaning/removing large scales periodically to reduce the wear and tear.

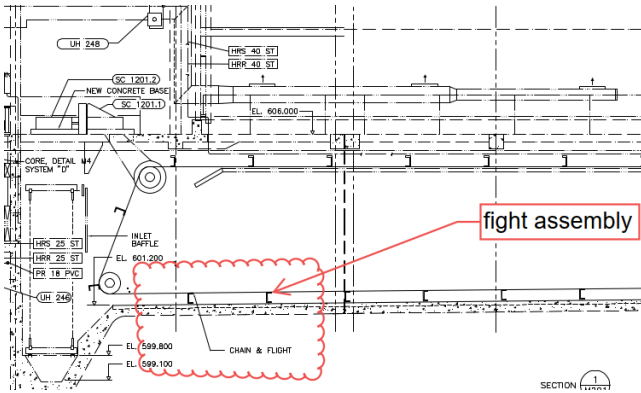
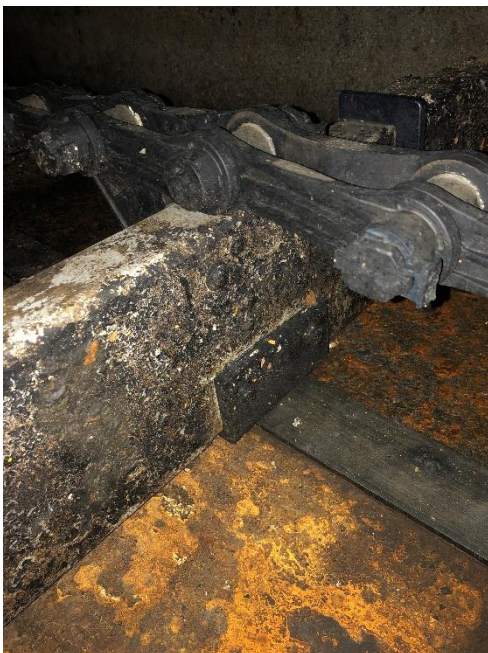
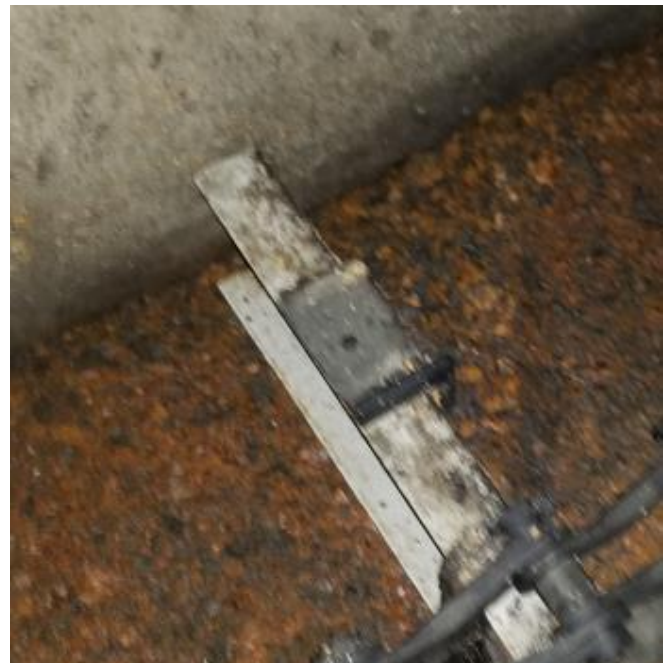
Item No:	M04-3L – Wear Shoes
Action Plan & Resolution Timeline Required:	1 year
Repair Priority:	P2
Location Detail: Tank #3	Description:

The wear shoes were in fair conditions. No major deficiencies were detected.

- All manufacturers' maintenance manuals of moving parts shall be followed.
- Inspection of wear shall be conducted on a regular basis.

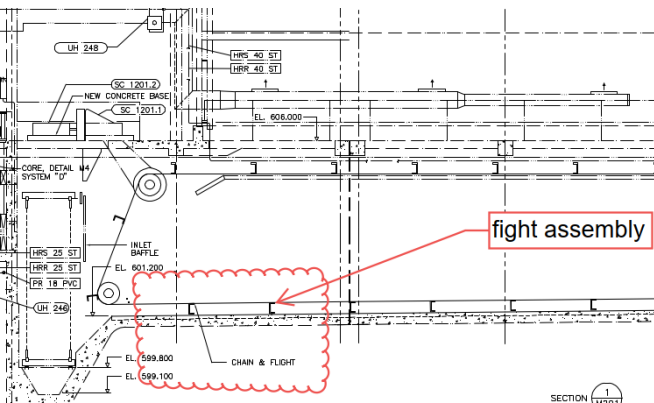
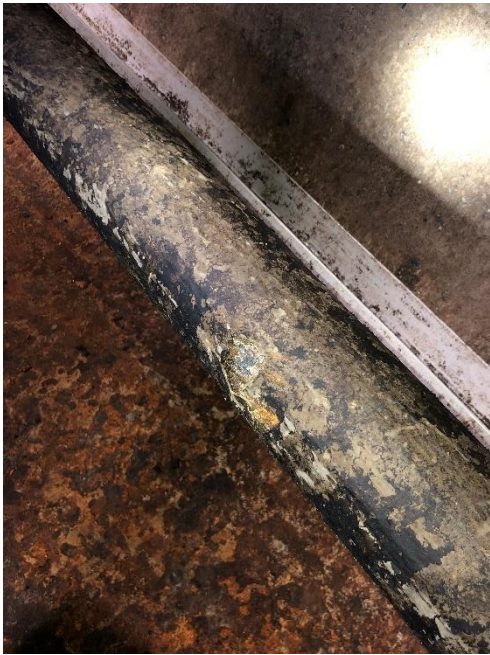
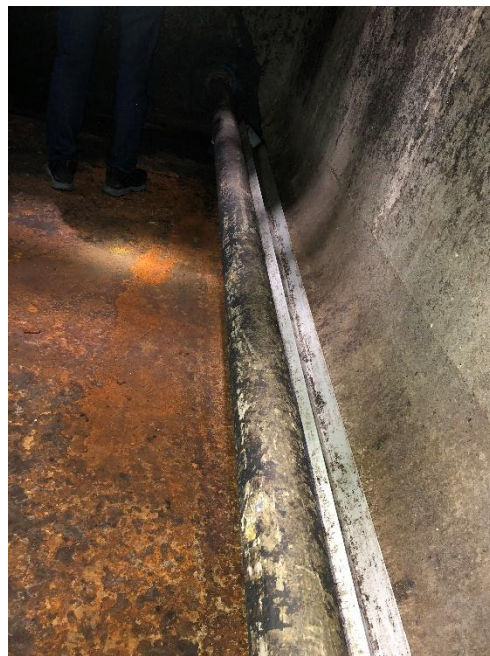
Item No:	M06-3L – C-Channel Fiberglass Flights
Action Plan & Resolution Timeline Required:	1 year
Repair Priority:	P2
Location Detail: Tank #3	Description:

The flight assembly were in fair conditions. Damage was observed most likely caused when the system failed.
	Required Action:
	<ul style="list-style-type: none"> - An engineering investigation shall be performed for a root cause analysis over the malfunctioning of the mechanical system along with the corrosion parameters to determine a maintenance plan/possible design modification. - All manufacturers' maintenance manuals of moving parts shall be followed. - Alignment of the drivers within the driving sprockets configuration shall be checked periodically ensuring there is no excessive misalignment/friction between chains, sprockets, shafts, and drivers. - Cleaning/removing large scales periodically to reduce the wear and tear.

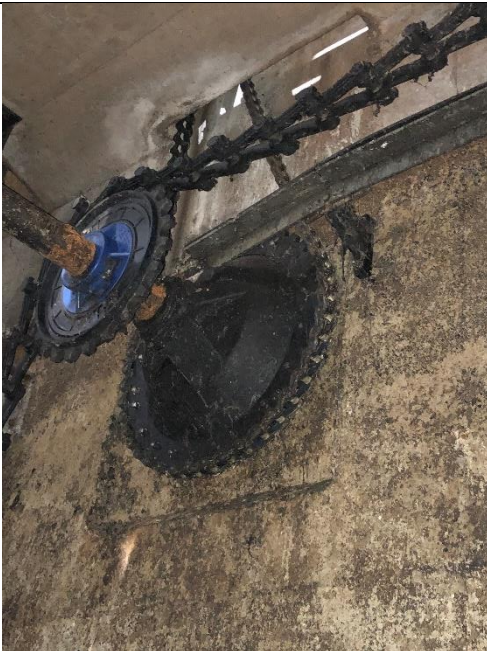
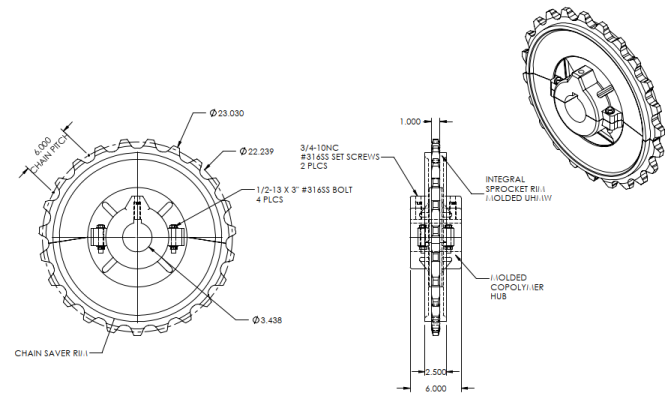
Item No: M07-3L – Drive Sprocket

The sprockets on the shaft were in a rusty/scaled condition.

- An engineering investigation should be performed for a root cause analysis over the malfunctioning of the mechanical system along with the corrosion parameters to determine a maintenance plan/possible design modification.
- All manufacturers' maintenance manuals of moving parts shall be followed.
- Alignment of the drivers within the driving sprockets configuration shall be checked periodically ensuring there is no excessive misalignment/friction between chains, sprockets, shafts, and drivers.
- Cleaning/removing scales periodically to reduce the wear and tear.
- Inspecting driven sprockets periodically, ensuring they are fixed on the shaft and fully synchronized with the driver shaft/sprocket without any slippage.

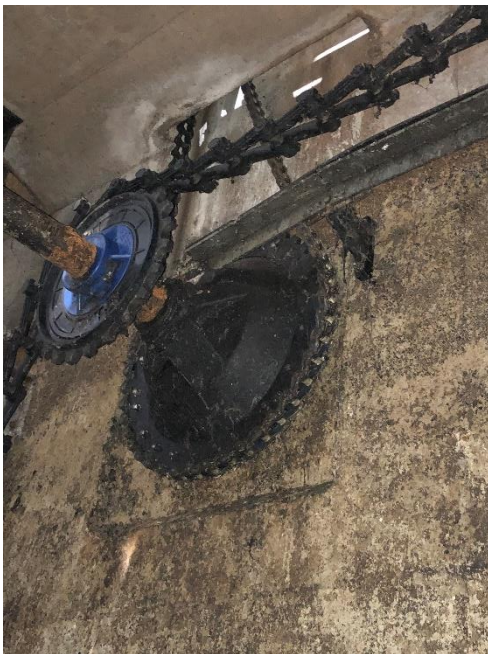
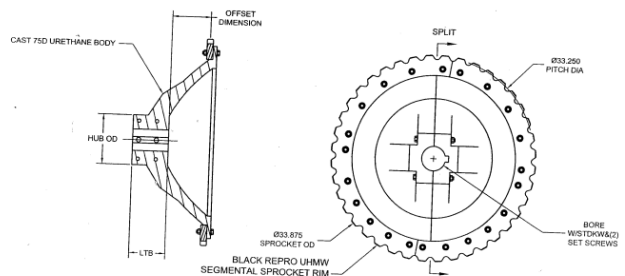
Item No:	M08-3L – Dished Offset Sprocket
Action Plan & Resolution Timeline Required:	1 year
Repair Priority:	P2
Location Detail: Tank #3	Description:

The sprockets on the shaft were in a rusty/scaled condition.

- An engineering investigation should be performed for a root cause analysis over the malfunctioning of the mechanical system along with the corrosion parameters to determine a maintenance plan/possible design modification.
- All manufacturers' maintenance manuals of moving parts shall be followed.
- Alignment of the drivers within the driving sprockets configuration shall be checked periodically ensuring there is no excessive misalignment/friction between chains, sprockets, shafts, and drivers.
- Cleaning/removing scales periodically to reduce the wear and tear.
- Inspecting driven sprockets periodically, ensuring they are fixed on the shaft and fully synchronized with the driver shaft/sprocket without any slippage.

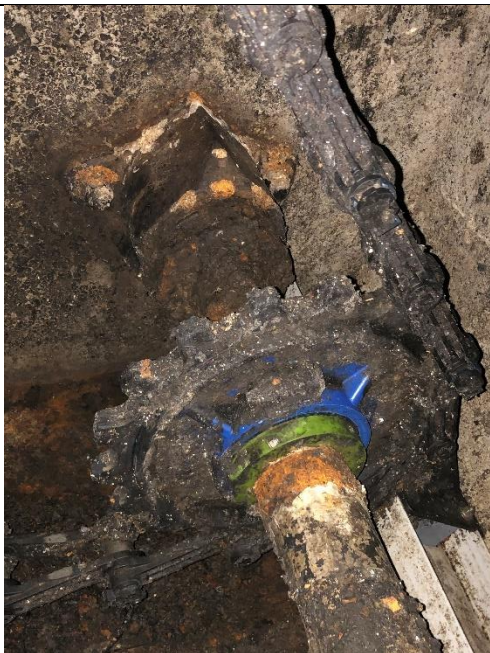
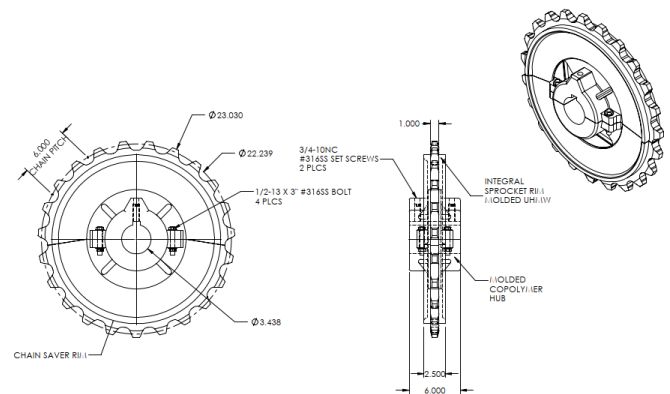
Item No: M09-3L – Idler Sprocket

The sprockets on the shaft were in a rusty/scaled condition. The shaft corrosion potentially caused restrictions in the movement of the sprockets.

- An engineering investigation should be performed for a root cause analysis over the malfunctioning of the mechanical system along with the corrosion parameters to determine a maintenance plan/possible design modification.
- All manufacturers' maintenance manuals of moving parts shall be followed.
- Alignment of the drivers within the driving sprockets configuration shall be checked periodically ensuring there is no excessive misalignment/friction between chains, sprockets, shafts, and drivers.
- Cleaning/removing scales periodically to reduce the wear and tear.
- Inspecting driven sprockets periodically, ensuring they are fixed on the shaft and fully synchronized with the driver shaft/sprocket without any slippage.

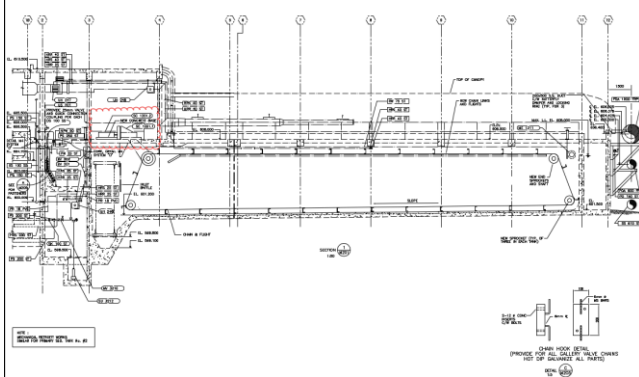
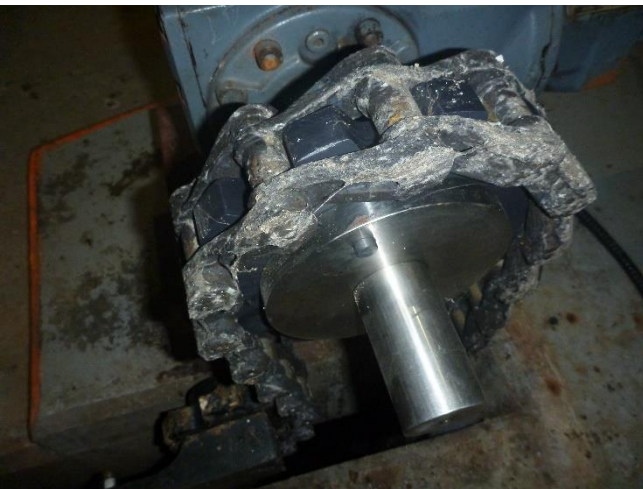
Item No:	M10-3L – Shear Pin Sprocket
Action Plan & Resolution Timeline Required:	1 year
Repair Priority:	P2
Location Detail: Tank #3	Description:

The sprockets on the drive motor shaft were in fair condition.

- All manufacturers' maintenance manuals of moving parts shall be followed.
- Alignment of the drivers within the driving sprockets configuration shall be checked periodically ensuring there is no excessive misalignment/friction between chains, sprockets, shafts, and drivers.
- Cleaning/removing scales periodically to reduce the wear and tear.
- Inspecting driven sprockets periodically, ensuring they are fixed on the shaft and fully synchronized with the driver shaft/sprocket without any slippage.

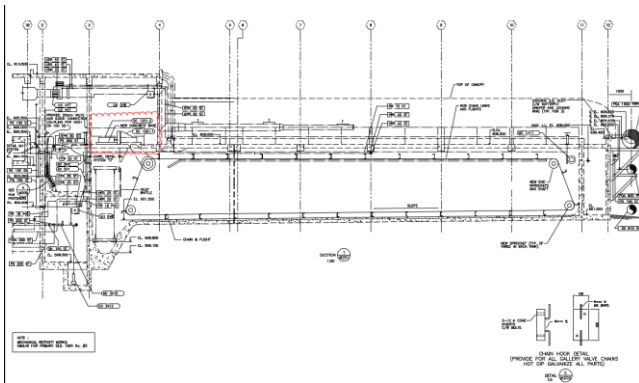
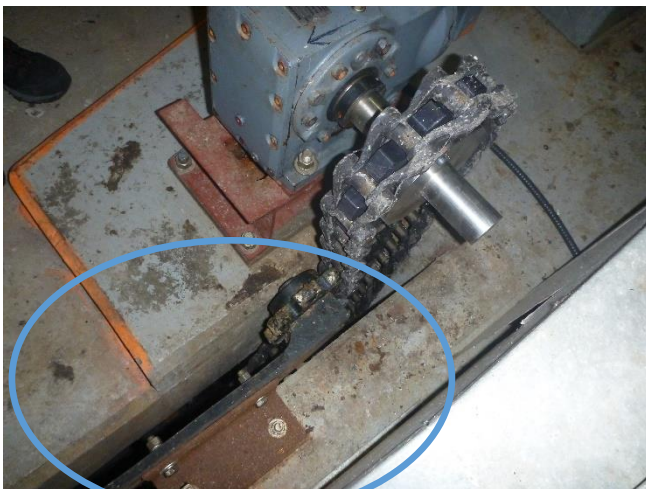
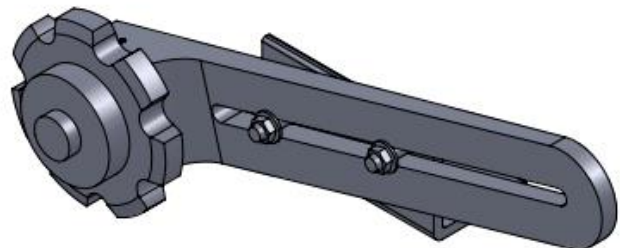
Item No:	M11-3L – Take Up Assembly
Action Plan & Resolution Timeline Required:	1 year
Repair Priority:	P2
Location Detail: Tank #3	Description:

The Take Up Assemblies were in fair condition.

- All manufacturers' maintenance manuals of moving parts shall be followed.
- Alignment of the drivers within the driving sprockets configuration shall be checked periodically ensuring there is no excessive misalignment/friction between chains, sprockets, shafts, and drivers.
- Cleaning/removing scales periodically to reduce the wear and tear.
- Inspecting driven sprockets periodically, ensuring they are fixed on the shaft and fully synchronized with the driver shaft/sprocket without any slippage.

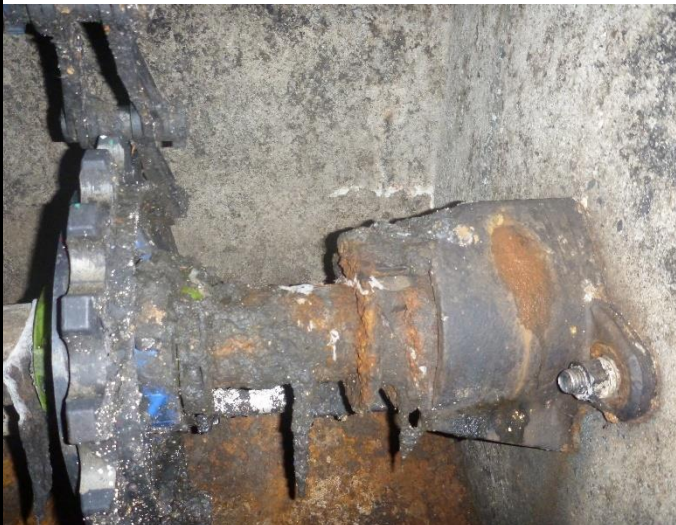
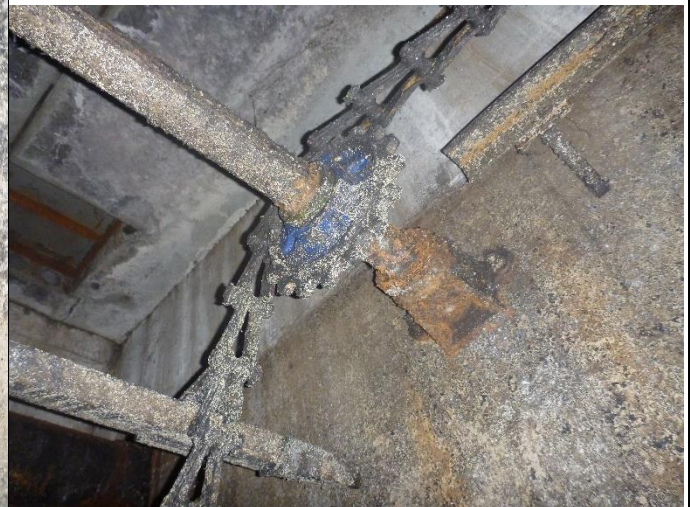
Item No:	M12-3L – Wall Bearings
Action Plan & Resolution Timeline Required:	1 year
Repair Priority:	P1E
Location Detail: Tank #3	Description:

The wall bearings were in a rusty/scaled condition.

- An engineering investigation should be performed for a root cause analysis over the malfunctioning of the mechanical system along with the corrosion parameters to determine a maintenance plan/possible design modification.
- All manufacturers' maintenance manuals of moving parts shall be followed.
- Cleaning/removing scales periodically to reduce the wear and tear.
- Inspecting shafts and wall bearings periodically, ensuring they are functioning properly within the whole power transmission system.

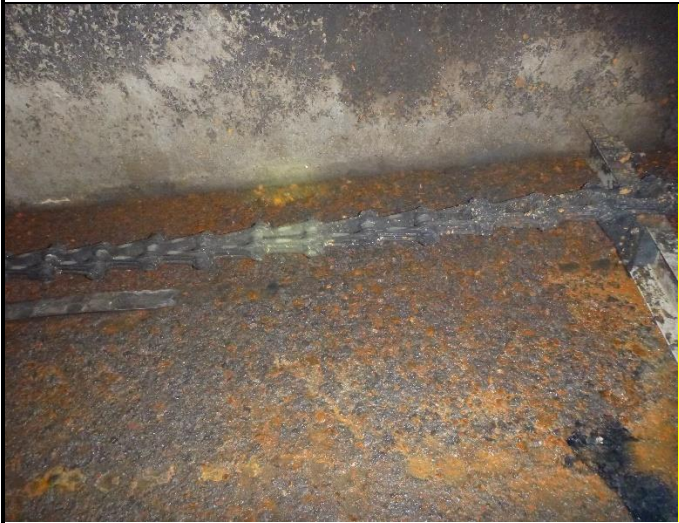
Item No:	M13-3L – Collector Wear Strip
Action Plan & Resolution Timeline Required:	1 year
Repair Priority:	P2
Location Detail: Tank #3	Description:
	The wear strips were in fair conditions. No major deficiencies were detected.
	Required Action:
	<ul style="list-style-type: none"> - All manufacturers' maintenance manuals of moving parts shall be followed. - Inspection of wear shall be conducted on a regular basis.

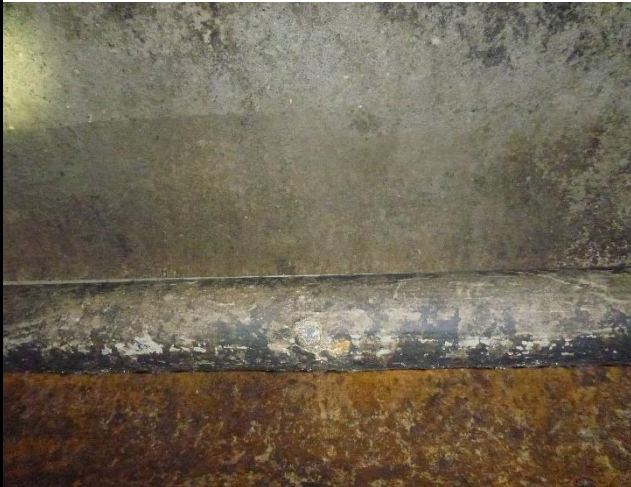
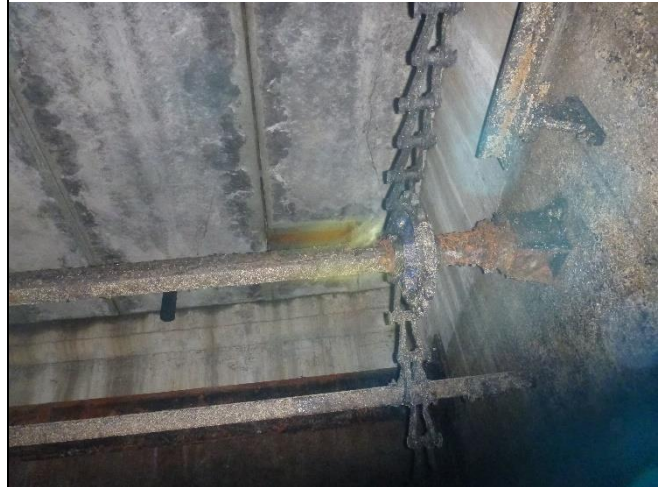
Item No:	M14-3L – Shafts, Pins and set collars
Action Plan & Resolution Timeline Required:	1 year
Repair Priority:	P2
Location Detail: Tank #3	Description:

The shafts were in a rusty/scaled condition.

- An engineering investigation should be performed for a root cause analysis over the malfunctioning of the mechanical system along with the corrosion parameters to determine a maintenance plan/possible design modification.
- All manufacturers' maintenance manuals of moving parts shall be followed.
- Cleaning/removing scales periodically to reduce the wear and tear.
- Inspecting shafts and wall bearings periodically, ensuring they are functioning properly within the whole power transmission system.

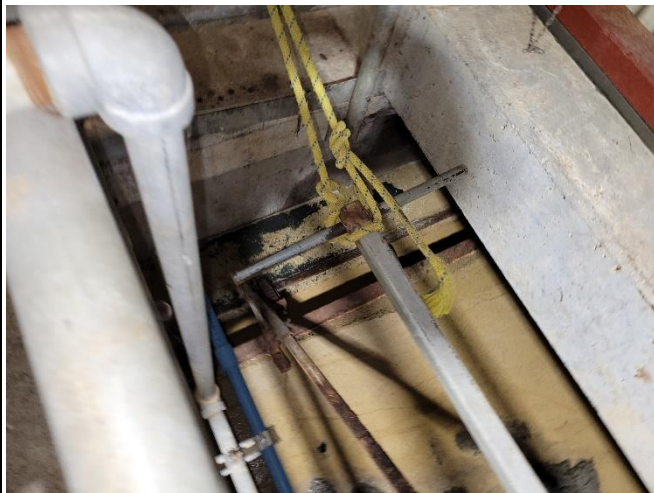
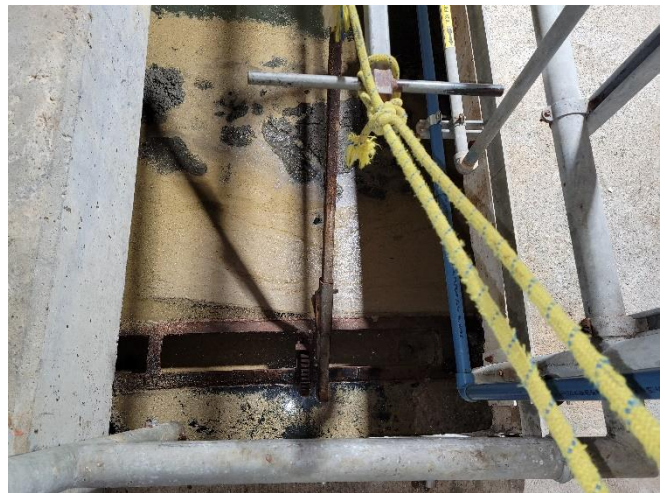
Item No: M15-3L – Skimmer

The skimmer is in a rusty/scaled condition. Operations noted without occasional movement of the skimmer, they are prone to seizing.

- An engineering investigation should be performed for a root cause analysis over the malfunctioning of the mechanical system along with the corrosion parameters.
- Consider a revised design for better reliability.
- All manufacturers' maintenance manuals of moving parts shall be followed.

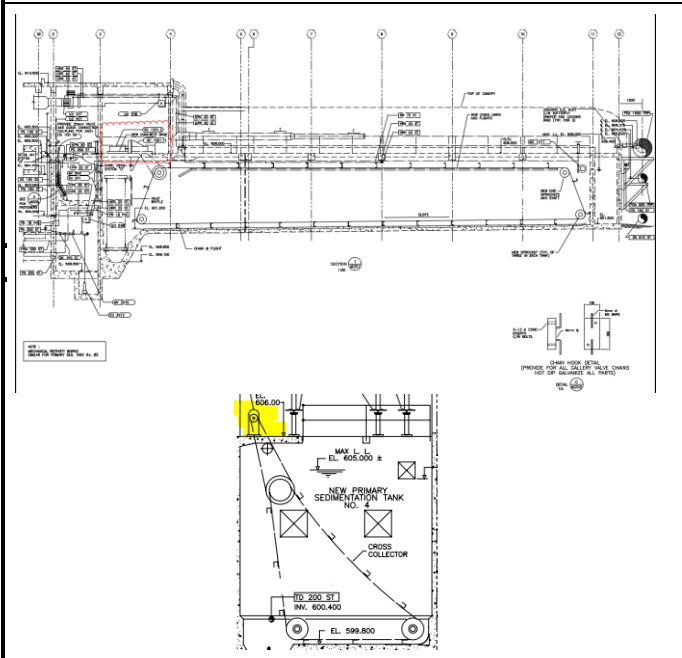
Item No:	M01-3C – Drive Motor / Drive Gearbox
Action Plan & Resolution Timeline Required:	1 year
Repair Priority:	P3
Location Detail: Tank #3	Description:

<p>The motor and gearbox were in a fair condition. However, they are in a corrosive environment and is operating continuously. Periodic maintenance plan is required.</p>
	Required Action:

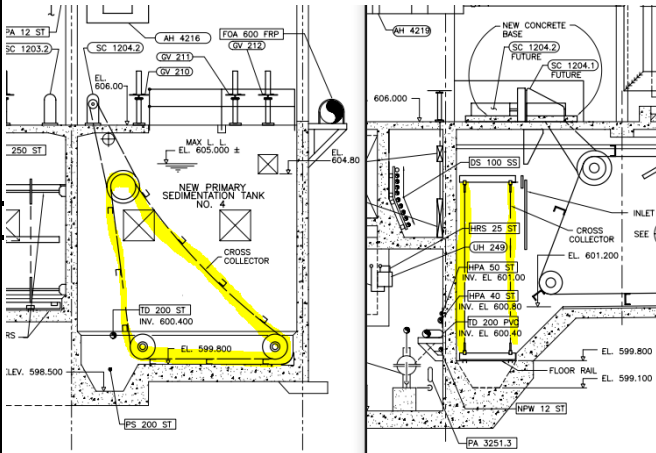
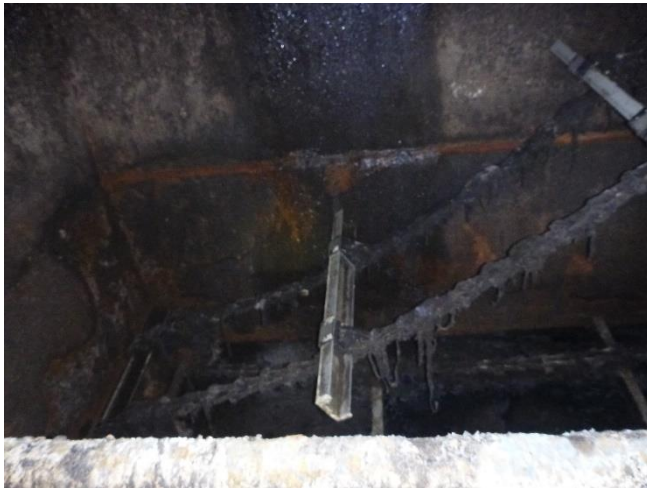
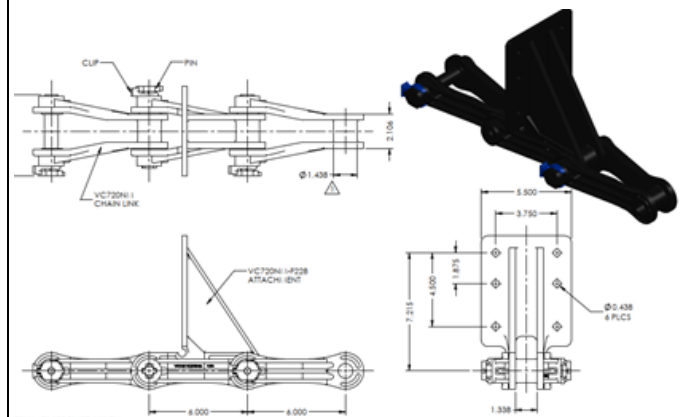
The collector chains were in fair conditions.

- All manufacturers' maintenance manuals of moving parts shall be followed.
- Alignment of the drivers within the driving sprockets configuration shall be checked periodically ensuring there is no excessive misalignment/friction between chains, sprockets, shafts, and drivers.
- Cleaning/removing large scales periodically to reduce the wear and tear.

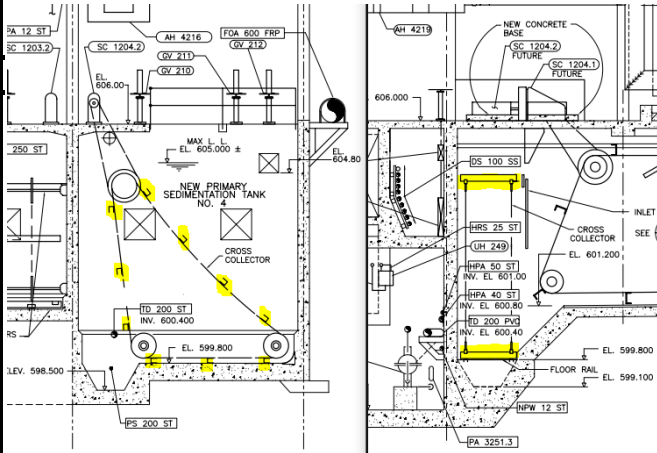
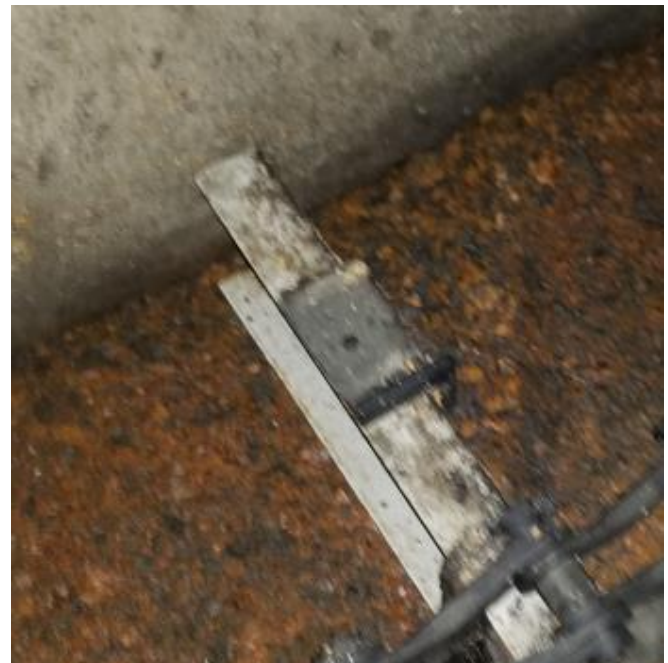
Item No:	M04-3C – Wear Shoes
Action Plan & Resolution Timeline Required:	1 year
Repair Priority:	P2
Location Detail: Tank #3	Description:

The wear shoes were in fair conditions. No major deficiencies were detected.

- All manufacturers' maintenance manuals of moving parts shall be followed.
- Inspection of wear shall be conducted on a regular basis.

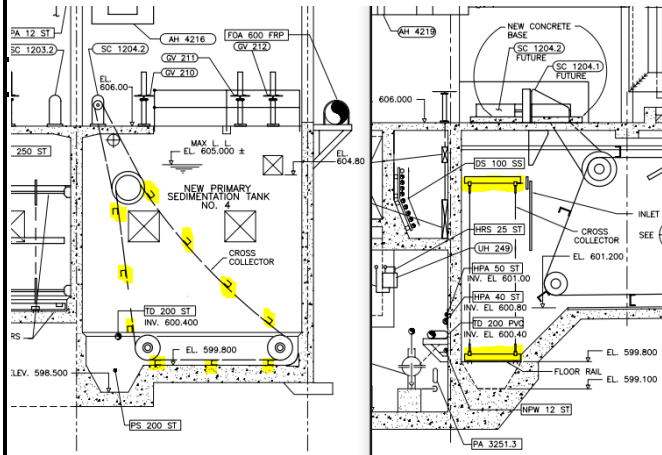
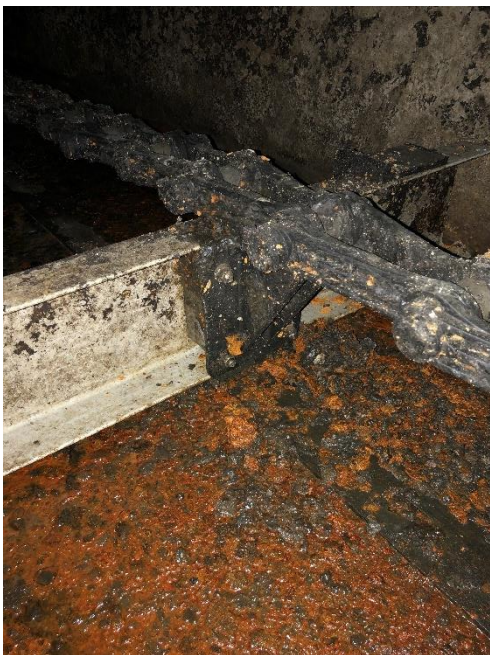
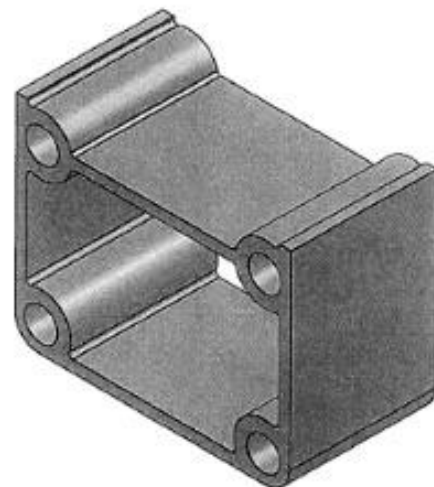
Item No:	M05-3C – Filler Blocks
Action Plan & Resolution Timeline Required:	1 year
Repair Priority:	P2
Location Detail: Tank #3	Description:

The filler blocks were in fair conditions. No major deficiencies were detected.

- Inspection for all the fasteners shall be conducted periodically.

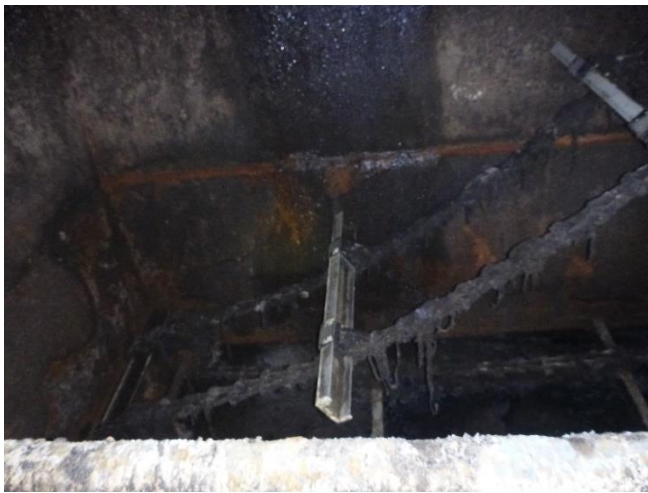
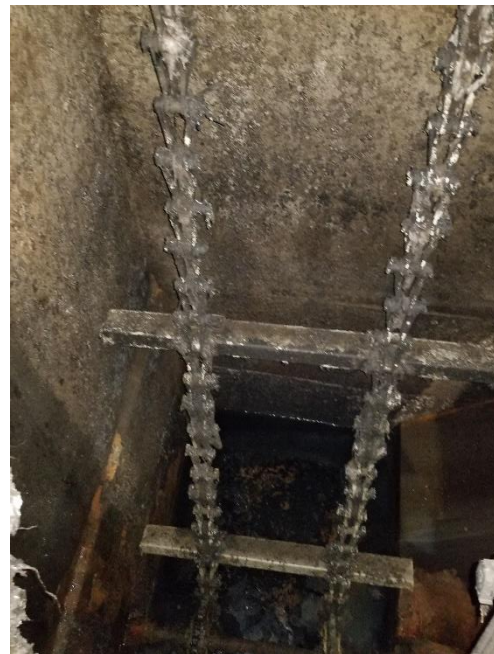
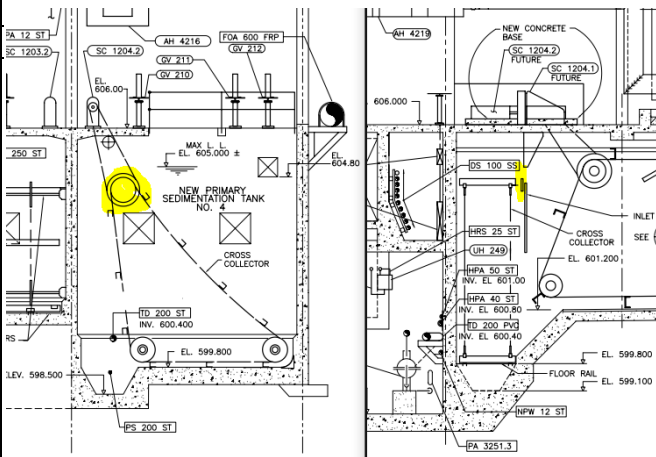
Item No: M07-3C – Drive Sprocket

The sprockets on the shaft were in a rusty/scaled condition.

- An engineering investigation should be performed for a root cause analysis over the malfunctioning of the mechanical system along with the corrosion parameters to determine a maintenance plan/possible design modification.
- All manufacturers' maintenance manuals of moving parts shall be followed.
- Alignment of the drivers within the driving sprockets configuration shall be checked periodically ensuring there is no excessive misalignment/friction between chains, sprockets, shafts, and drivers.
- Cleaning/removing scales periodically to reduce the wear and tear.
- Inspecting driven sprockets periodically, ensuring they are fixed on the shaft and fully synchronized with the driver shaft/sprocket without any slippage.

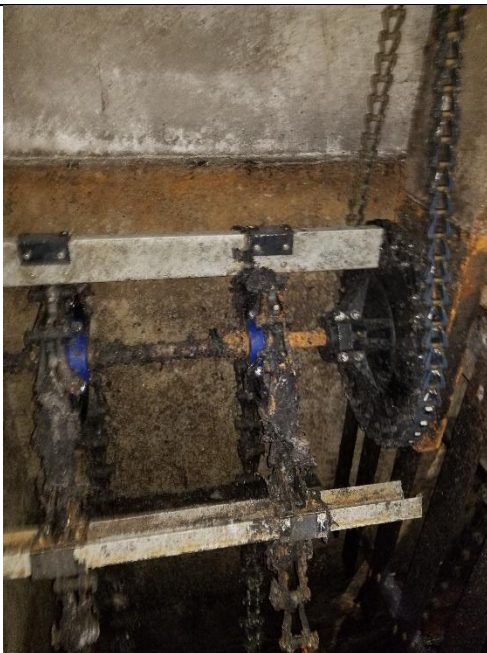
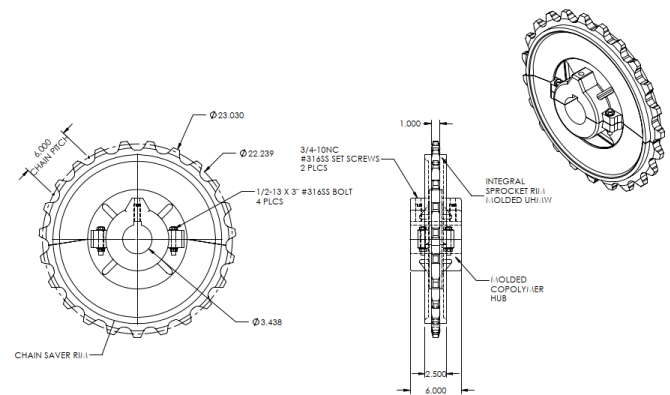
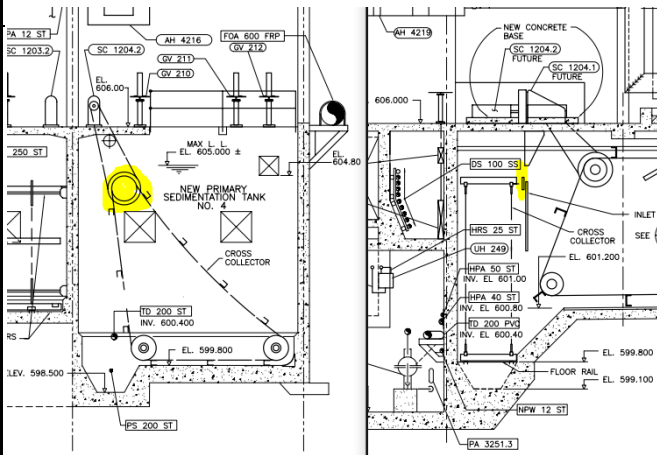
Item No: M08-3C – Dished Offset Sprocket

Location Detail: Tank #3
Description: The sprockets on the shaft were in a rusty/scaled condition.

- An engineering investigation should be performed for a root cause analysis over the malfunctioning of the mechanical system along with the corrosion parameters to determine a maintenance plan/possible design modification.
- All manufacturers' maintenance manuals of moving parts shall be followed.
- Alignment of the drivers within the driving sprockets configuration shall be checked periodically ensuring there is no excessive misalignment/friction between chains, sprockets, shafts, and drivers.
- Cleaning/removing scales periodically to reduce the wear and tear.
- Inspecting driven sprockets periodically, ensuring they are fixed on the shaft and fully synchronized with the driver shaft/sprocket without any slippage.

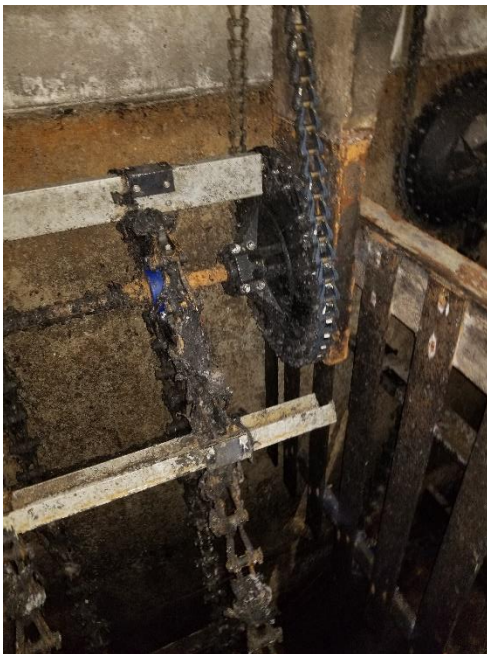
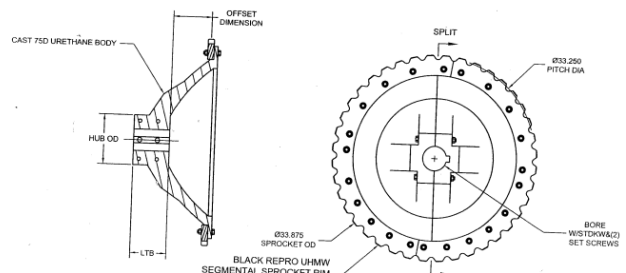
Item No: M09-3C – Idler Sprocket

The sprockets on the shaft were in a rusty/scaled condition. The shaft corrosion potentially caused restrictions in the movement of the sprockets.

- An engineering investigation should be performed for a root cause analysis over the malfunctioning of the mechanical system along with the corrosion parameters to determine a maintenance plan/possible design modification.
- All manufacturers' maintenance manuals of moving parts shall be followed.
- Alignment of the drivers within the driving sprockets configuration shall be checked periodically ensuring there is no excessive misalignment/friction between chains, sprockets, shafts, and drivers.
- Cleaning/removing scales periodically to reduce the wear and tear.
- Inspecting driven sprockets periodically, ensuring they are fixed on the shaft and fully synchronized with the driver shaft/sprocket without any slippage.

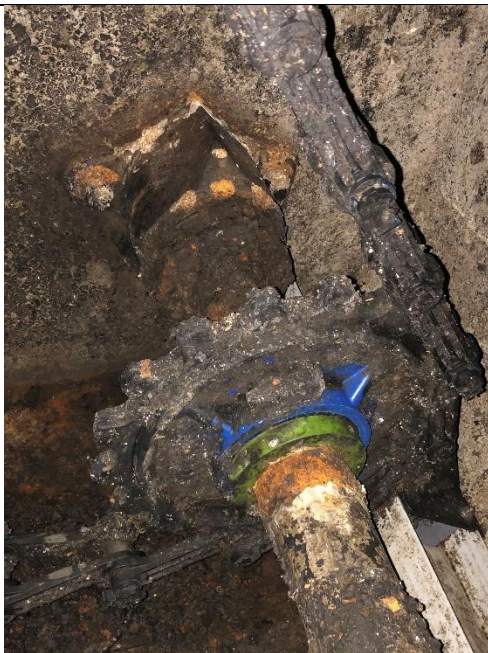
Item No:	M10-3C – Shear Pin Sprocket
Action Plan & Resolution Timeline Required:	1 year
Repair Priority:	P2
Location Detail: Tank #3	Description:

The sprockets on the drive motor shaft were in fair condition.

- All manufacturers' maintenance manuals of moving parts shall be followed.
- Alignment of the drivers within the driving sprockets configuration shall be checked periodically ensuring there is no excessive misalignment/friction between chains, sprockets, shafts, and drivers.
- Cleaning/removing scales periodically to reduce the wear and tear.
- Inspecting driven sprockets periodically, ensuring they are fixed on the shaft and fully synchronized with the driver shaft/sprocket without any slippage.

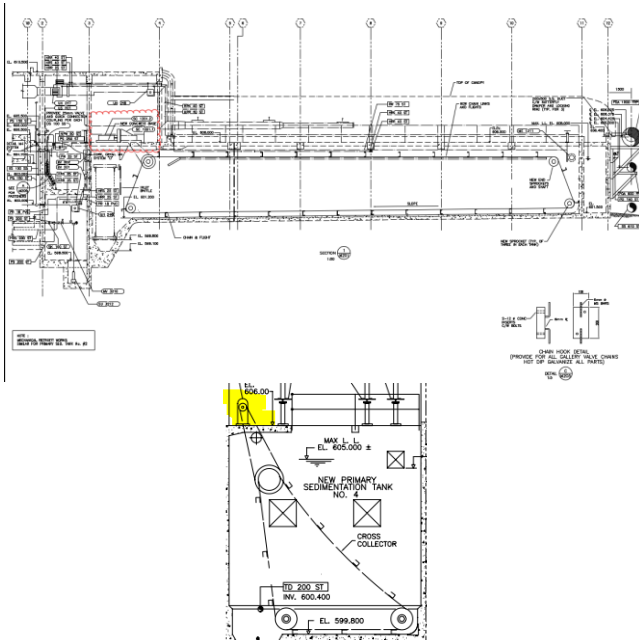
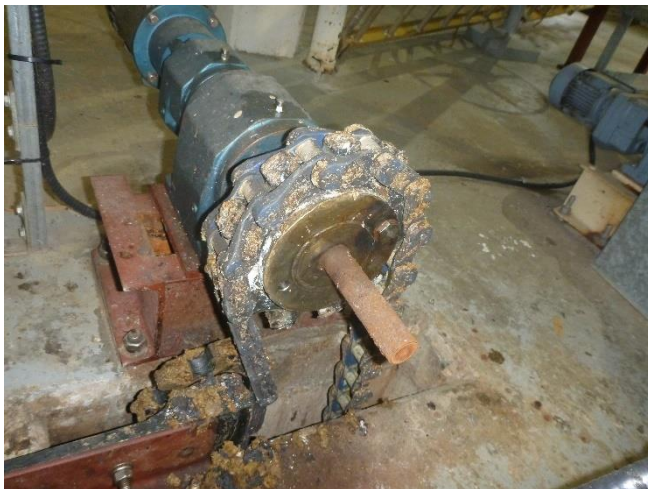
Item No:	M11-3C – Take Up Assembly
Action Plan & Resolution Timeline Required:	1 year
Repair Priority:	P2
Location Detail: Tank #3	Description:

The Take Up Assemblies were in fair condition.

- All manufacturers' maintenance manuals of moving parts shall be followed.
- Alignment of the drivers within the driving sprockets configuration shall be checked periodically ensuring there is no excessive misalignment/friction between chains, sprockets, shafts, and drivers.
- Cleaning/removing scales periodically to reduce the wear and tear.
- Inspecting driven sprockets periodically, ensuring they are fixed on the shaft and fully synchronized with the driver shaft/sprocket without any slippage.

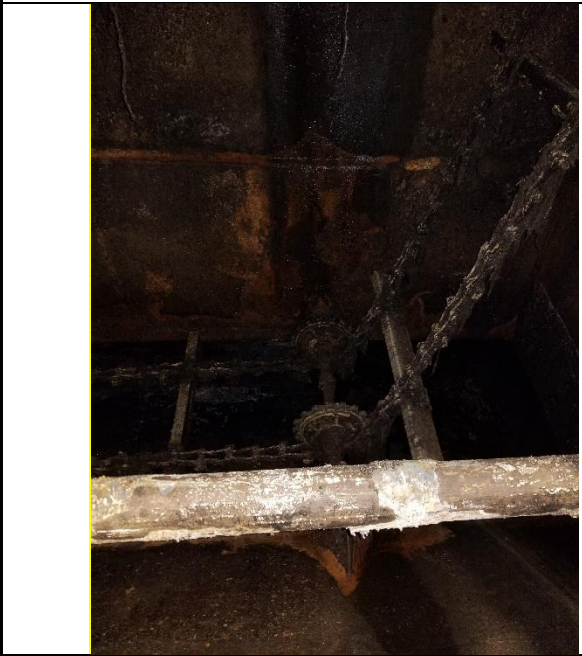
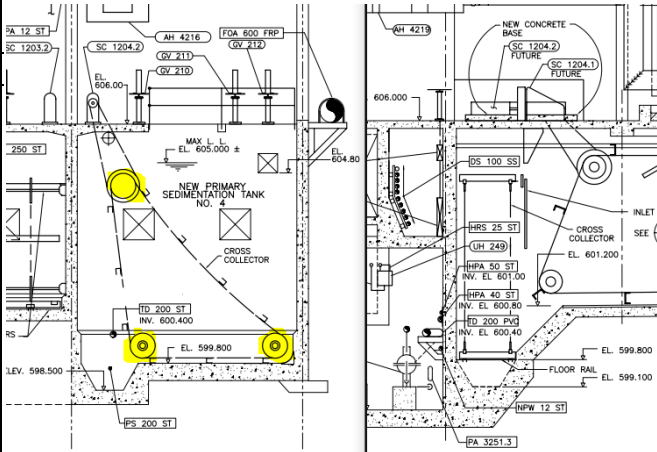
Item No:	M14-3C – Shafts, Pins and set collars
Action Plan & Resolution Timeline Required:	1 year
Repair Priority:	P2
Location Detail: Tank #3	Description:

The shafts were in a rusty/scaled condition.

- An engineering investigation should be performed for a root cause analysis over the malfunctioning of the mechanical system along with the corrosion parameters to determine a maintenance plan/possible design modification.
- All manufacturers' maintenance manuals of moving parts shall be followed.
- Cleaning/removing scales periodically to reduce the wear and tear.
- Inspecting shafts and wall bearings periodically, ensuring they are functioning properly within the whole power transmission system.

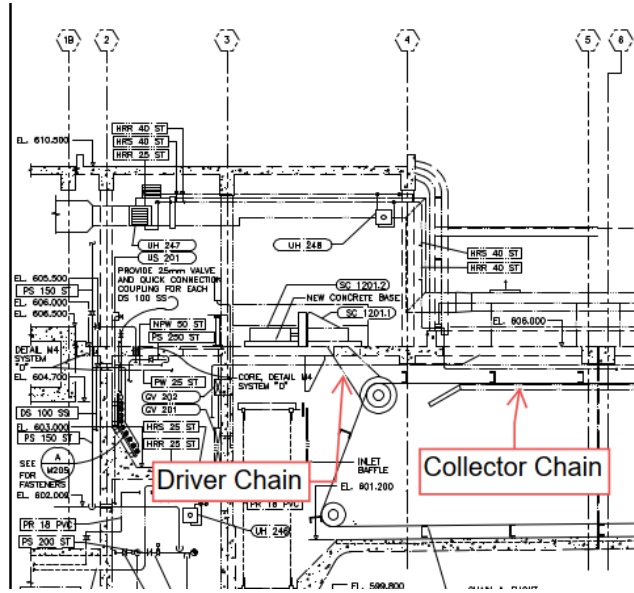
Description:
The drive chains were in fair conditions. However, restrictions on the movement of the wall bearings and sprockets caused increased tension and stresses on the equipment.

- All manufacturers' maintenance manuals of moving parts shall be followed.
- Alignment of the drivers within the driving sprockets configuration shall be checked periodically ensuring there is no excessive misalignment/friction between chains, sprockets, shafts, and drivers.
- Cleaning/removing large scales periodically to reduce the wear and tear.

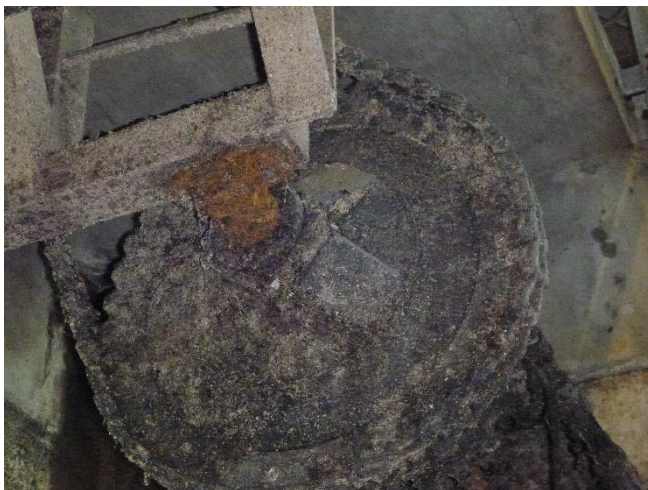
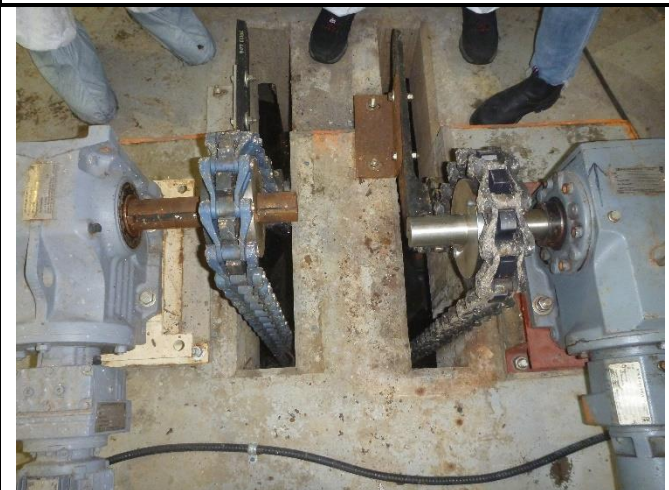
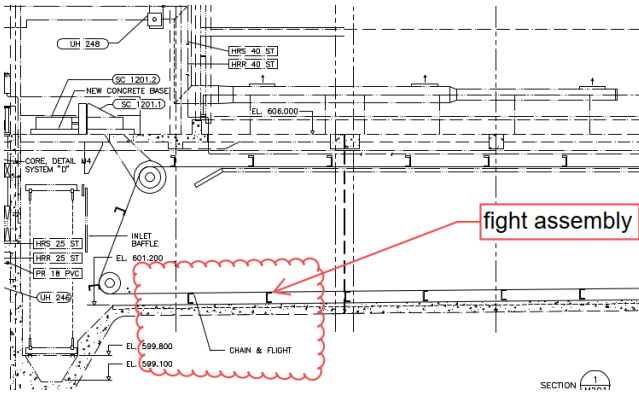
Item No: M04-4L – Wear Shoes

Description:
The wear shoes were in fair conditions. No major deficiencies were detected.

- Required Action:
- All manufacturers' maintenance manuals of moving parts shall be followed.
 - Inspection of wear shall be conducted on a regular basis.

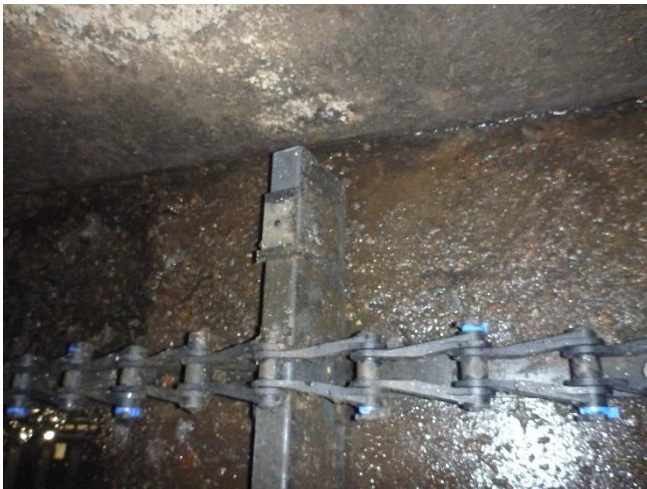
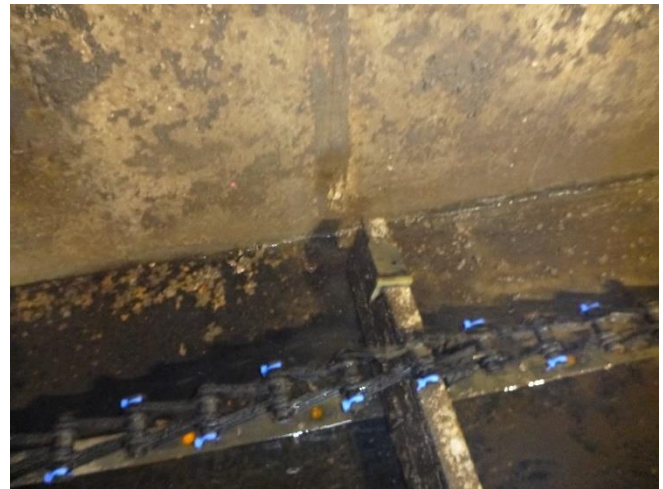
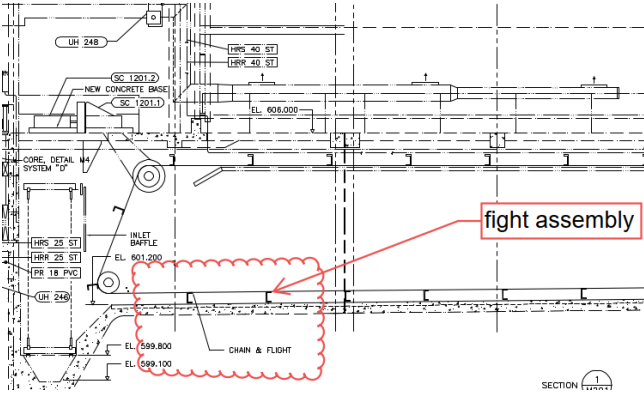
Item No:	M05-4L – Filler Blocks
Action Plan & Resolution Timeline Required:	1 year
Repair Priority:	P2
Location Detail: Tank #4	Description:

The filler blocks were in fair conditions. No major deficiencies were detected.

- Inspection for all the fasteners shall be conducted periodically.

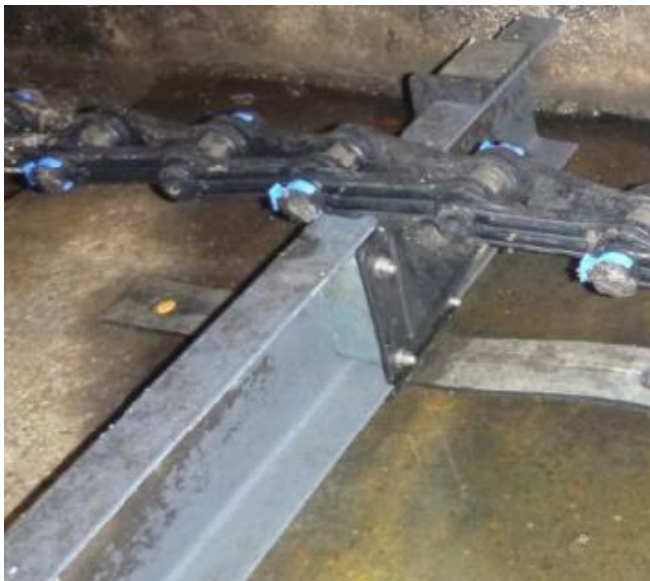
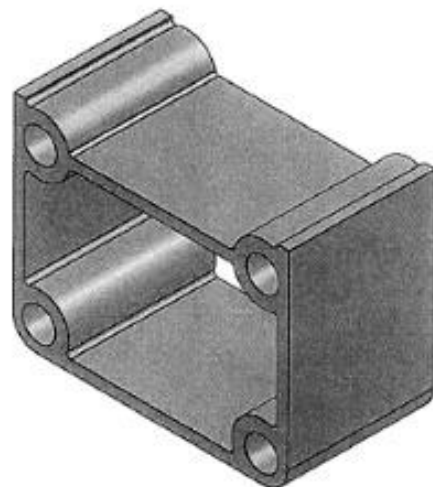
Item No:	M06-4L – C-Channel Fiberglass Flights
Action Plan & Resolution Timeline Required:	1 year
Repair Priority:	P2
Location Detail: Tank #4	Description:

<p>The flight assembly were in fair conditions. Damage was observed most likely caused when the system failed.</p>
	<p>Required Action:</p> <ul style="list-style-type: none"> - An engineering investigation shall be performed for a root cause analysis over the malfunctioning of the mechanical system along with the corrosion parameters to determine a maintenance plan/possible design modification. - All manufacturers' maintenance manuals of moving parts shall be followed. - Alignment of the drivers within the driving sprockets configuration shall be checked periodically ensuring there is no excessive misalignment/friction between chains, sprockets, shafts, and drivers. - Cleaning/removing large scales periodically to reduce the wear and tear.
