Resort Municipality of Whistler: Wastewater Treatment Plant Primary Sedimentation Tank Assessment Report

Project No. 210505

January 26th, 2022

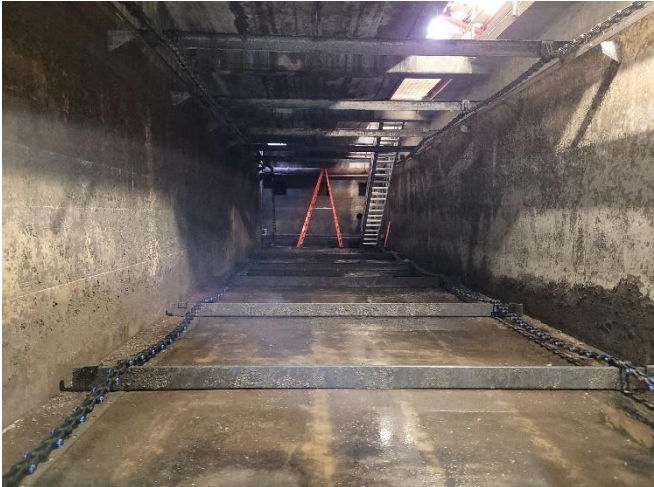
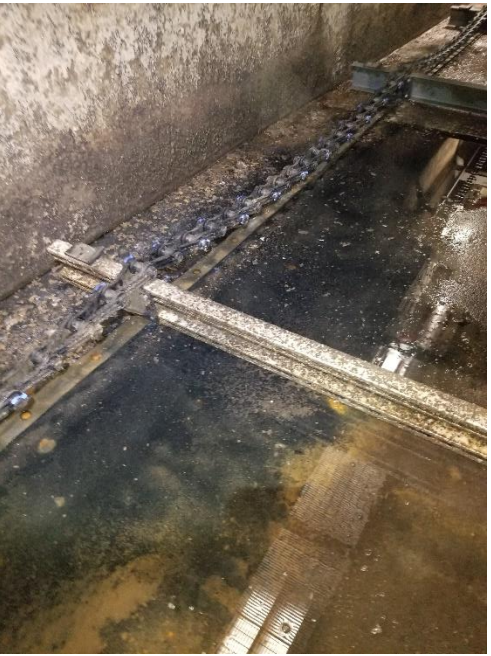
Item No: M07-4L – Drive Sprocket

The sprockets on the shaft were in a rusty/scaled condition.

- An engineering investigation should be performed for a root cause analysis over the malfunctioning of the mechanical system along with the corrosion parameters to determine a maintenance plan/possible design modification.
- All manufacturers' maintenance manuals of moving parts shall be followed.
- Alignment of the drivers within the driving sprockets configuration shall be checked periodically ensuring there is no excessive misalignment/friction between chains, sprockets, shafts, and drivers.
- Cleaning/removing scales periodically to reduce the wear and tear.
- Inspecting driven sprockets periodically, ensuring they are fixed on the shaft and fully synchronized with the driver shaft/sprocket without any slippage.

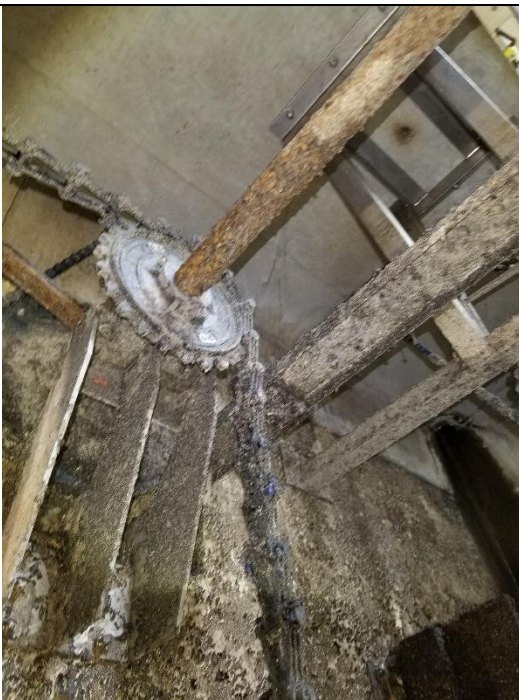
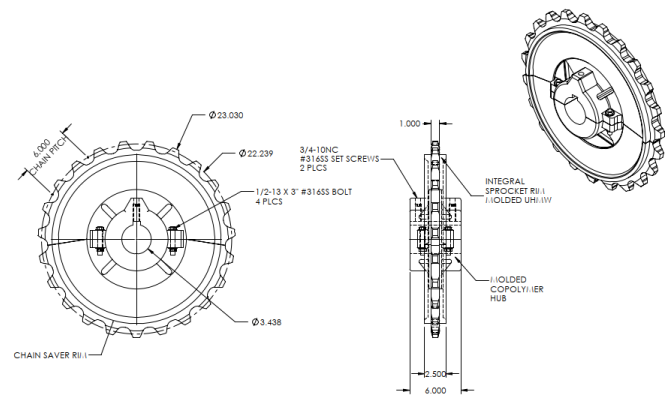
Item No:	M08-4L – Dished Offset Sprocket
Action Plan & Resolution Timeline Required:	1 year
Repair Priority:	P2
Location Detail: Tank #4	Description:

The sprockets on the shaft were in a rusty/scaled condition.

- An engineering investigation should be performed for a root cause analysis over the malfunctioning of the mechanical system along with the corrosion parameters to determine a maintenance plan/possible design modification.
- All manufacturers' maintenance manuals of moving parts shall be followed.
- Alignment of the drivers within the driving sprockets configuration shall be checked periodically ensuring there is no excessive misalignment/friction between chains, sprockets, shafts, and drivers.
- Cleaning/removing scales periodically to reduce the wear and tear.
- Inspecting driven sprockets periodically, ensuring they are fixed on the shaft and fully synchronized with the driver shaft/sprocket without any slippage.

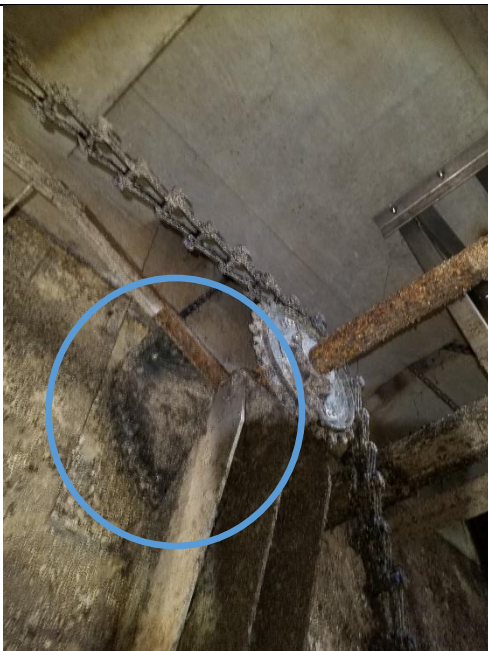
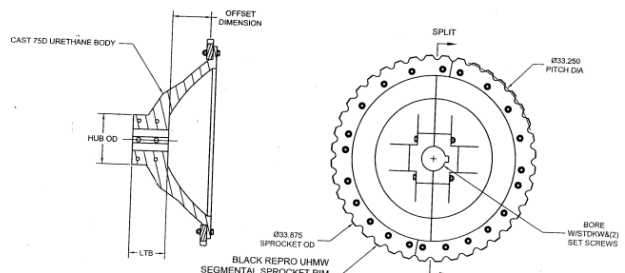
Item No: M09-4L – Idler Sprocket

The sprockets on the shaft were in a rusty/scaled condition. The shaft corrosion potentially caused restrictions in the movement of the sprockets.

- An engineering investigation should be performed for a root cause analysis over the malfunctioning of the mechanical system along with the corrosion parameters to determine a maintenance plan/possible design modification.
- All manufacturers' maintenance manuals of moving parts shall be followed.
- Alignment of the drivers within the driving sprockets configuration shall be checked periodically ensuring there is no excessive misalignment/friction between chains, sprockets, shafts, and drivers.
- Cleaning/removing scales periodically to reduce the wear and tear.
- Inspecting driven sprockets periodically, ensuring they are fixed on the shaft and fully synchronized with the driver shaft/sprocket without any slippage.

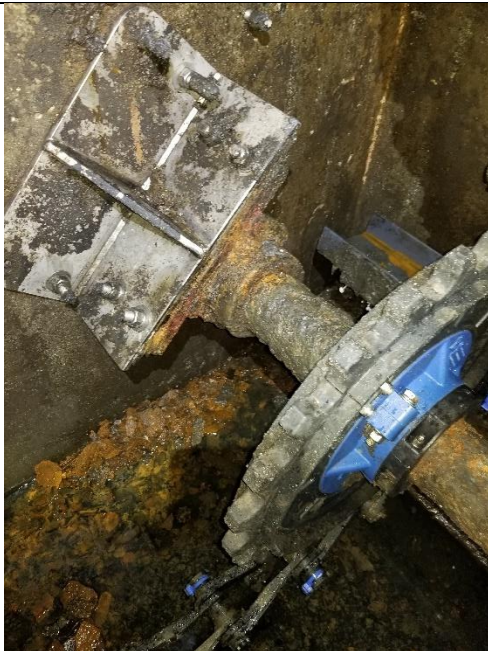
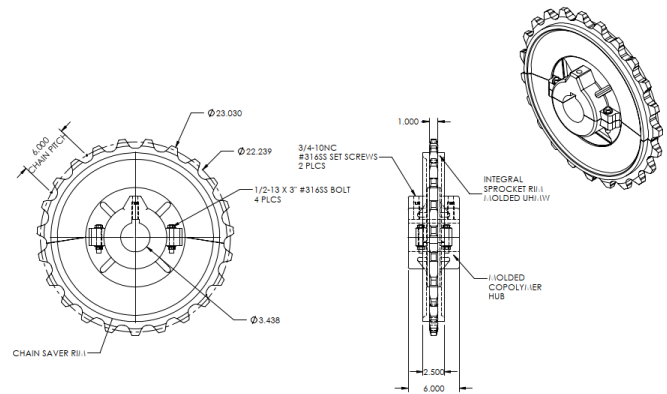
Item No:	M10-4L – Shear Pin Sprocket
Action Plan & Resolution Timeline Required:	1 year
Repair Priority:	P2
Location Detail: Tank #4	Description:

The sprockets on the drive motor shaft were in fair condition.

- All manufacturers' maintenance manuals of moving parts shall be followed.
- Alignment of the drivers within the driving sprockets configuration shall be checked periodically ensuring there is no excessive misalignment/friction between chains, sprockets, shafts, and drivers.
- Cleaning/removing scales periodically to reduce the wear and tear.
- Inspecting driven sprockets periodically, ensuring they are fixed on the shaft and fully synchronized with the driver shaft/sprocket without any slippage.

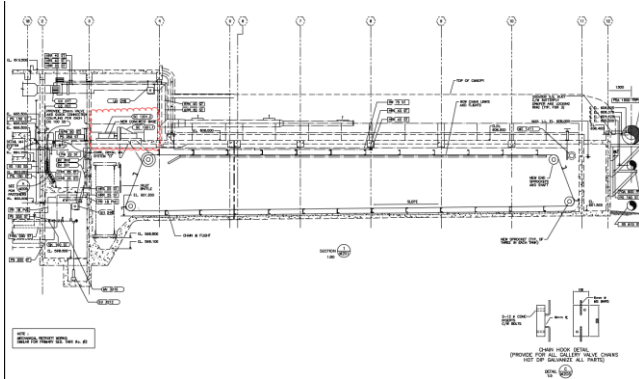
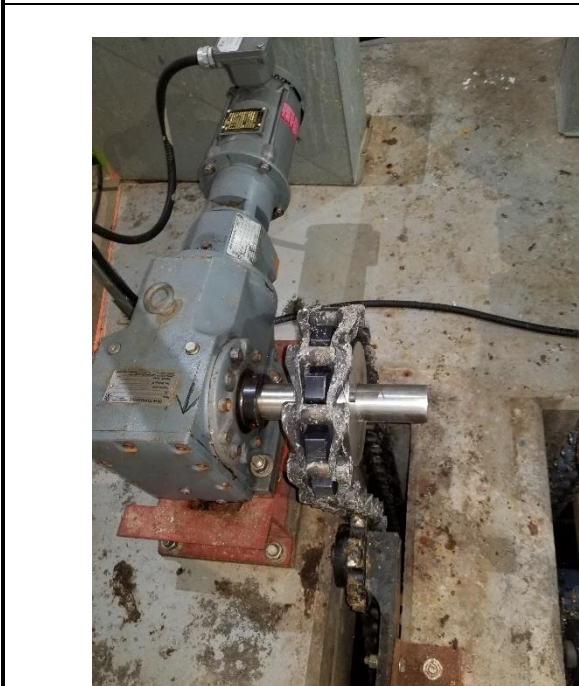
Item No:	M11-4L – Take Up Assembly
Action Plan & Resolution Timeline Required:	1 year
Repair Priority:	P1E
Location Detail: Tank #4	Description:

The Take Up Assemblies were in fair condition.

- An engineering investigation should be performed for a root cause analysis over the malfunctioning of the mechanical system along with the corrosion parameters to determine a maintenance plan/possible design modification.
- All manufacturers' maintenance manuals of moving parts shall be followed.
- Alignment of the drivers within the driving sprockets configuration including take up assembly shall be checked periodically ensuring there is no excessive misalignment/friction between chains, sprockets, shafts, take up assembly and drivers and the driving chain has tensed up properly.
- Cleaning/removing scales periodically to reduce the wear and tear.

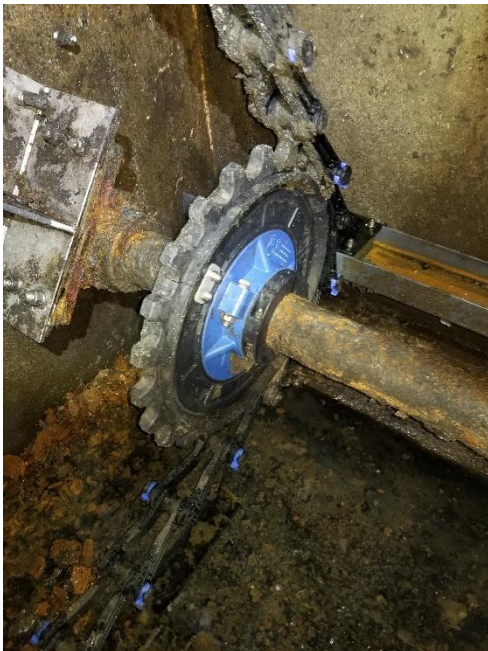
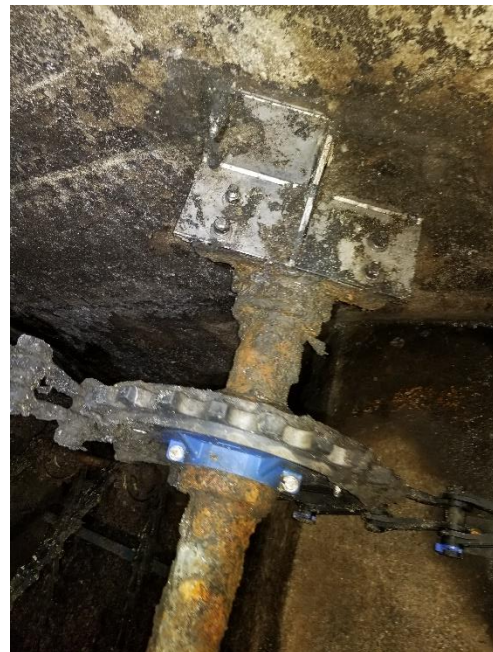
Item No: M12-4L – Wall Bearings

The wall bearings were in a rusty/scaled condition.

- An engineering investigation should be performed for a root cause analysis over the malfunctioning of the mechanical system along with the corrosion parameters to determine a maintenance plan/possible design modification.
- All manufacturers' maintenance manuals of moving parts shall be followed.
- Cleaning/removing scales periodically to reduce the wear and tear.
- Inspecting shafts and wall bearings periodically, ensuring they are functioning properly within the whole power transmission system.

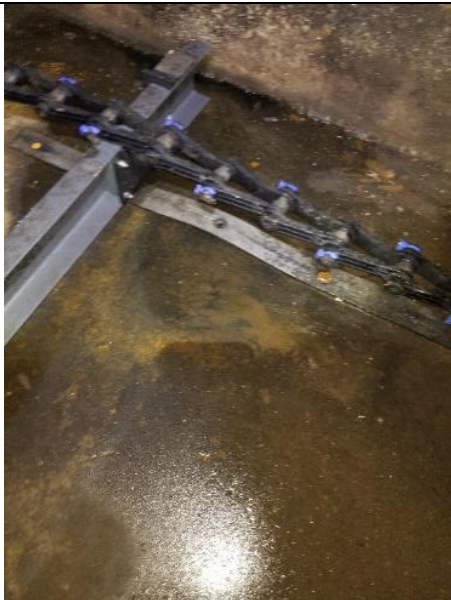
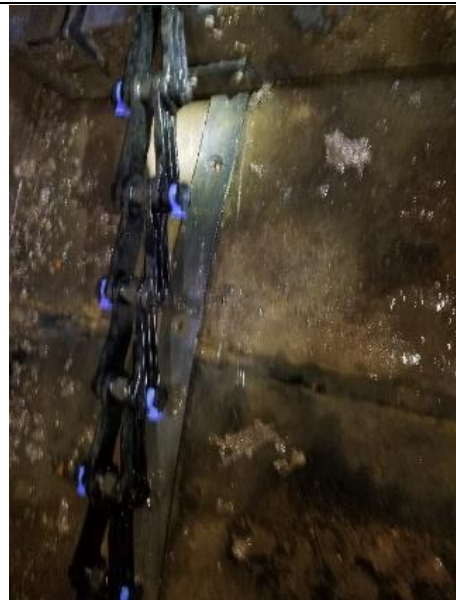
Item No:	M13-4L – Collector Wear Strip
Action Plan & Resolution Timeline Required:	1 year
Repair Priority:	P1R
Location Detail: Tank #4	Description:
	Missing bolts and consequently lifted off strip. This lifting off can act as an obstacle against the flights.
	Required Action:
	<ul style="list-style-type: none"> - All manufacturers' maintenance manuals of moving parts shall be followed. - Cleaning/removing scales periodically to reduce the wear and tear. - Moving of the flights shall be inspected periodically since any asymmetrical moving of the flights can be flagged as malfunctioning of some parts of collector system including the Wear strips integrity.

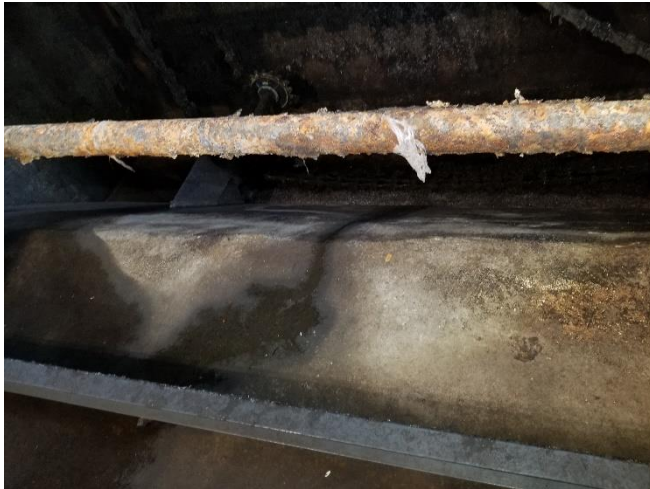
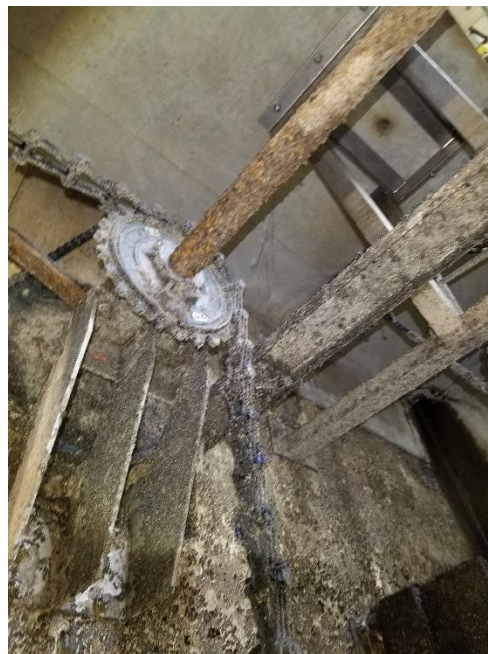
Item No: M14-4L – Shafts, Pins and set collars

The shafts were in a rusty/scaled condition.

- An engineering investigation should be performed for a root cause analysis over the malfunctioning of the mechanical system along with the corrosion parameters to determine a maintenance plan/possible design modification.
- All manufacturers' maintenance manuals of moving parts shall be followed.
- Cleaning/removing scales periodically to reduce the wear and tear.
- Inspecting shafts and wall bearings periodically, ensuring they are functioning properly within the whole power transmission system.

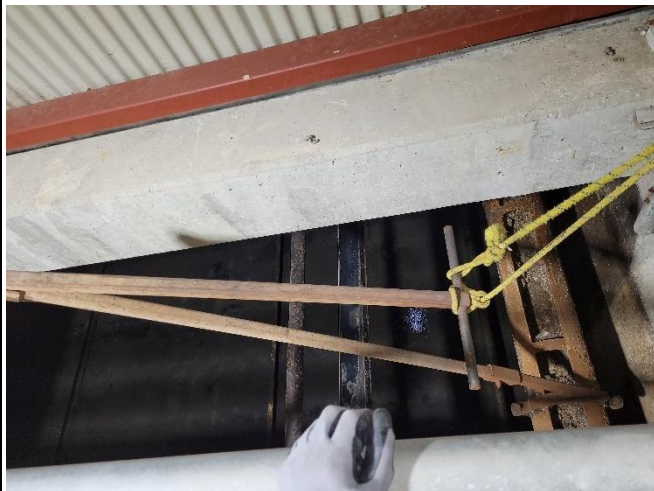
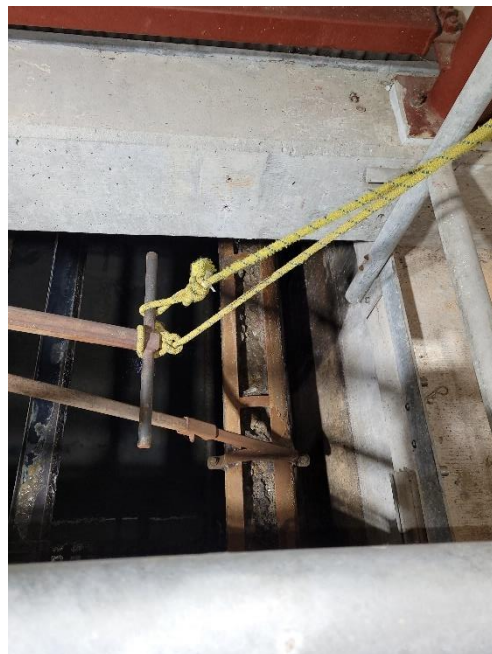
Item No: M15-4L – Skimmer

The skimmer is in a rusty/scaled condition. Operations noted without occasional movement of the skimmer, they are prone to seizing.

- An engineering investigation should be performed for a root cause analysis over the malfunctioning of the mechanical system along with the corrosion parameters.
- Consider a revised design for better reliability.
- All manufacturers' maintenance manuals of moving parts shall be followed.

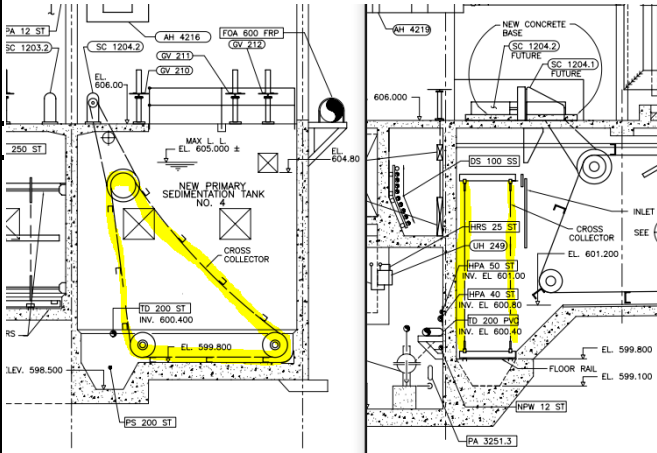
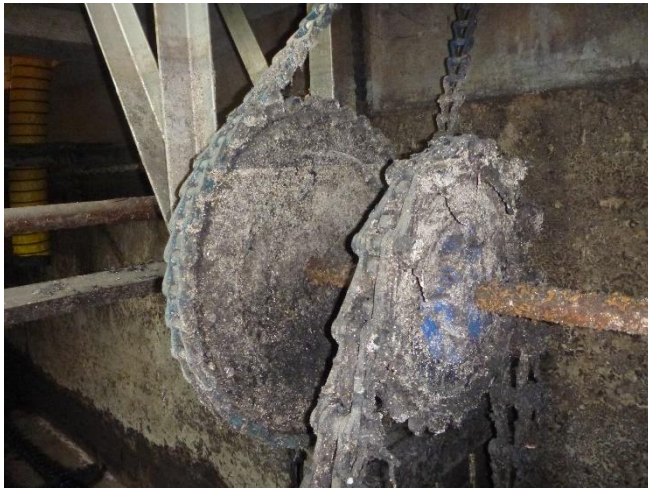
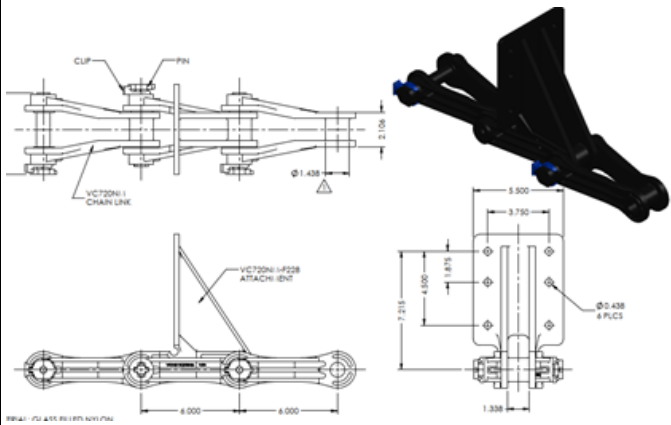
The collector chains were in fair conditions.

- All manufacturers' maintenance manuals of moving parts shall be followed.
- Alignment of the drivers within the driving sprockets configuration shall be checked periodically ensuring there is no excessive misalignment/friction between chains, sprockets, shafts, and drivers.
- Cleaning/removing large scales periodically to reduce the wear and tear.

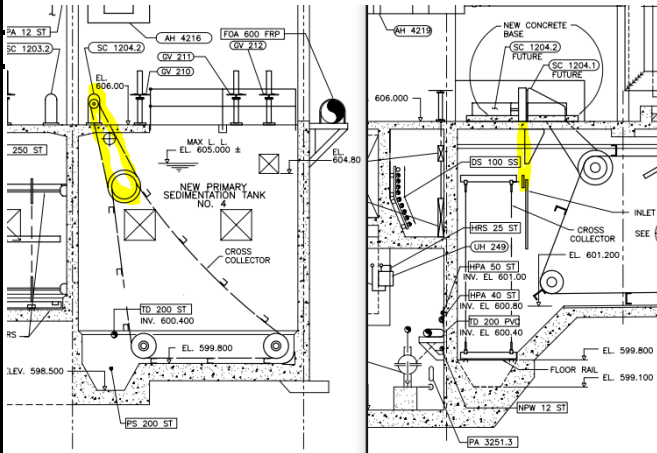
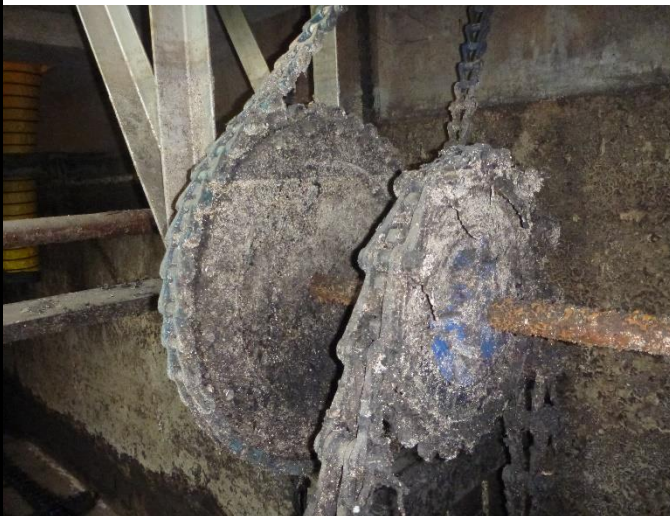
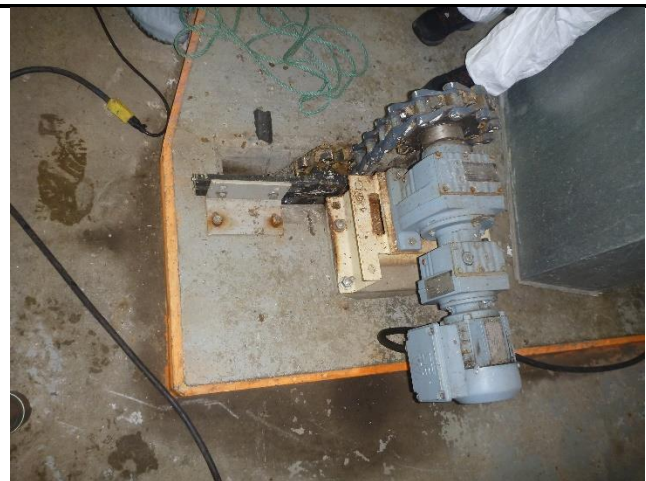
M03-4C – Drive Chain

The drive chains were in fair conditions.

- All manufacturers' maintenance manuals of moving parts shall be followed.
- Alignment of the drivers within the driving sprockets configuration shall be checked periodically ensuring there is no excessive misalignment/friction between chains, sprockets, shafts, and drivers.
- Cleaning/removing large scales periodically to reduce the wear and tear.

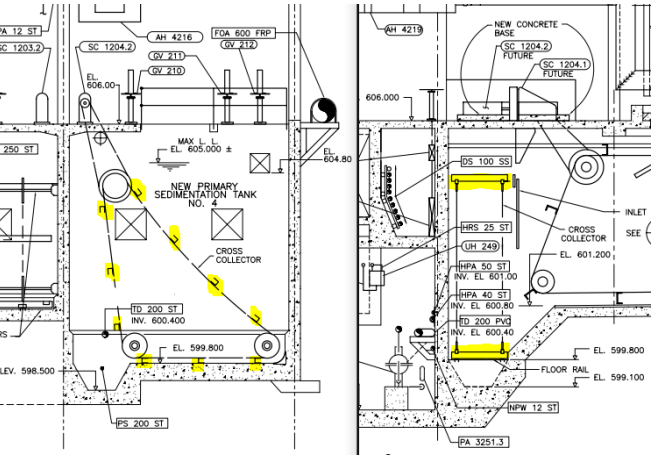
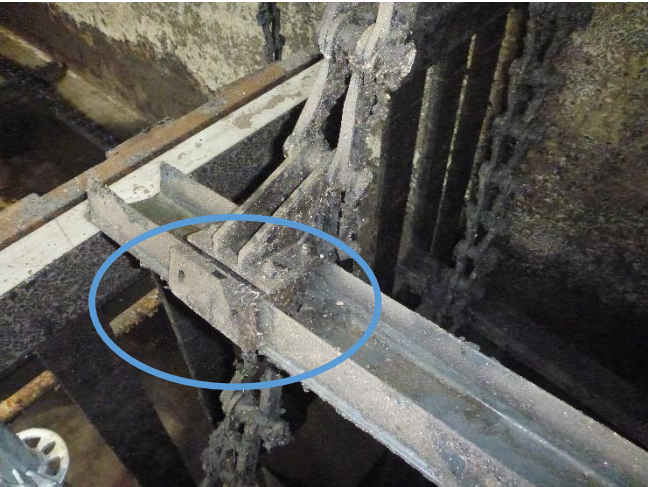
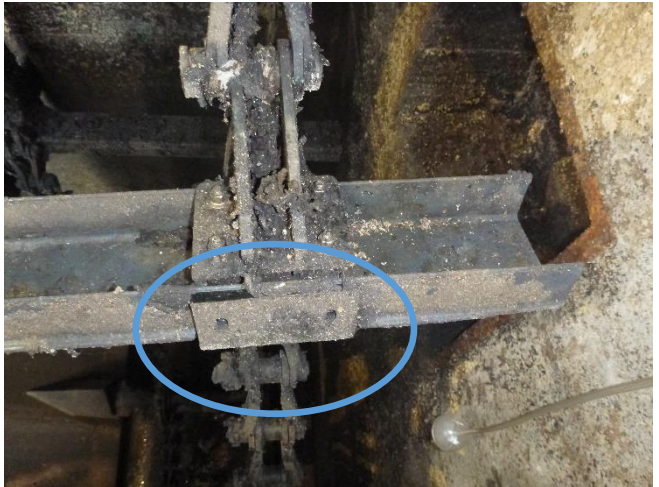
Item No:	M04-4C – Wear Shoes
Action Plan & Resolution Timeline Required:	1 year
Repair Priority:	P2
Location Detail: Tank #4	Description:

The wear shoes were in fair conditions. No major deficiencies were detected.

- All manufacturers' maintenance manuals of moving parts shall be followed.
- Inspection of wear shall be conducted on a regular basis.

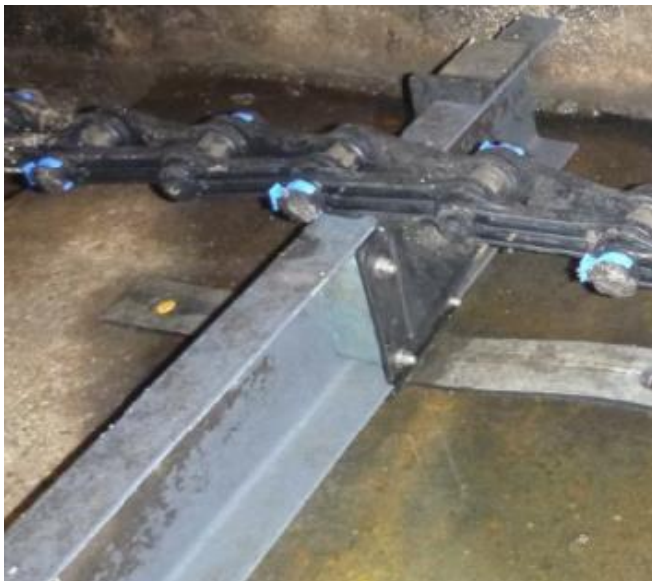
M05-4C – Filler Blocks

The filler blocks were in fair conditions. No major deficiencies were detected.

- Inspection for all the fasteners shall be conducted periodically.

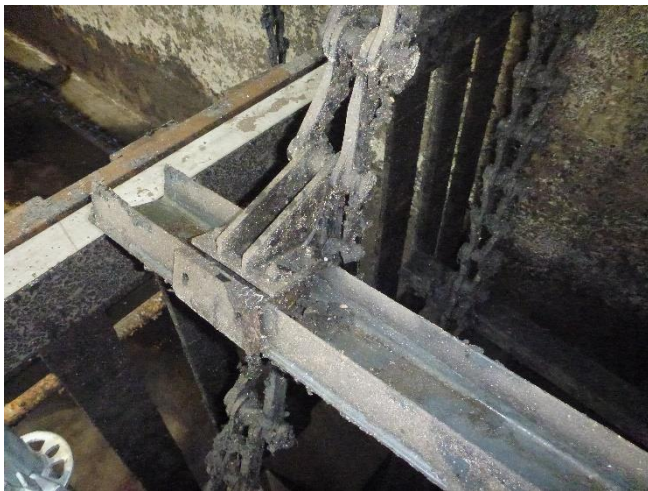
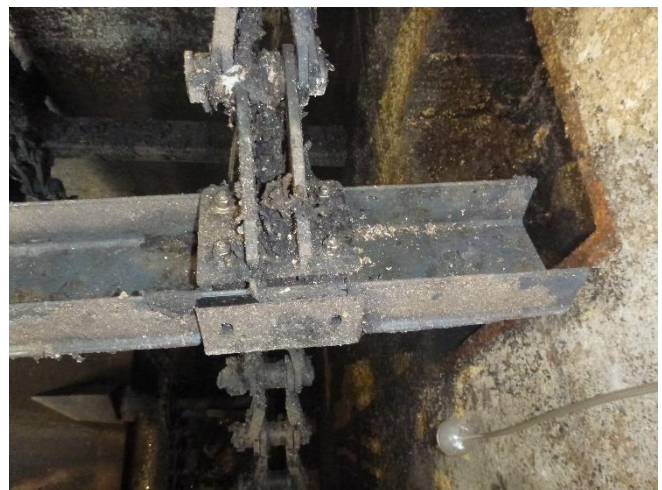
M06-4C – C-Channel Fiberglass Flights

The flight assembly were in fair conditions.

- An engineering investigation shall be performed for a root cause analysis over the malfunctioning of the mechanical system along with the corrosion parameters to determine a maintenance plan/possible design modification.
- All manufacturers' maintenance manuals of moving parts shall be followed.
- Alignment of the drivers within the driving sprockets configuration shall be checked periodically ensuring there is no excessive misalignment/friction between chains, sprockets, shafts, and drivers.
- Cleaning/removing large scales periodically to reduce the wear and tear.

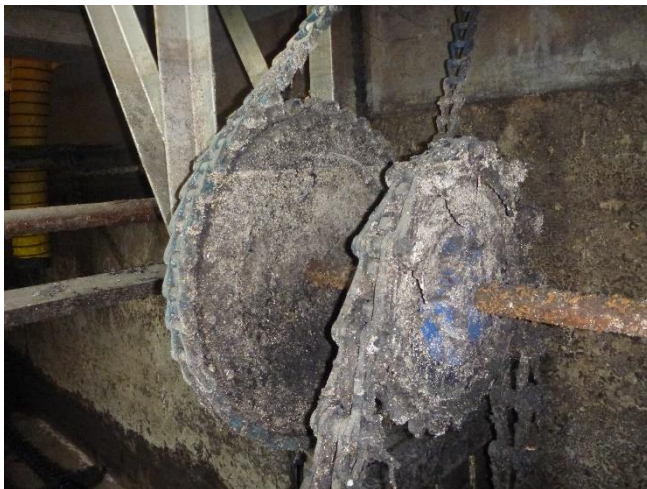
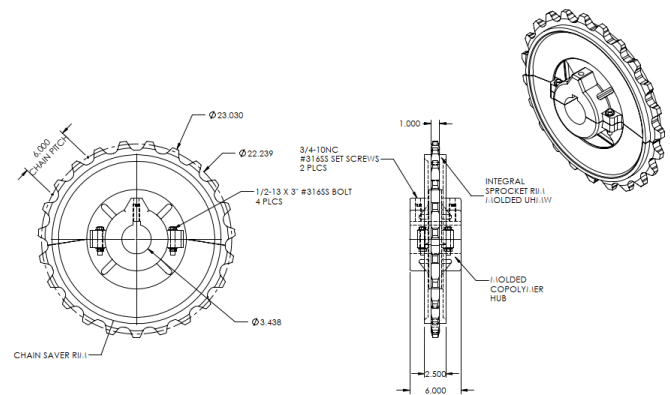
Item No: M07-4C – Drive Sprocket

Location Detail: Tank #4
Description: The sprockets on the shaft were in a rusty/scaled condition.

- An engineering investigation should be performed for a root cause analysis over the malfunctioning of the mechanical system along with the corrosion parameters to determine a maintenance plan/possible design modification.
- All manufacturers' maintenance manuals of moving parts shall be followed.
- Alignment of the drivers within the driving sprockets configuration shall be checked periodically ensuring there is no excessive misalignment/friction between chains, sprockets, shafts, and drivers.
- Cleaning/removing scales periodically to reduce the wear and tear.
- Inspecting driven sprockets periodically, ensuring they are fixed on the shaft and fully synchronized with the driver shaft/sprocket without any slippage.

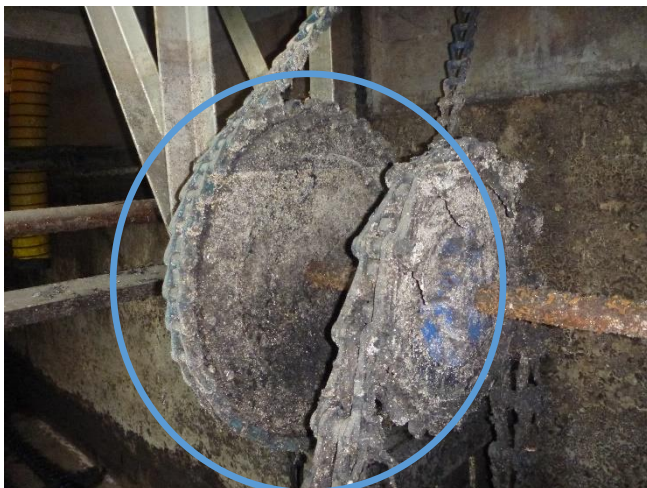
Item No:	M08-4C – Dished Offset Sprocket
Action Plan & Resolution Timeline Required:	1 year
Repair Priority:	P2
Location Detail: Tank #4	Description:

The sprockets on the shaft were in a rusty/scaled condition.

- An engineering investigation should be performed for a root cause analysis over the malfunctioning of the mechanical system along with the corrosion parameters to determine a maintenance plan/possible design modification.
- All manufacturers' maintenance manuals of moving parts shall be followed.
- Alignment of the drivers within the driving sprockets configuration shall be checked periodically ensuring there is no excessive misalignment/friction between chains, sprockets, shafts, and drivers.
- Cleaning/removing scales periodically to reduce the wear and tear.
- Inspecting driven sprockets periodically, ensuring they are fixed on the shaft and fully synchronized with the driver shaft/sprocket without any slippage.

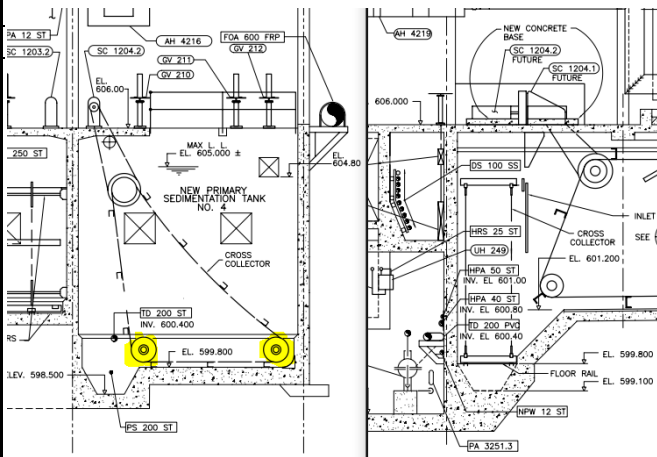
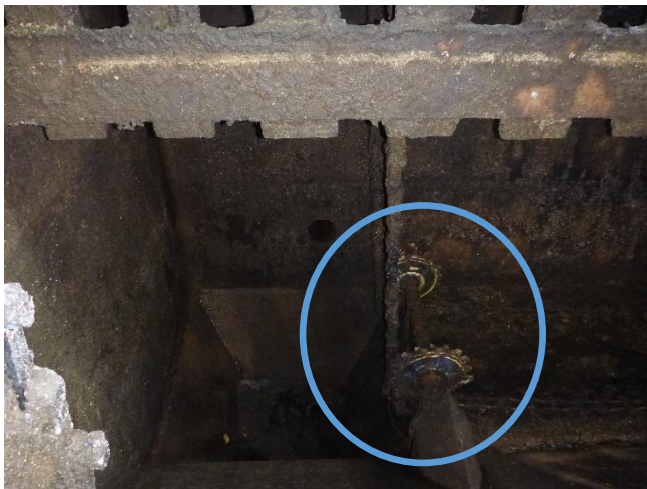
Item No: M09-4C – Idler Sprocket

The sprockets on the shaft were in a rusty/scaled condition. The shaft corrosion potentially caused restrictions in the movement of the sprockets.

- An engineering investigation should be performed for a root cause analysis over the malfunctioning of the mechanical system along with the corrosion parameters to determine a maintenance plan/possible design modification.
- All manufacturers' maintenance manuals of moving parts shall be followed.
- Alignment of the drivers within the driving sprockets configuration shall be checked periodically ensuring there is no excessive misalignment/friction between chains, sprockets, shafts, and drivers.
- Cleaning/removing scales periodically to reduce the wear and tear.
- Inspecting driven sprockets periodically, ensuring they are fixed on the shaft and fully synchronized with the driver shaft/sprocket without any slippage.

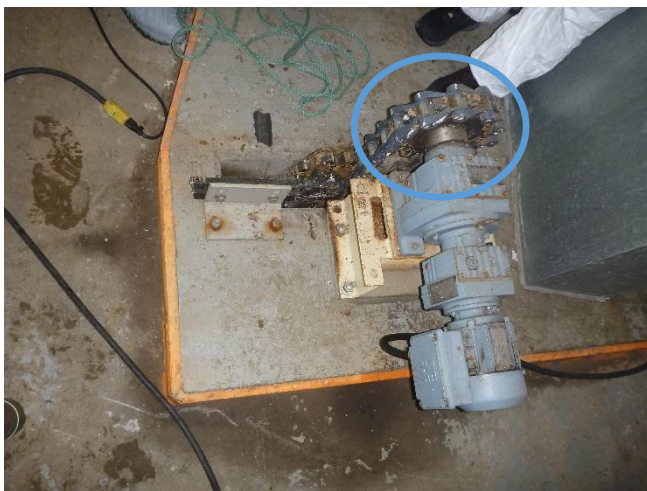
Item No:	M10-4C – Shear Pin Sprocket
Action Plan & Resolution Timeline Required:	1 year
Repair Priority:	P2
Location Detail: Tank #4	Description:

The sprockets on the drive motor shaft were in fair condition.

- All manufacturers' maintenance manuals of moving parts shall be followed.
- Alignment of the drivers within the driving sprockets configuration shall be checked periodically ensuring there is no excessive misalignment/friction between chains, sprockets, shafts, and drivers.
- Cleaning/removing scales periodically to reduce the wear and tear.
- Inspecting driven sprockets periodically, ensuring they are fixed on the shaft and fully synchronized with the driver shaft/sprocket without any slippage.

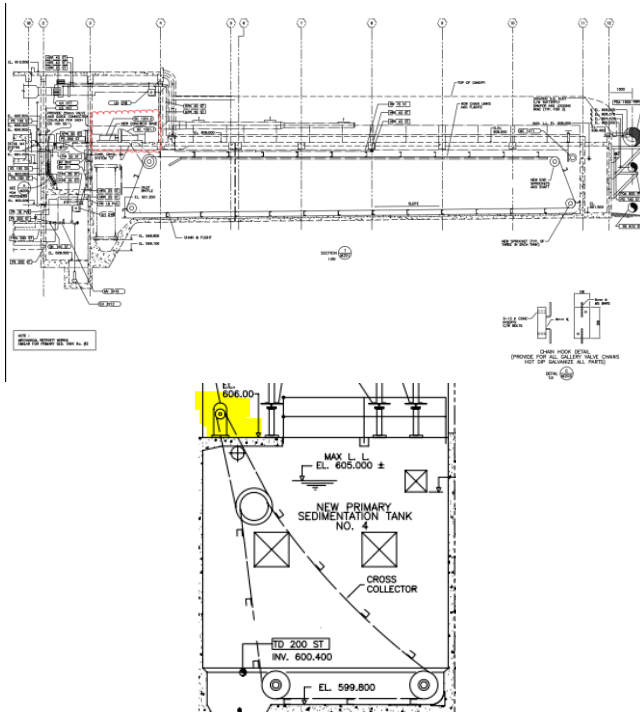
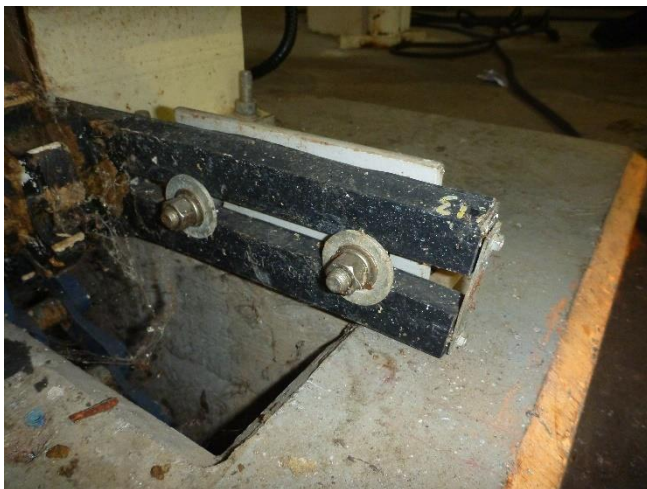
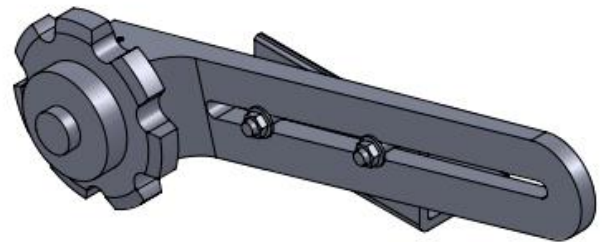
Item No:	M11-4C – Take Up Assembly
Action Plan & Resolution Timeline Required:	1 year
Repair Priority:	P2
Location Detail: Tank #4	Description:

The Take Up Assemblies were in fair condition.

- All manufacturers' maintenance manuals of moving parts shall be followed.
- Alignment of the drivers within the driving sprockets configuration shall be checked periodically ensuring there is no excessive misalignment/friction between chains, sprockets, shafts, and drivers.
- Cleaning/removing scales periodically to reduce the wear and tear.
- Inspecting driven sprockets periodically, ensuring they are fixed on the shaft and fully synchronized with the driver shaft/sprocket without any slippage.

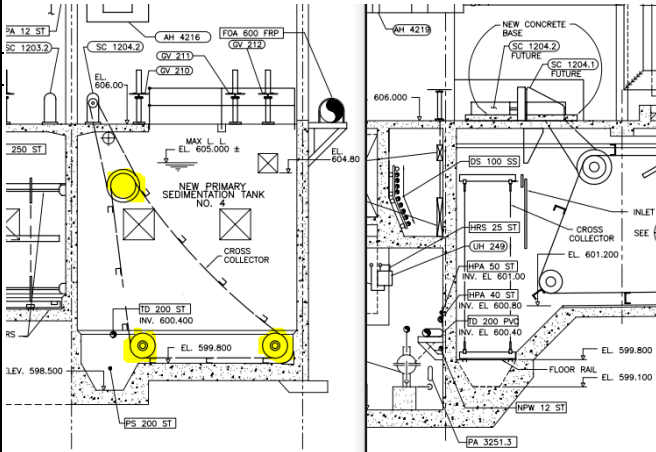
Item No: M12-4C – Wall Bearings

The wall bearings were in a rusty/scaled condition.

- An engineering investigation should be performed for a root cause analysis over the malfunctioning of the mechanical system along with the corrosion parameters to determine a maintenance plan/possible design modification.
- All manufacturers' maintenance manuals of moving parts shall be followed.
- Cleaning/removing scales periodically to reduce the wear and tear.
- Inspecting shafts and wall bearings periodically, ensuring they are functioning properly within the whole power transmission system.

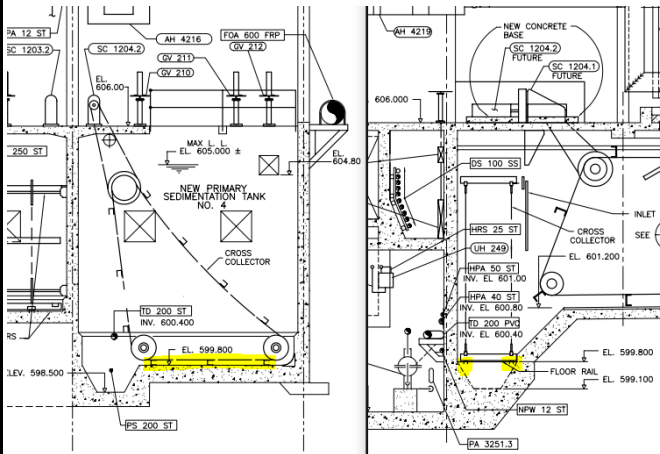
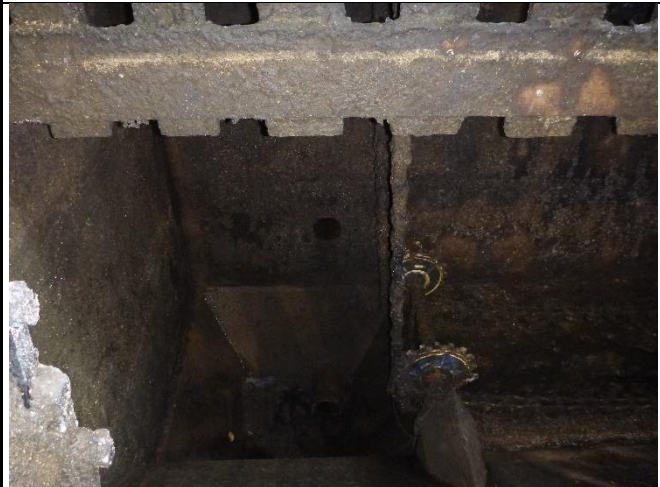
Item No:	M13-4C – Collector Wear Strip
Action Plan & Resolution Timeline Required:	1 year
Repair Priority:	P2

Location Detail: Tank #4	Description: Not accessible.
--------------------------	---------------------------------

- All manufacturers' maintenance manuals of moving parts shall be followed.
- Inspection of wear shall be conducted on a regular basis.

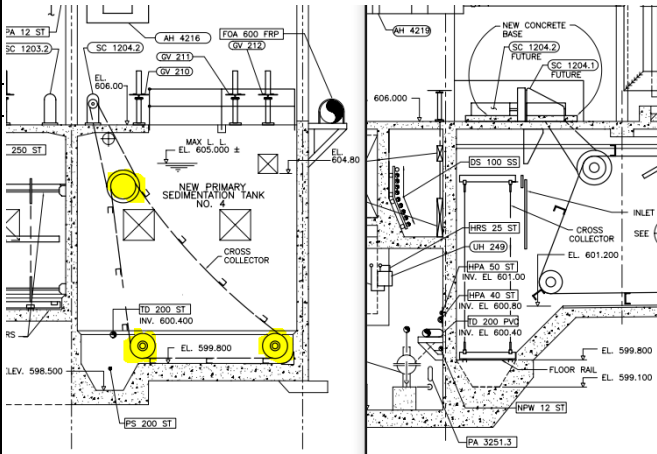
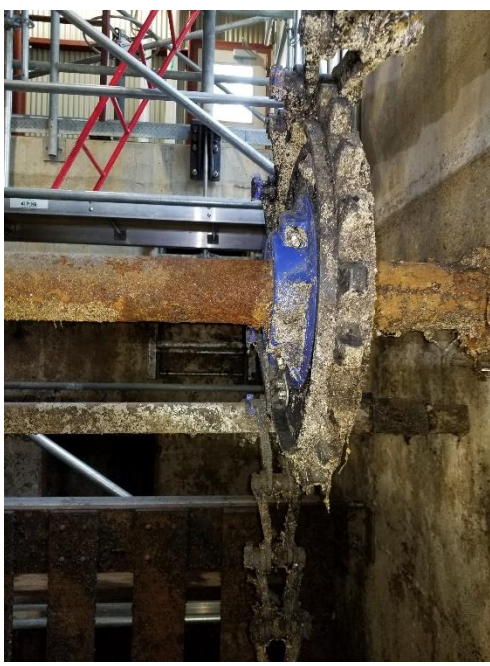
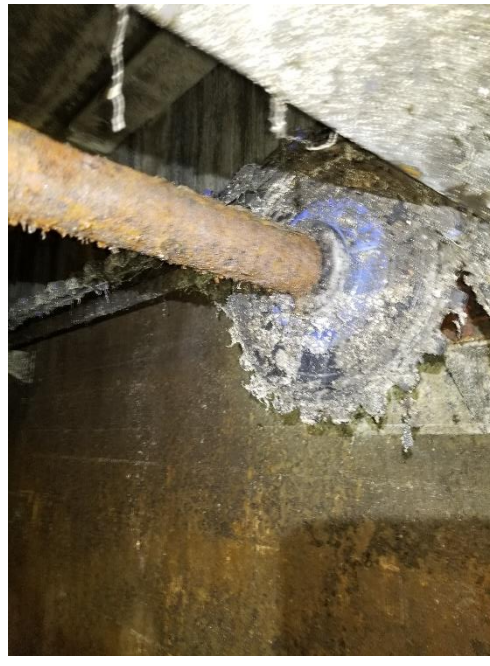
Item No:	M14-4C – Shafts, Pins and set collars
Action Plan & Resolution Timeline Required:	1 year
Repair Priority:	P2

Location Detail: Tank #4	Description: The shafts were in a rusty/scaled condition.
--------------------------	--

- An engineering investigation should be performed for a root cause analysis over the malfunctioning of the mechanical system along with the corrosion parameters to determine a maintenance plan/possible design modification.
- All manufacturers' maintenance manuals of moving parts shall be followed.
- Cleaning/removing scales periodically to reduce the wear and tear.
- Inspecting shafts and wall bearings periodically, ensuring they are functioning properly within the whole power transmission system.

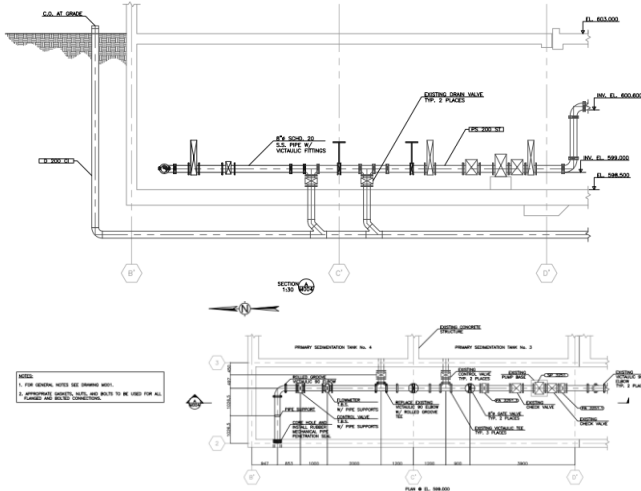
Item No: M15

Location Detail: EQ system of Tank #1 through #4 Description:

The system is observed to be in a newer condition. However, lack of proper pipe supports was observed and block valves to the tanks are very worn out. They may need to be replaced. Heat tracing and insulation was not installed on exterior piping and valves.

- An engineering investigation should be performed for overall piping and pipe support system/configuration for a better supporting and performance design.
- An engineering investigation should be performed for exterior piping system to determine the need for heat tracing and/or insulation.
- All manufacturers' maintenance manuals of piping components, valves and instruments shall be followed.

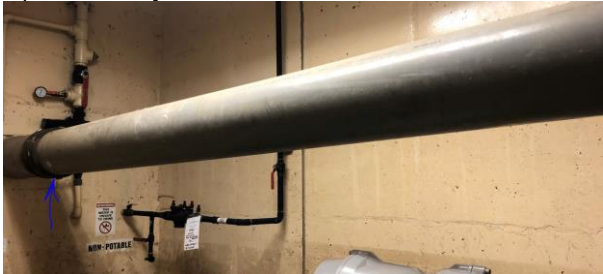
Lack of proper supporting

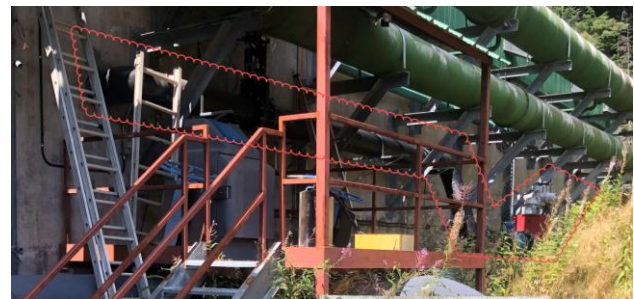
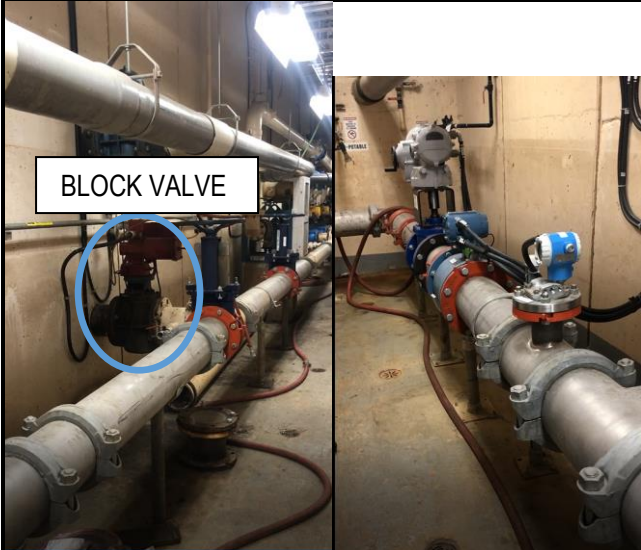
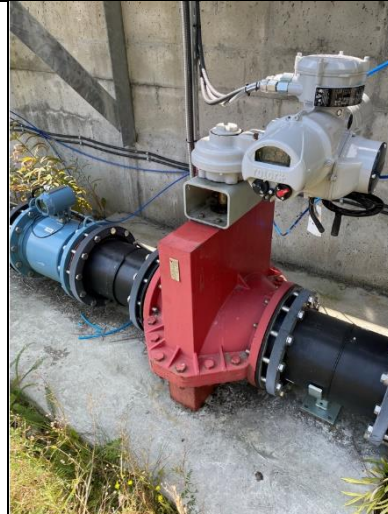
Outdoor control valve without any heat tracing or insulation.

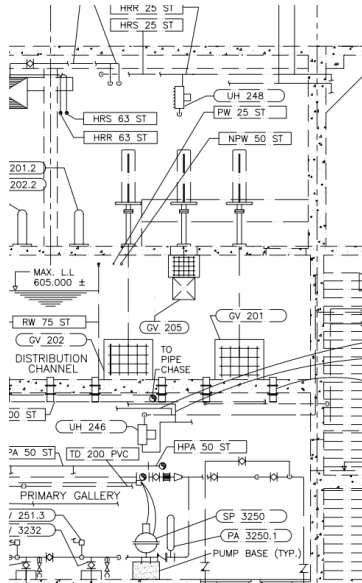
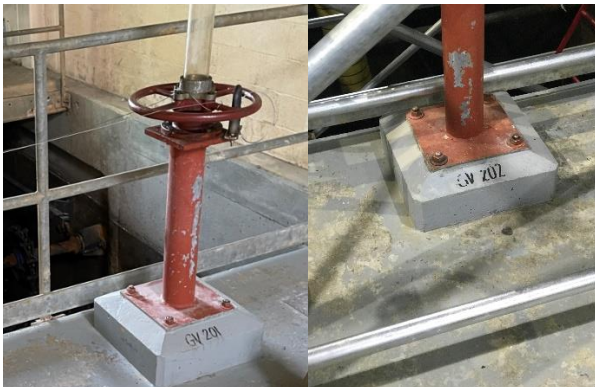
Item No: M16-11

GV 201, GV 202, GV 203
Scales at the gates and the gate valves blades was observed. Actuators are in a fair condition.

- An engineering investigation should be performed for overall Gate Valves performances/integrity.
- All manufacturers' maintenance manuals of the valves and actuators shall be followed.
- Cleaning periodically the scales on the gates and blades inside the tank can increase the valve/actuator performance and sealing properties.

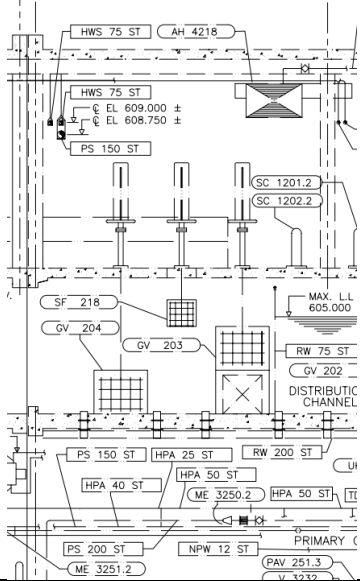
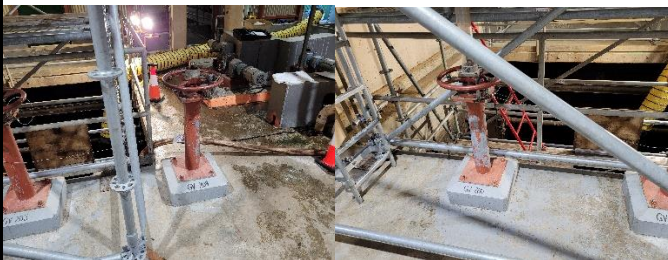
Item No: M16-2I

GV 204, GV 206
Scales at the gates and the gate valves blades was observed. Actuators are in a fair condition.

- An engineering investigation should be performed for overall Gate Valves performances/integrity.
- All manufacturers' maintenance manuals of the valves and actuators shall be followed.
- Cleaning periodically the scales on the gates and blades inside the tank can increase the valve/actuator performance and sealing properties.

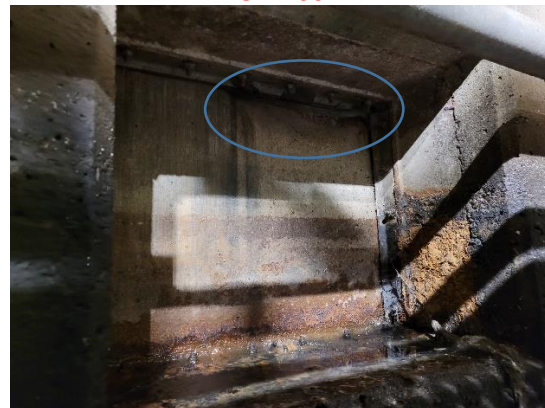
GV 205
A displaced gasket was observed. Repair is required.

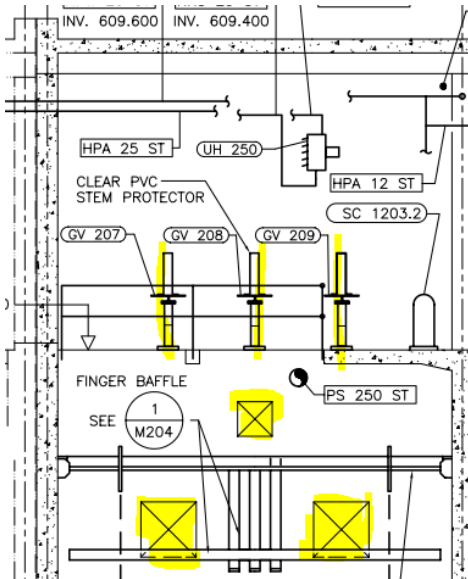
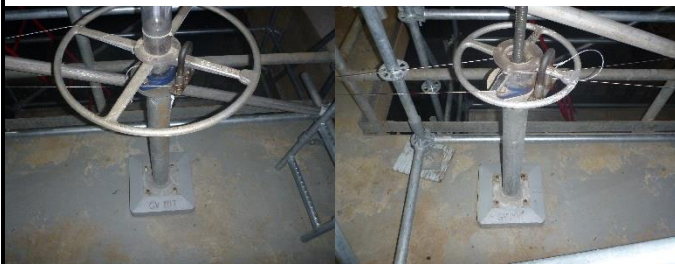
Item No: M16-3I

GV 207, GV 208, GV 209
Scales at the gates and the gate valves blades was observed. Actuators are in a fair condition.

- An engineering investigation should be performed for overall Gate Valves performances/integrity.
- All manufacturers' maintenance manuals of the valves and actuators shall be followed.
- Cleaning periodically the scales on the gates and blades inside the tank can increase the valve/actuator performance and sealing properties.

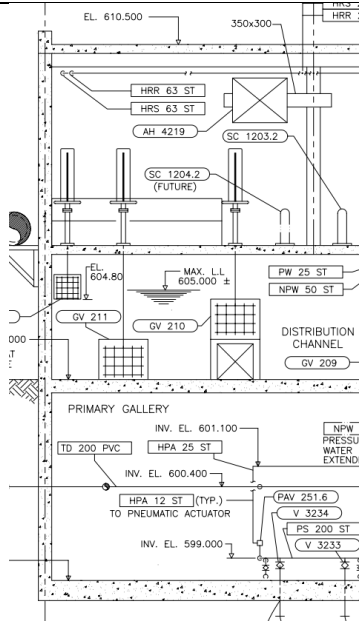
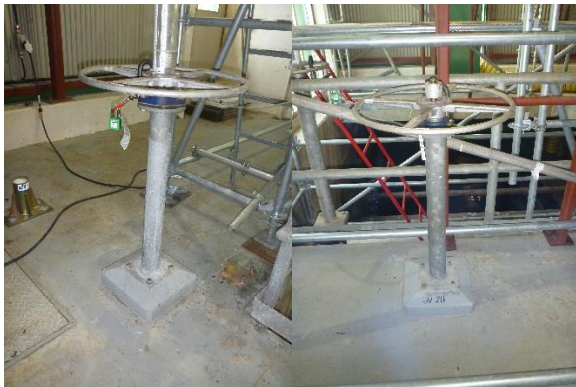
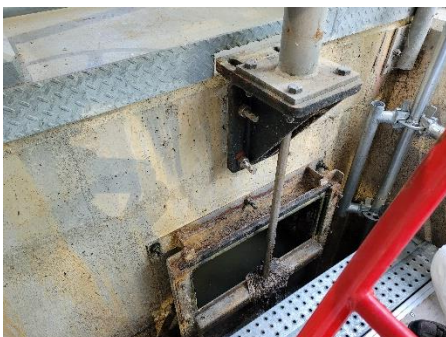
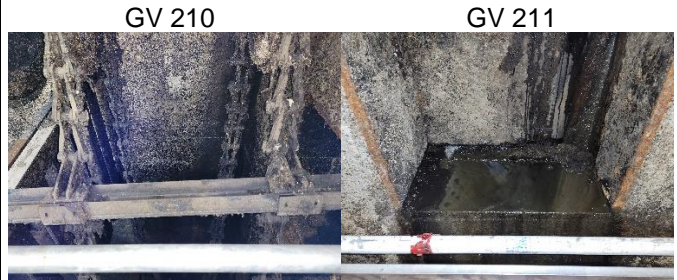
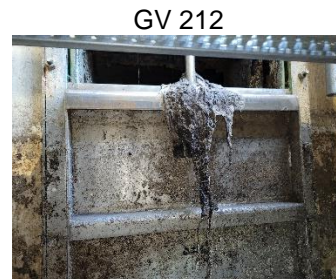
Item No: M16-4I

GV 210, GV 211, GV 212
Scales at the gates and the gate valves blades was observed. Actuators are in a fair condition.

- An engineering investigation should be performed for overall Gate Valves performances/integrity.
- All manufacturers' maintenance manuals of the valves and actuators shall be followed.
- Cleaning periodically the scales on the gates and blades inside the tank can increase the valve/actuator performance and sealing properties.

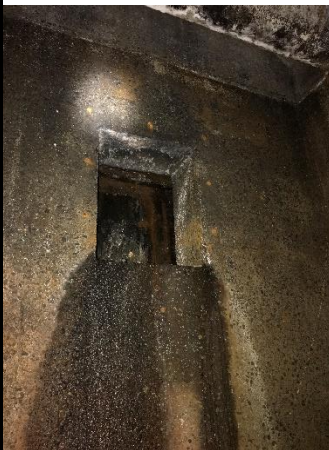
GV 213

GV 213, GV 214, GV 215
Scales at the gates and the gate valves blades was observed. Actuators are in a fair condition.
