Resort Municipality of Whistler: Wastewater Treatment Plant Primary Sedimentation Tank Assessment Report

Project No. 210505

January 26th, 2022

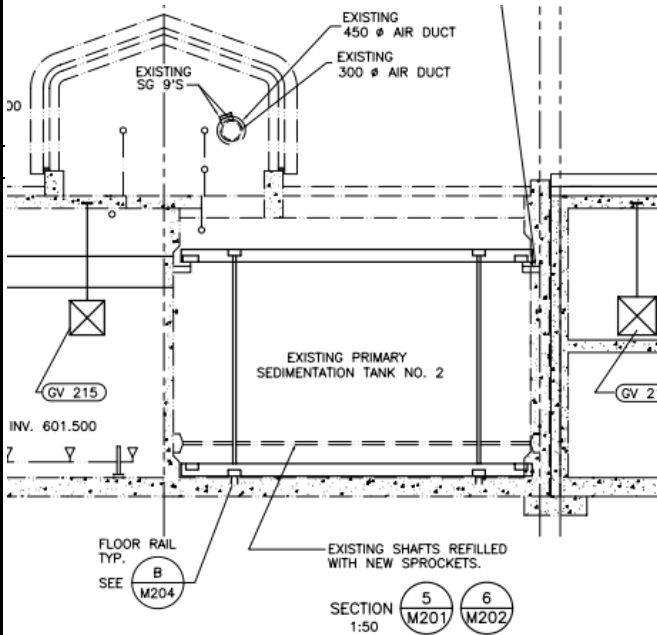
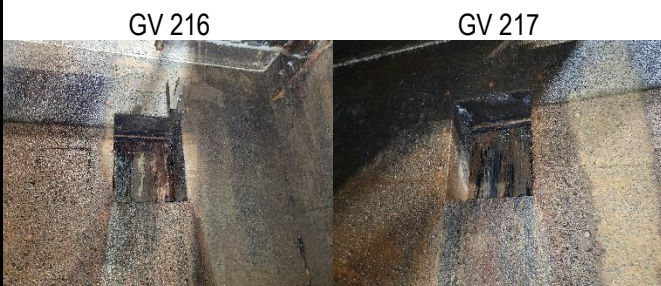
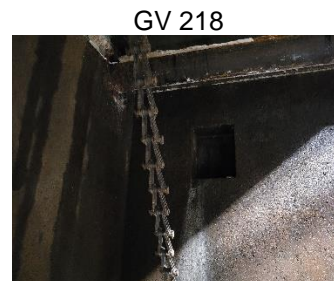
Item No: M16-20

GV 216, GV 217, GV 218
Scales at the gates and the gate valves blades was observed. Actuators are in a fair condition.

- An engineering investigation should be performed for overall Gate Valves performances/integrity.
- All manufacturers' maintenance manuals of the valves and actuators shall be followed.
- Cleaning periodically the scales on the gates and blades inside the tank can increase the valve/actuator performance and sealing properties.

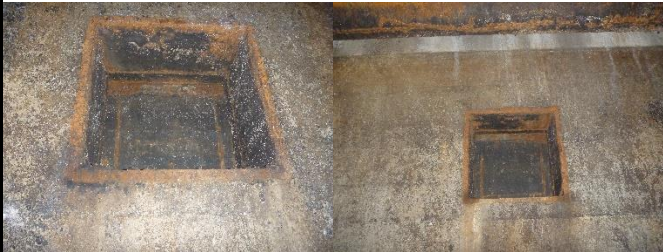
GV 220

GV 219, GV 220, GV 221
Scales at the gates and the gate valves blades was observed. Actuators are in a fair condition.

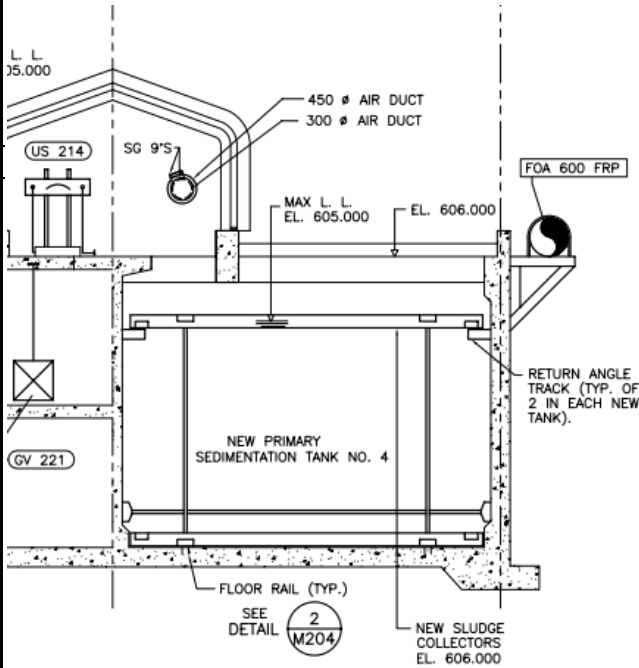
GV 222, GV 223, GV 224
Scales at the gates and the gate valves blades was observed. Actuators are in a fair condition.

- An engineering investigation should be performed for overall Gate Valves performances/integrity.
- All manufacturers' maintenance manuals of the valves and actuators shall be followed.
- Cleaning periodically the scales on the gates and blades inside the tank can increase the valve/actuator performance and sealing properties.

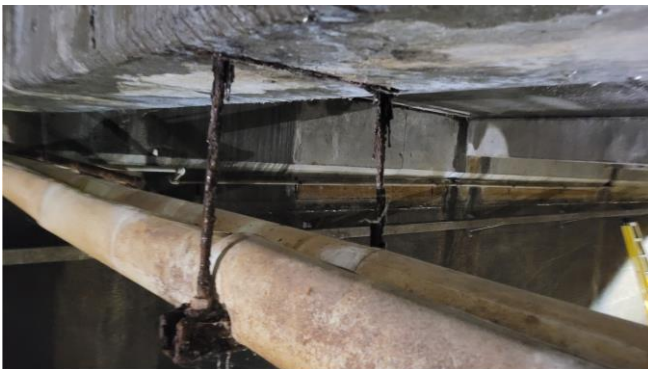
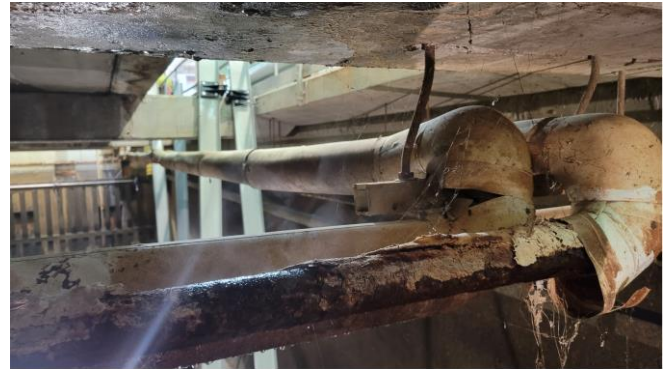
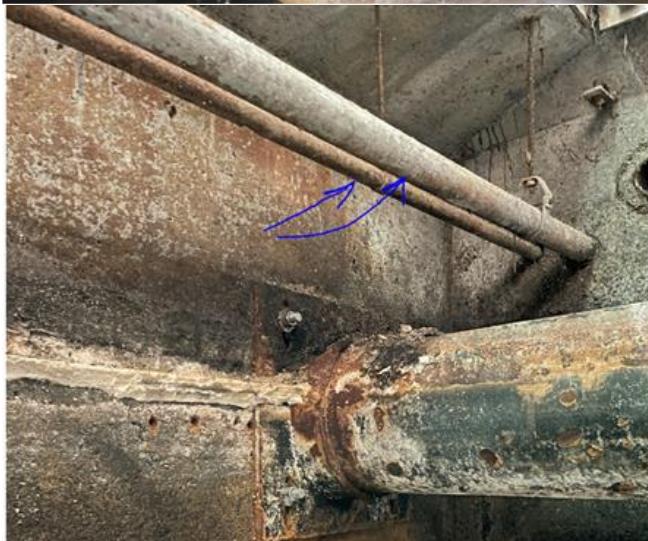
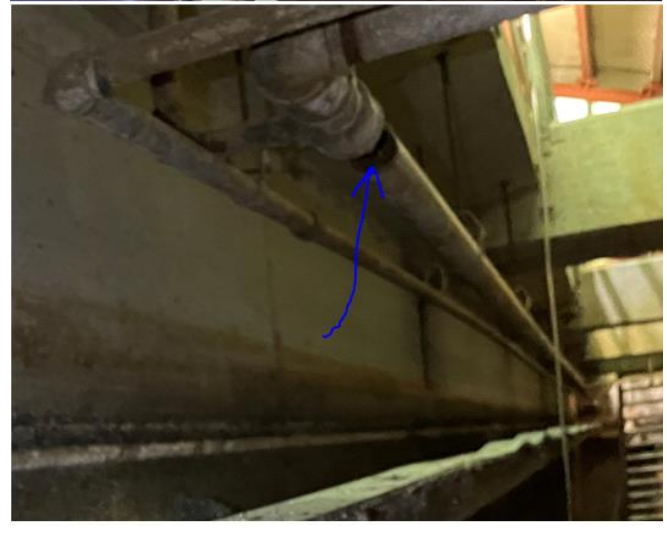
Item No:	M17
Action Plan & Resolution Timeline Required:	1 year
Repair Priority:	P1E
Location Detail: Tank #1, 3 and 4	Description:
	Scales and possible corrosion for some portions of the pipes and supports that did not have proper sleeve were observable in the tank areas.
	Required Action:
Process Piping	<ul style="list-style-type: none"> - An engineering investigation/specific piping inspection/NDE should be performed for determining the remaining life span of the piping system in those areas. - Cleaning periodically the scales and annually inspection of the piping system is recommended to check the corrosion level and piping system integrity

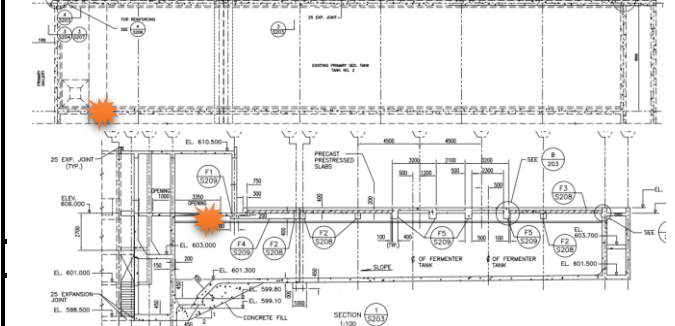
Item No: S01

Concrete Deterioration – Abrasion & Etch Damage

- NDT test to identify Cover and Possible steel corrosion.

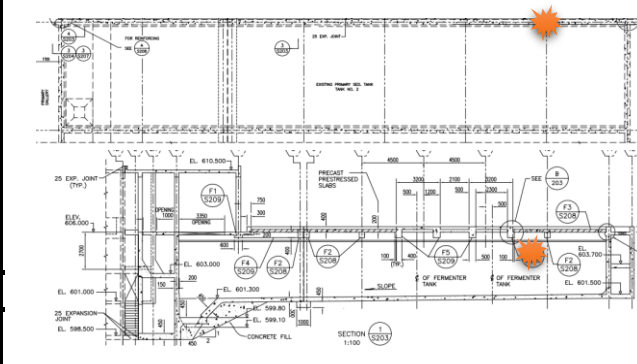
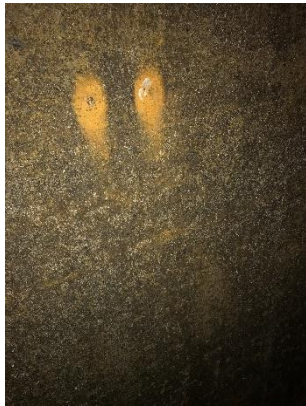
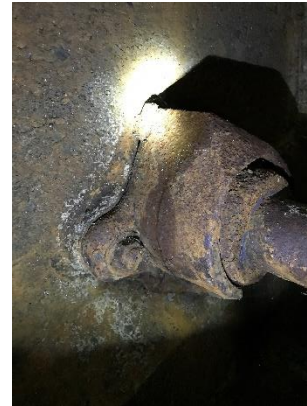
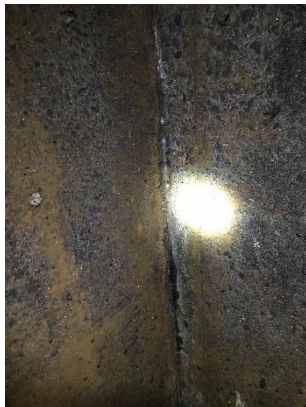
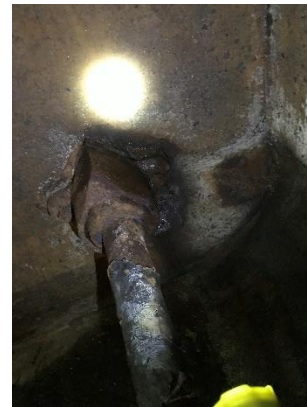
Concrete wall

Concrete Deterioration –Etch Damage

- NDT test to identify Cover and Possible steel corrosion.
- Destructive test to find Alkalinity of concrete especially near to exposed formwork support.

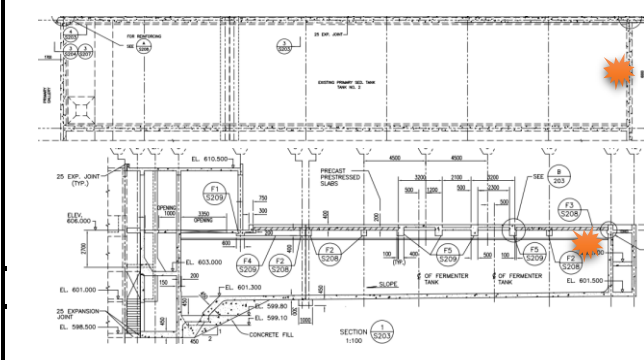
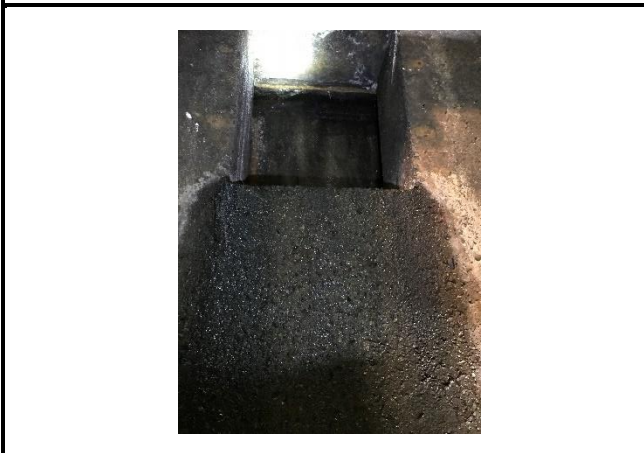
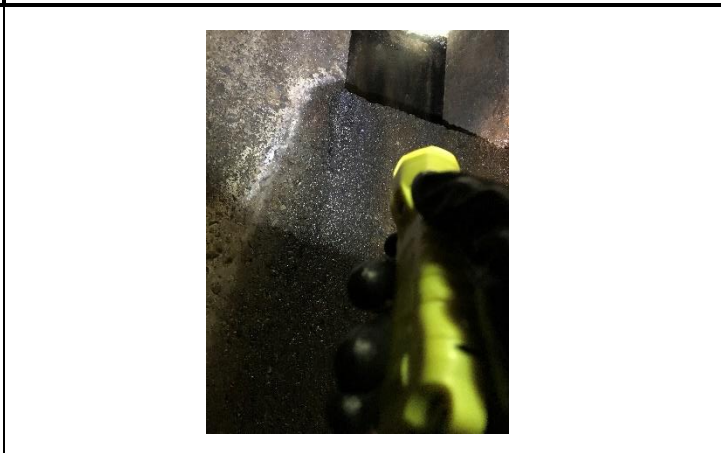
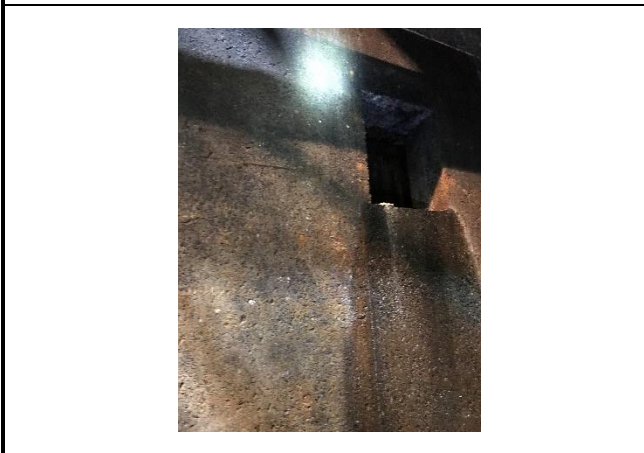
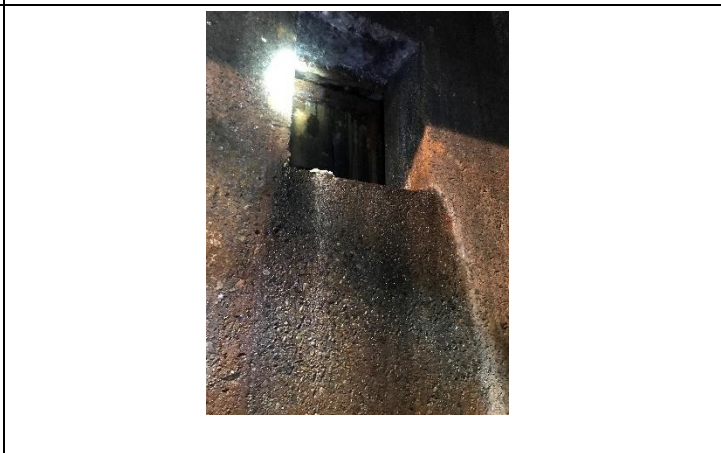
Concrete wall near outlet gate

Concrete Deterioration –Leaching Action and Etch Concrete

- Required Action:
- NDT test to identify Cover and Possible steel corrosion.
 - Destructive test to find Alkalinity of concrete especially near to exposed formwork support.

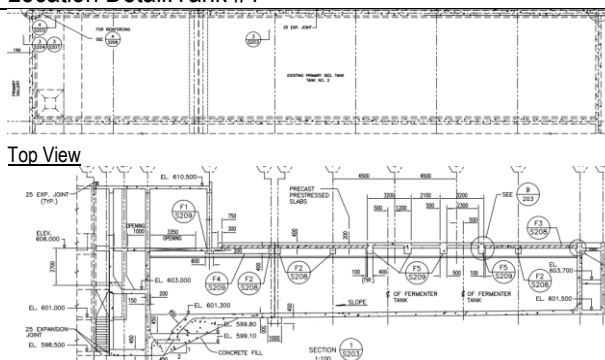
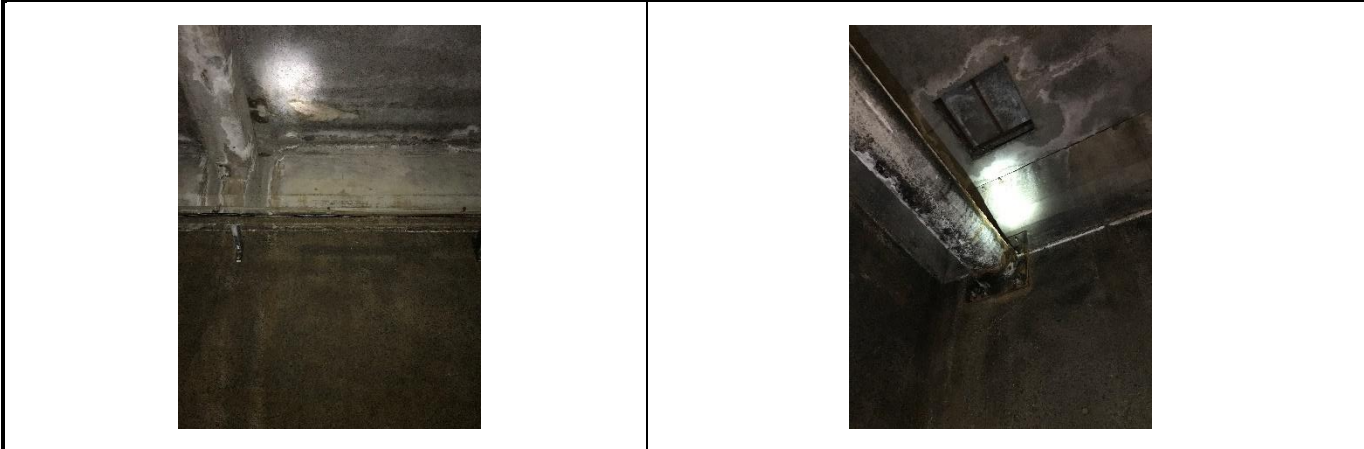
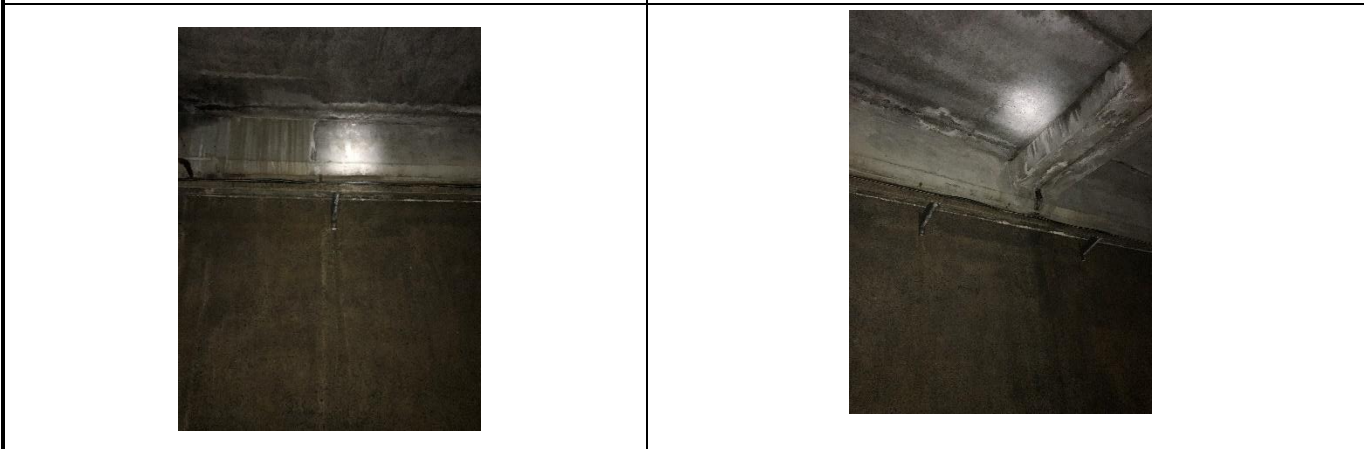
<p>Top View</p> <p>Side View</p> <p>Concrete Roof, access lid Multiple Location</p>	<p>Description:</p> <p>Concrete Deterioration –Leaching Action</p> <p>Required Action:</p> <ul style="list-style-type: none"> - NDT test to identify Cover and Possible steel corrosion. - Destructive test to find Alkalinity of concrete especially near to exposed formwork support.
---	--

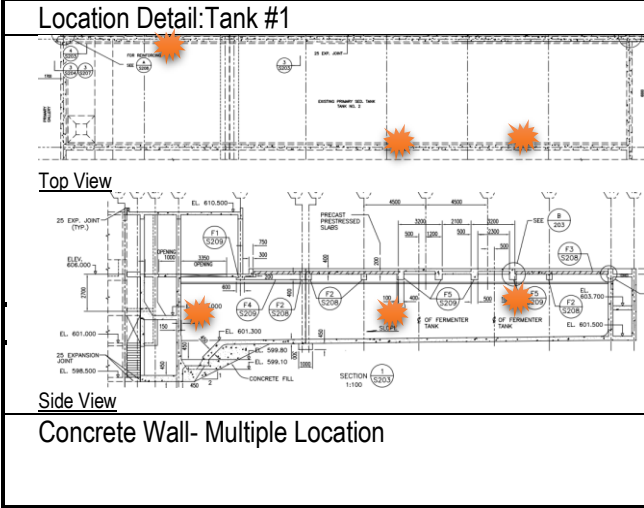
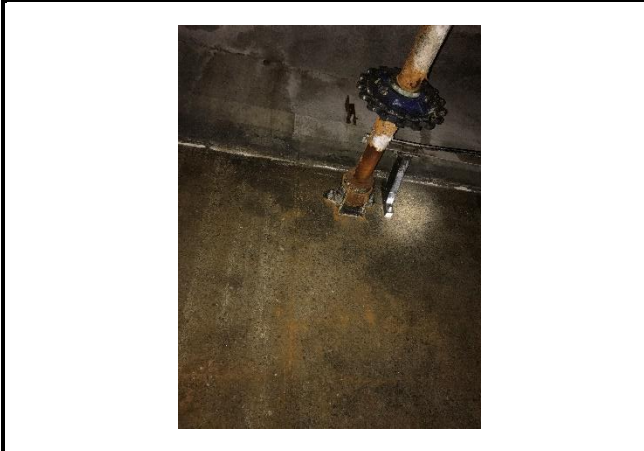
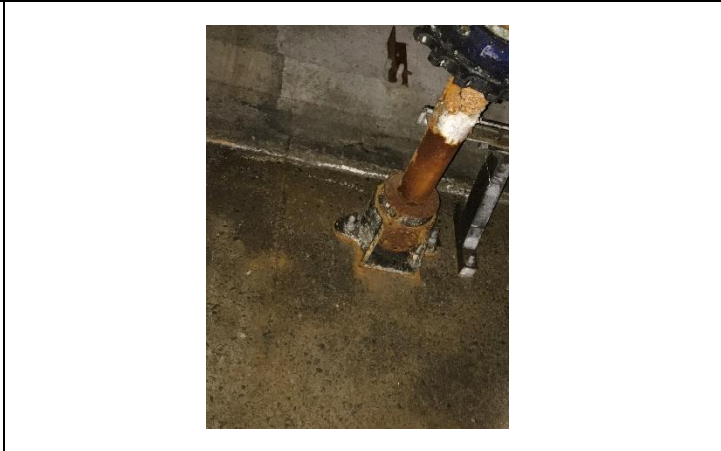
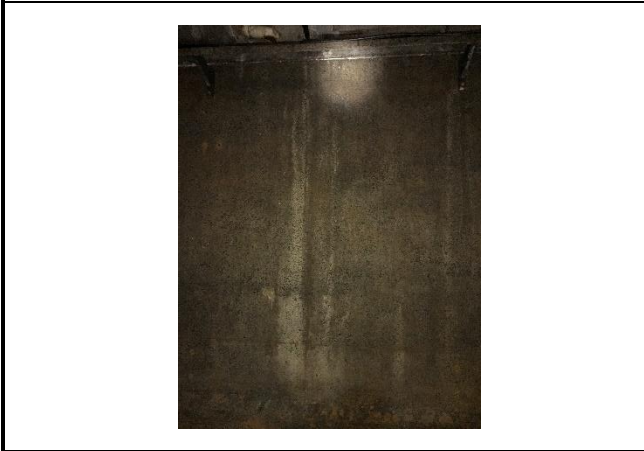
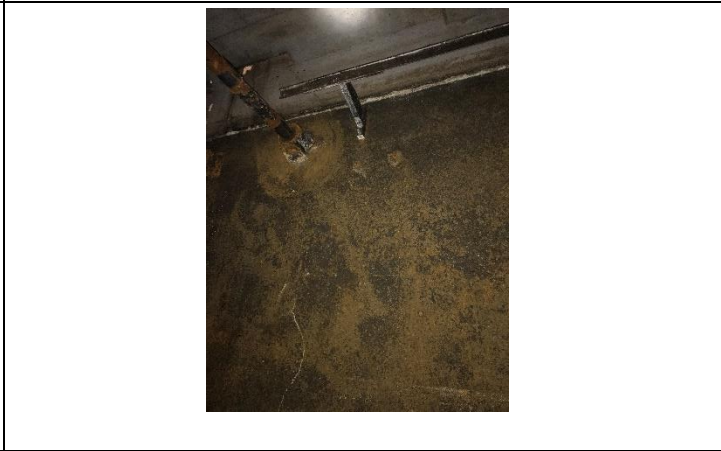
Description:
Concrete Deterioration –Etch Concrete

- Required Action:
- NDT test to identify Cover and Possible steel corrosion.
 - Destructive test to find Alkalinity of concrete especially near to exposed formwork support.

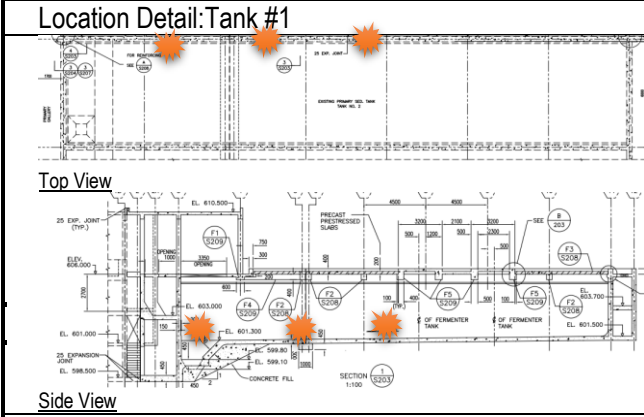
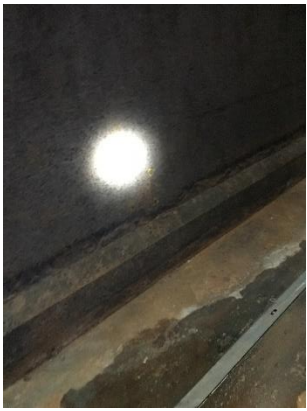
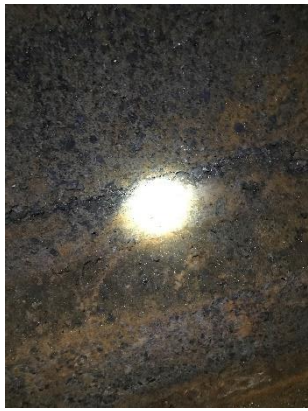
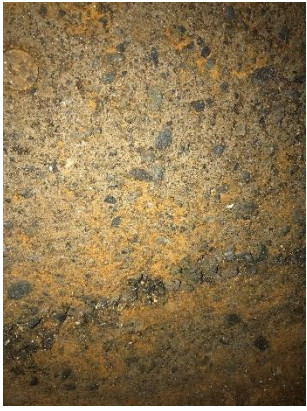
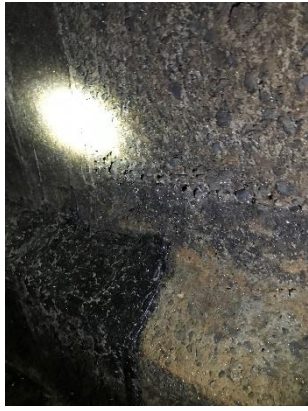
Concrete Wall- Bottom of tank-Multiple Location

Description:
Concrete Deterioration –Abrasion Damage and Etch Concrete

- Required Action:
- NDT test to identify Cover and Possible steel corrosion.
 - Destructive test to find Alkalinity of concrete especially near to exposed formwork support.

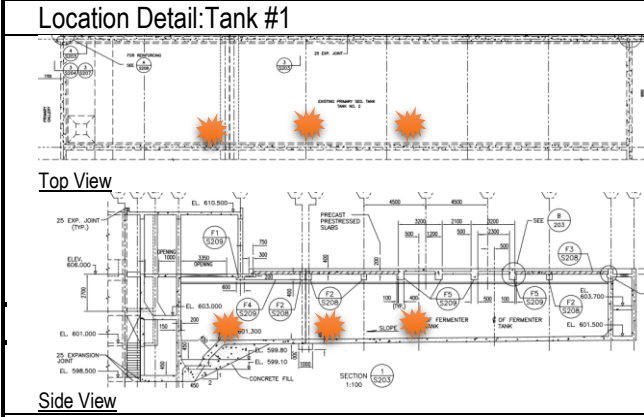
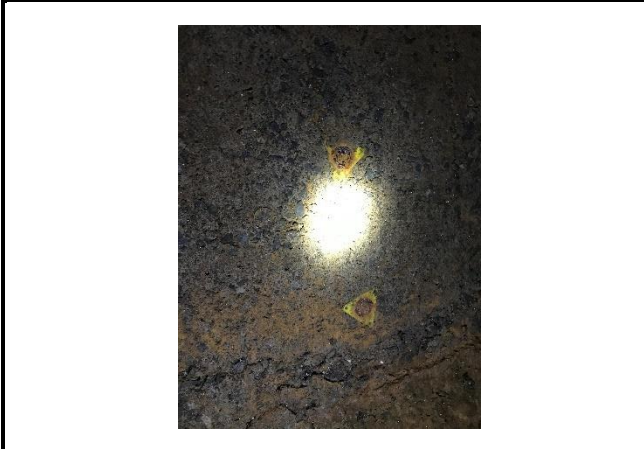
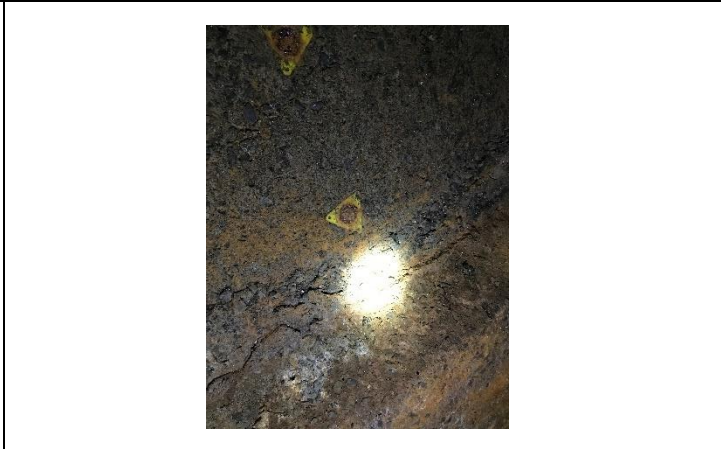
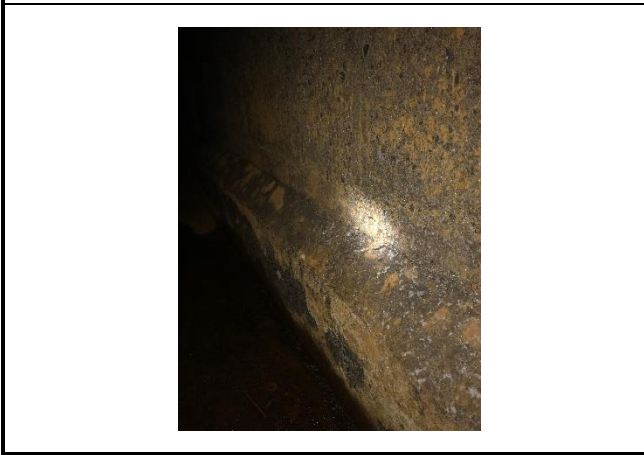
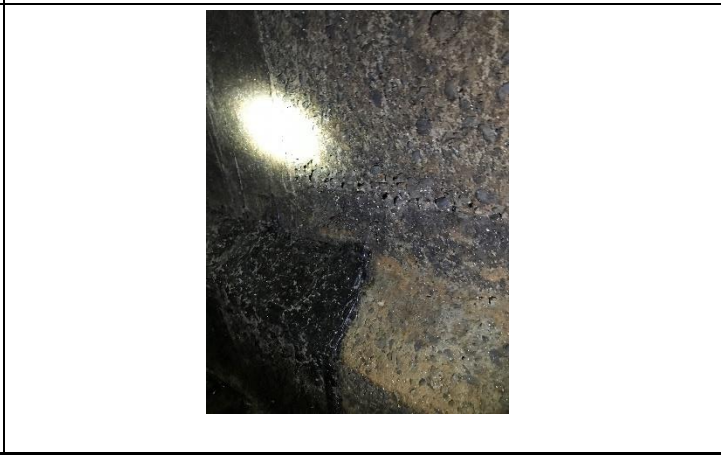
Concrete Wall- Bottom of tank-Multiple Location

Concrete Deterioration –Abrasion Damage, Etch Concrete and Leaching Action

- Required Action:
- NDT test to identify Cover and Possible steel corrosion.
 - Destructive test to find Alkalinity of concrete especially near to exposed formwork support.

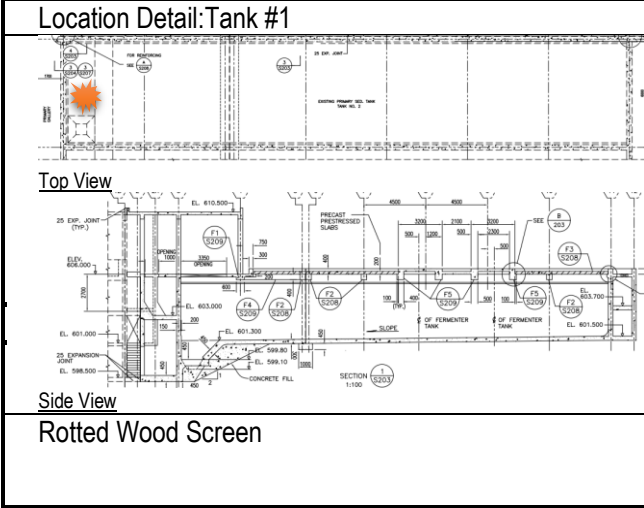
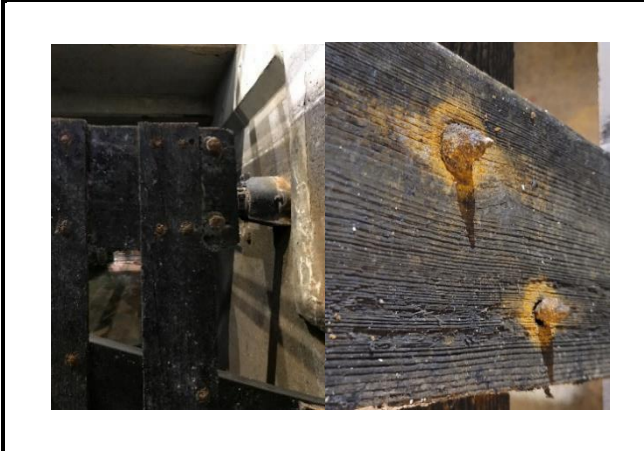
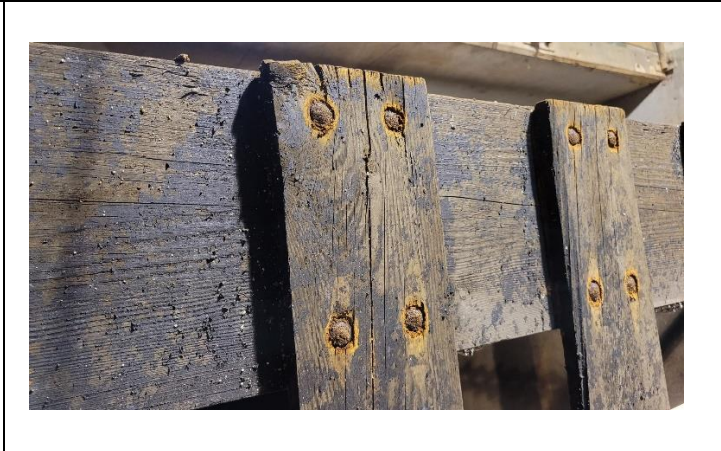
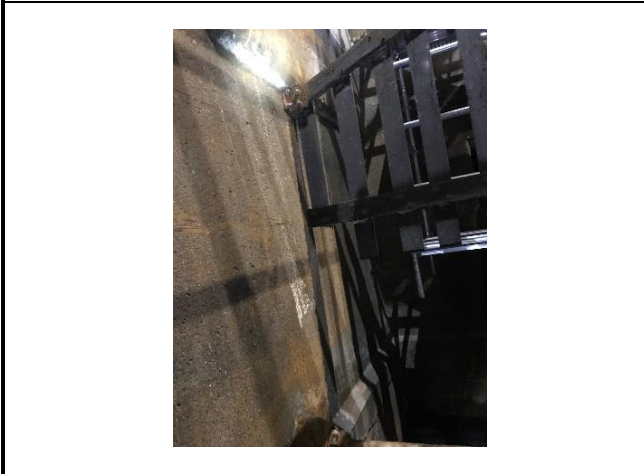
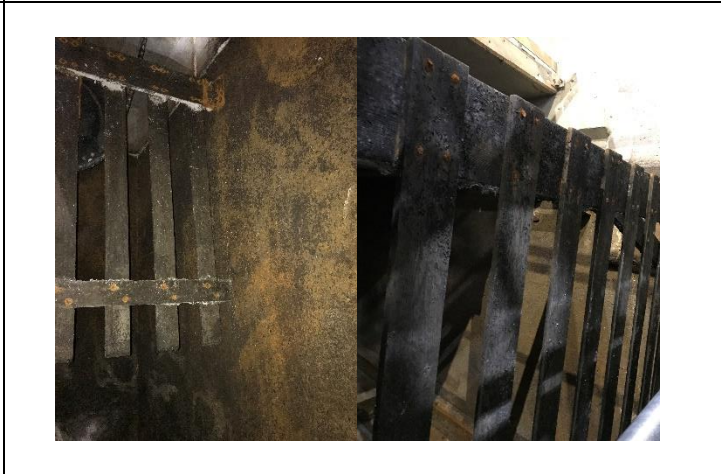
Description:
Wood Screen – deteriorating.
Fasteners on wood screen – corroded and require replacement.

- Replace wood screen complete with fasteners. Consider using a different type of material such as HDP.

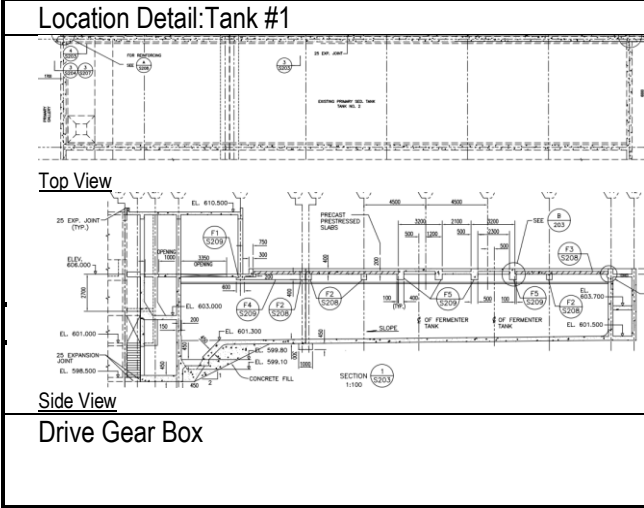
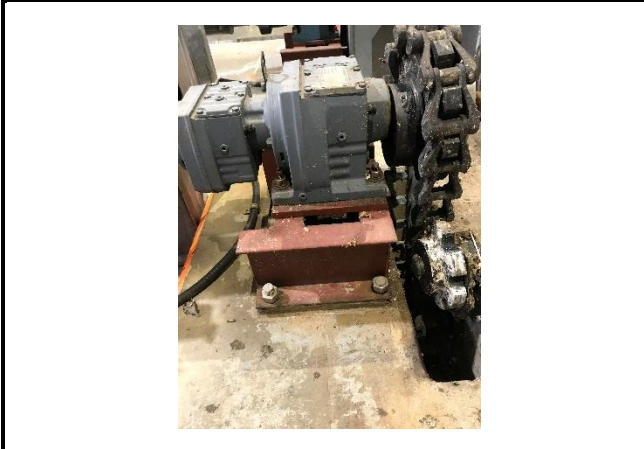
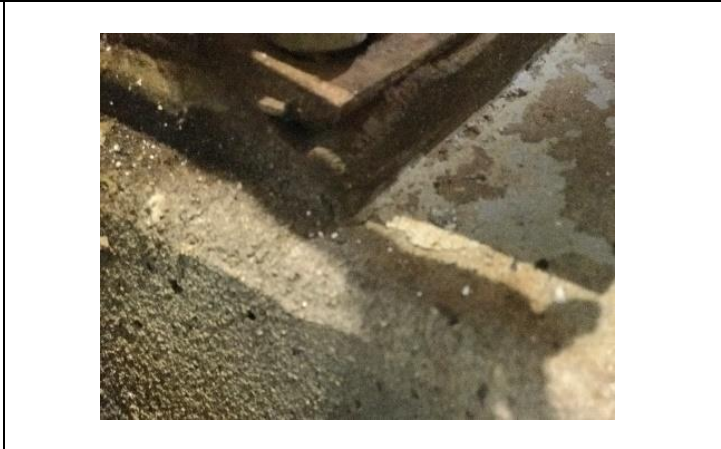
Description:
Crack in Grout

Required Action:
- Repair Grout.

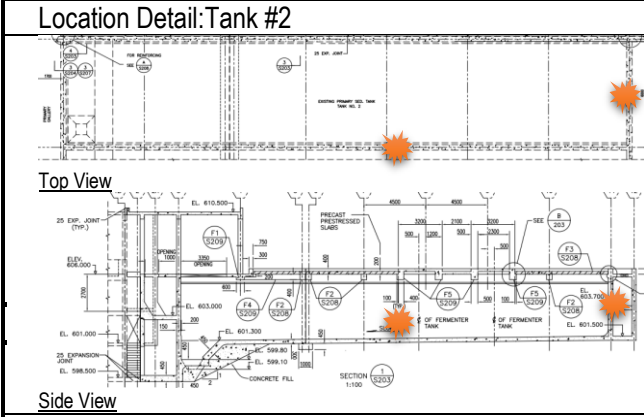
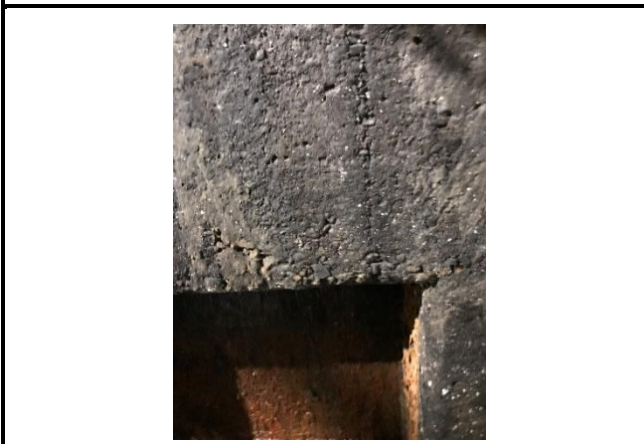
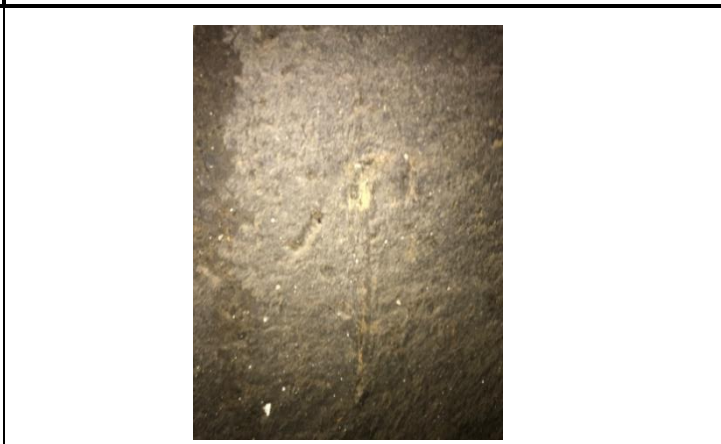
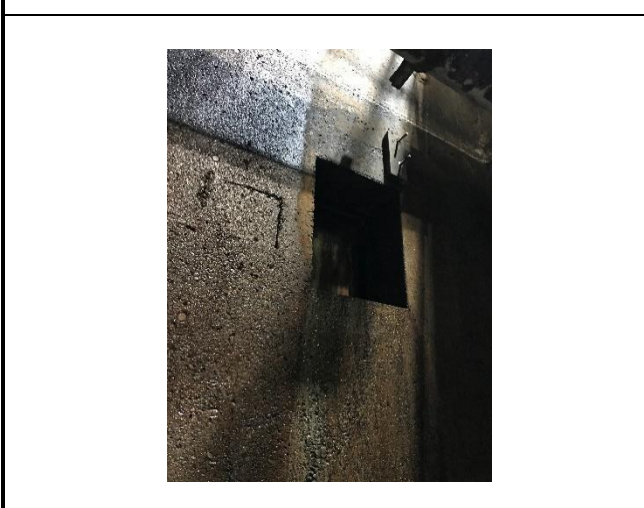
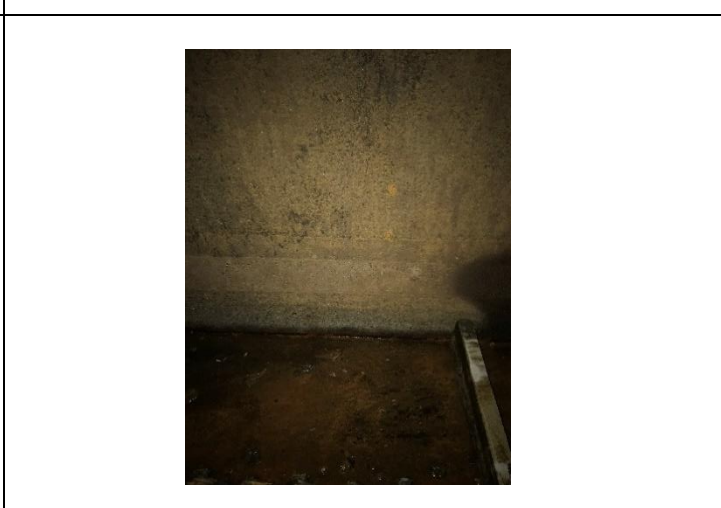
Item No:	S10
Action Plan & Resolution Timeline Required:	1 year
Repair Priority:	P2

Description:
Concrete Deterioration –Abrasion Damage and Etch Concrete

Side View
Concrete Wall- Bottom of tank-Multiple Location

- Required Action:
- NDT test to identify Cover and Possible steel corrosion.
 - Destructive test to find Alkalinity of concrete especially near to exposed formwork support.

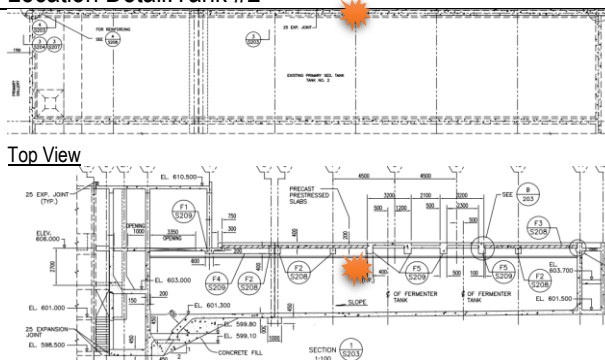
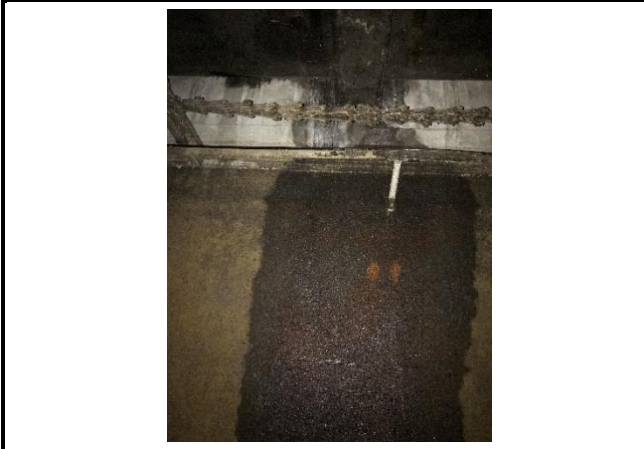
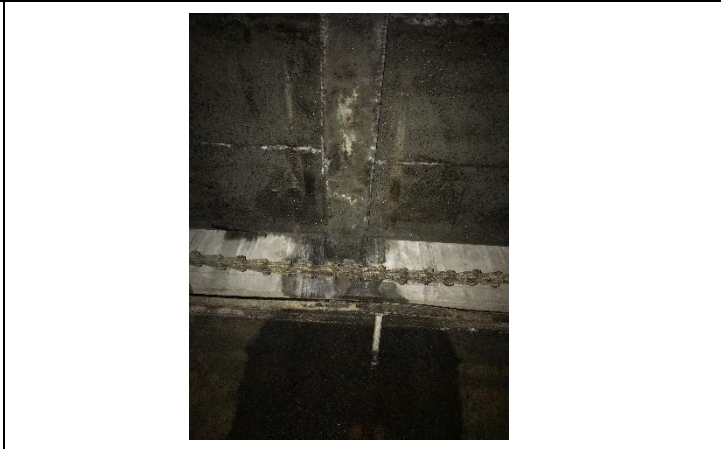
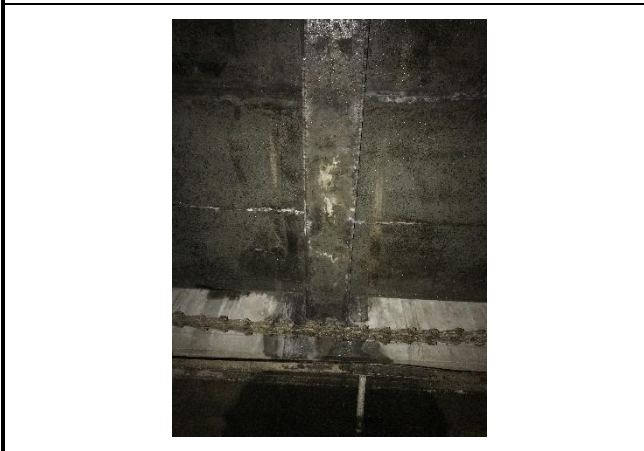
Item No:	S12
Action Plan & Resolution Timeline Required:	1 year
Repair Priority:	P2

Description:
Concrete Deterioration –Leaching Action

- Required Action:
- NDT test to identify Cover and Possible steel corrosion.
 - Destructive test to find Alkalinity of concrete especially near to exposed formwork support.

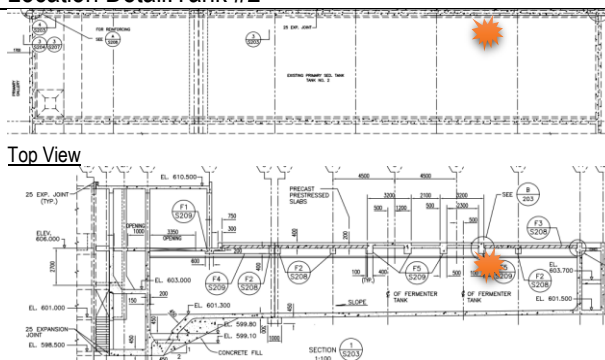
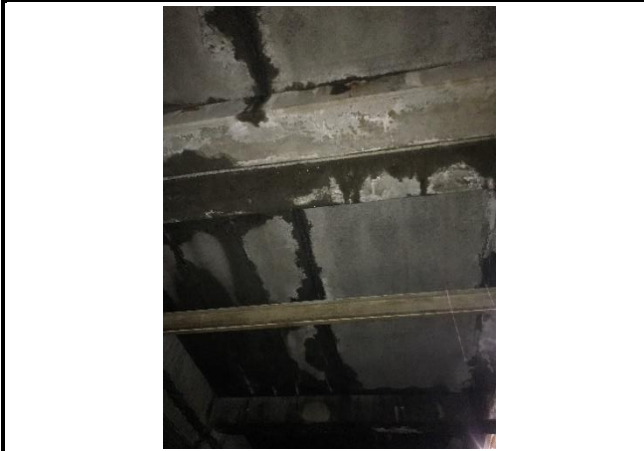
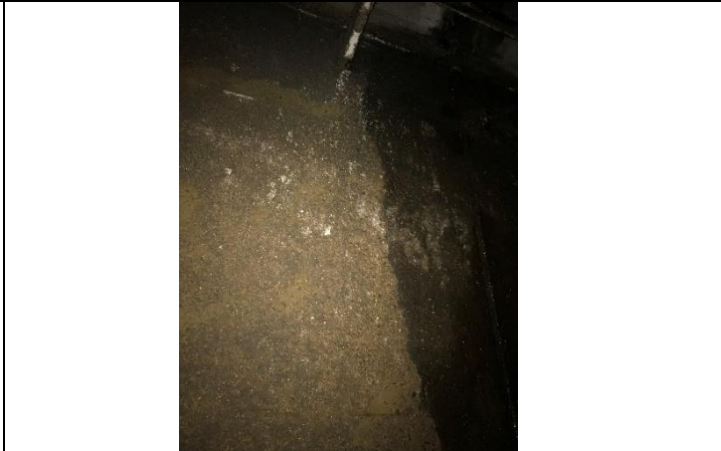
Item No:	S13
Action Plan & Resolution Timeline Required:	1 year
Repair Priority:	P2

Concrete Deterioration –Leaching Action

- Required Action:
- NDT test to identify Cover and Possible steel corrosion.
 - Destructive test to find Alkalinity of concrete especially near to exposed formwork support.

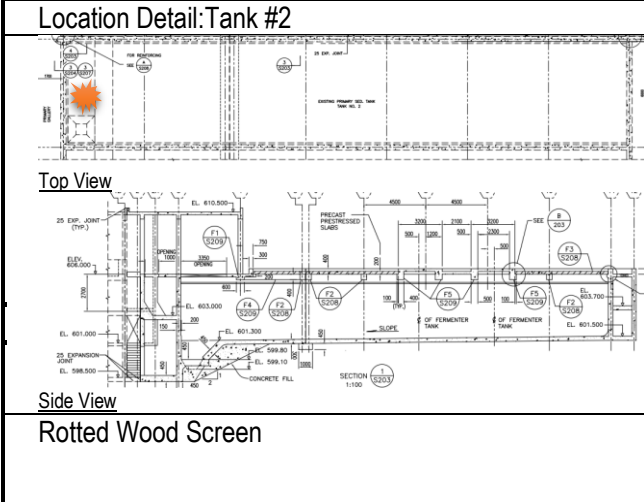
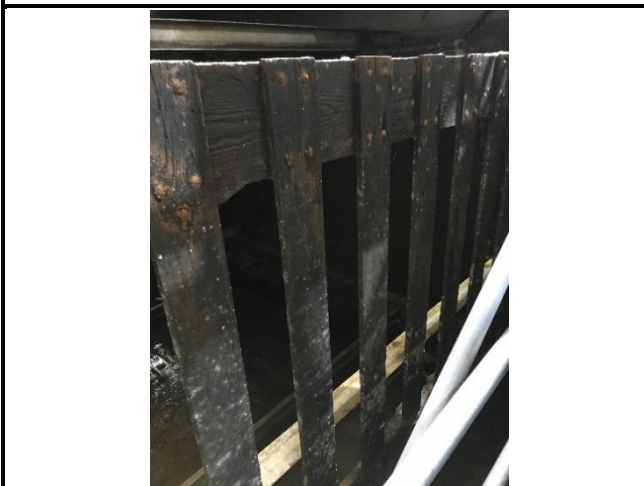
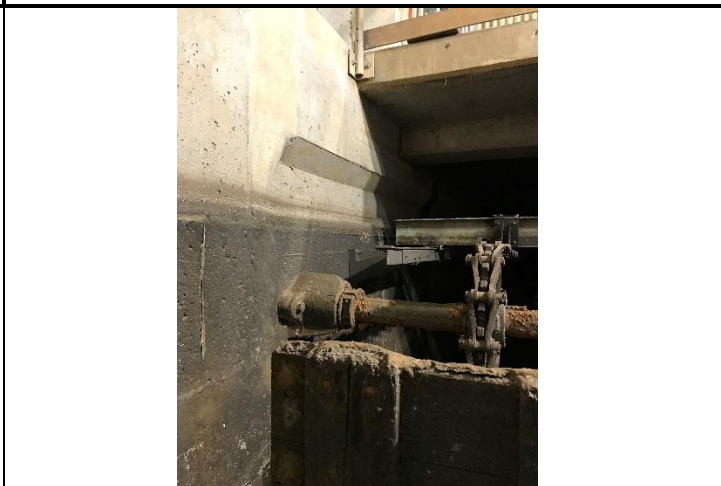
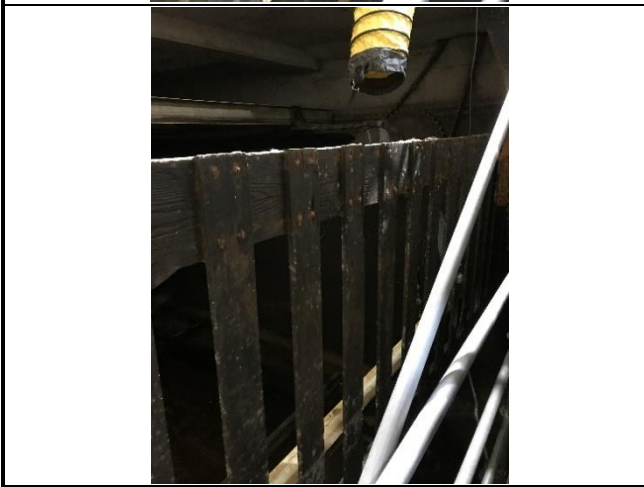
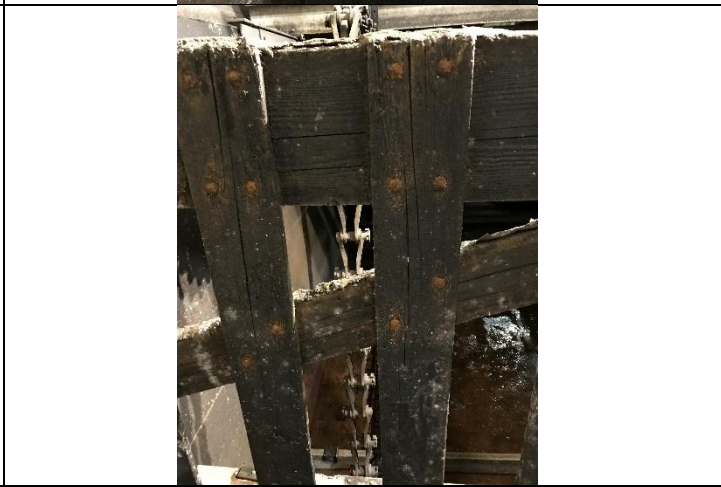
Item No:	S14
Action Plan & Resolution Timeline Required:	45 days
Repair Priority:	P1E

Description:
Wood Screen – deteriorating.
Fasteners on wood screen – corroded and require replacement.

- Replace wood screen complete with fasteners. Consider using a different type of material such as HDP.

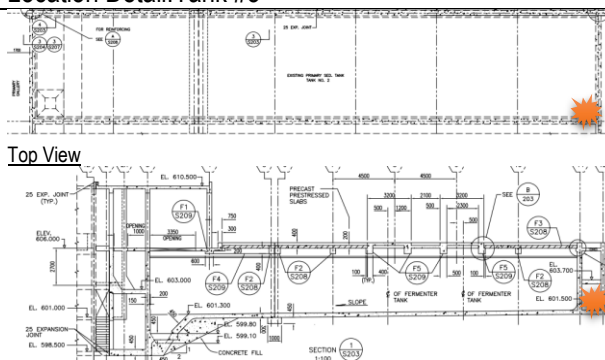
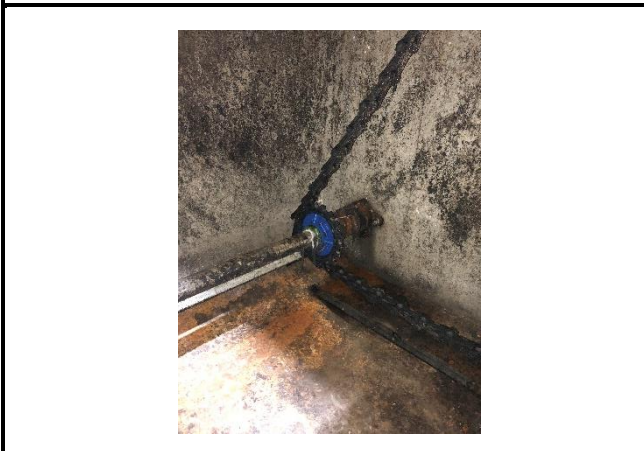
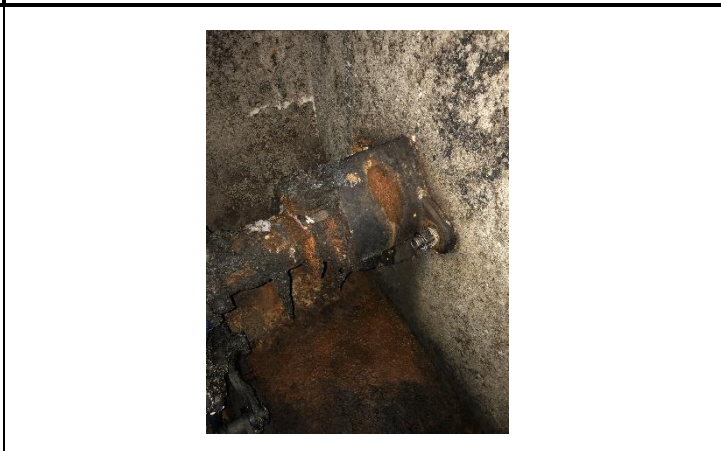
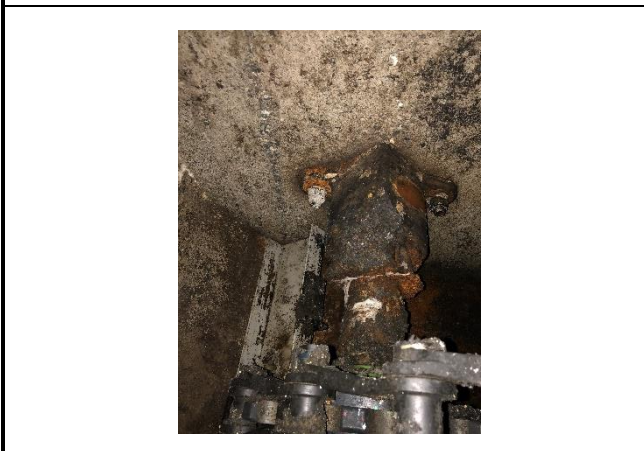
Item No:	S16
Action Plan & Resolution Timeline Required:	1 year
Repair Priority:	P2

Description:
Concrete Deterioration –Etch Damage

- Required Action:
- NDT test to identify Cover and Possible steel corrosion.
 - Destructive test to find Alkalinity of concrete.
 - Anchorage review.

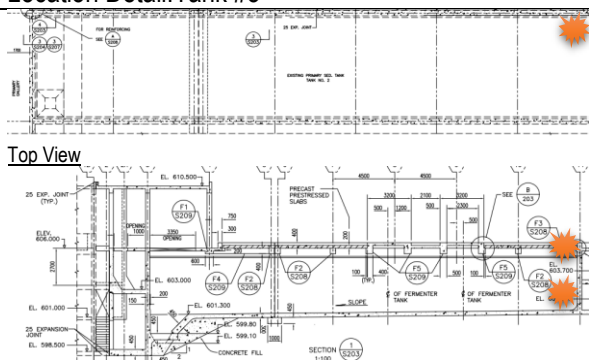
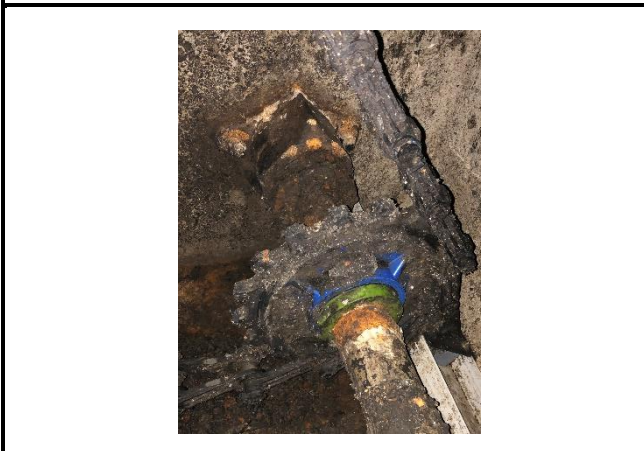
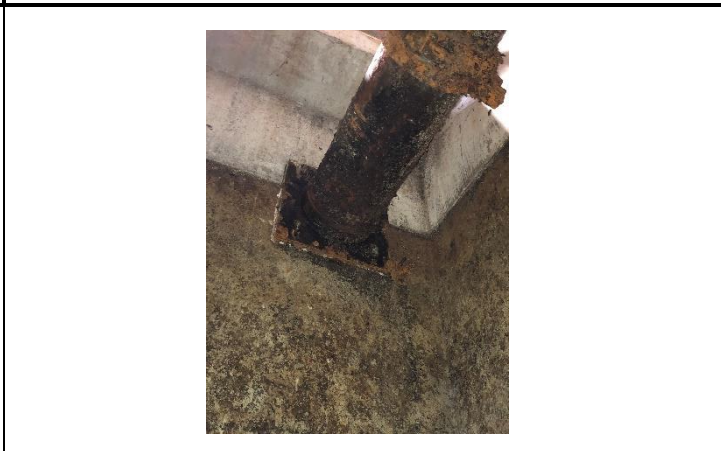
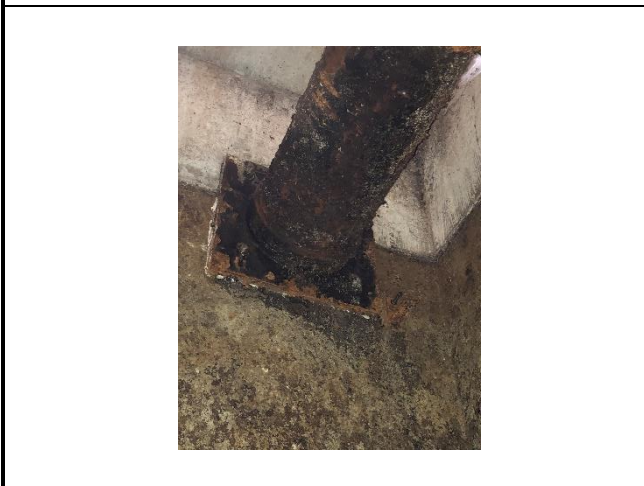
Item No:	S17
Action Plan & Resolution Timeline Required:	1 year
Repair Priority:	P2

Description:
Concrete Deterioration –Etch Damage

- Required Action:**
- NDT test to identify Cover and Possible steel corrosion.
 - Destructive test to find Alkalinity of concrete.
 - Anchorage review.

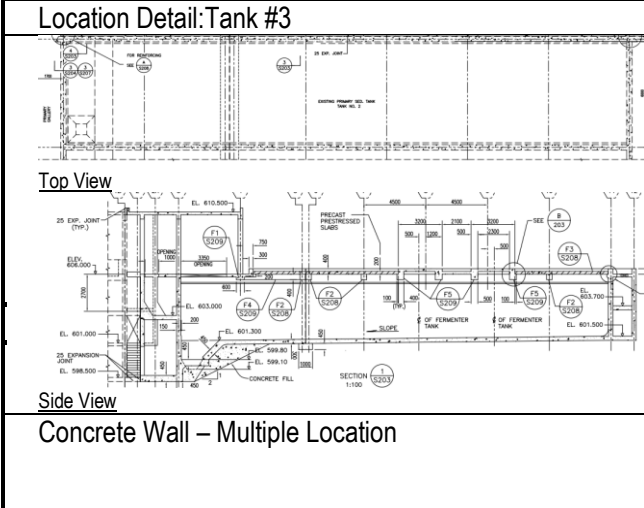
Item No:	S18
Action Plan & Resolution Timeline Required:	1 year
Repair Priority:	P2

Description:
Concrete Deterioration –Abrasion Damage, Etch Concrete

- NDT test to identify Cover and Possible steel corrosion.
- Destructive test to find Alkalinity of concrete.

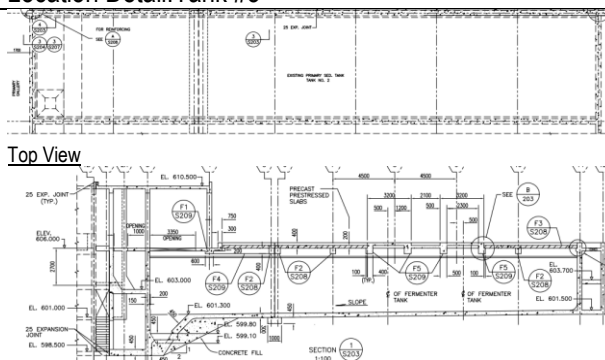
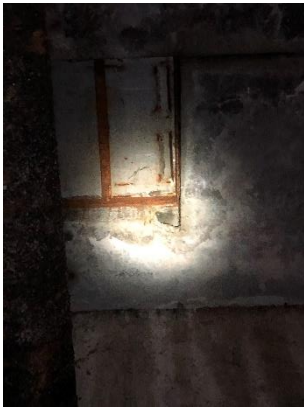
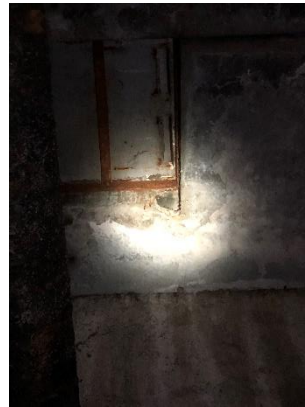
<p>Location Detail: Tank #3</p>

<p>Top View</p> <p>Side View</p> <p>Concrete Roof – Roof Hatch</p>	<p>Description:</p> <p>Concrete Deterioration – Leaching Action- Damage on Concrete – Corrosion on Steel Frame</p> <p>Required Action:</p> <ul style="list-style-type: none"> - NDT test to identify Cover and Possible steel corrosion. - Destructive test to find Alkalinity of concrete. - Fix Concrete. - Paint - Repair Steel Frame
--	--
