Resort Municipality of Whistler: Wastewater Treatment Plant Primary Sedimentation Tank Assessment Report

Project No. 210505

January 26th, 2022

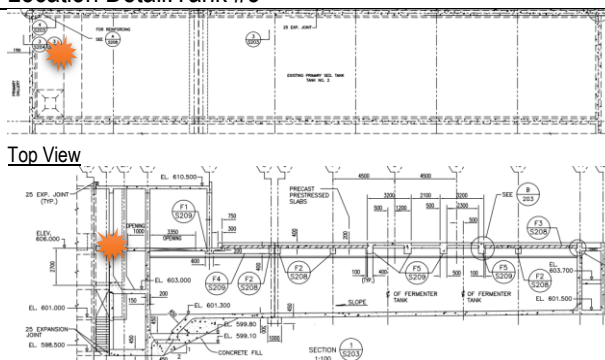
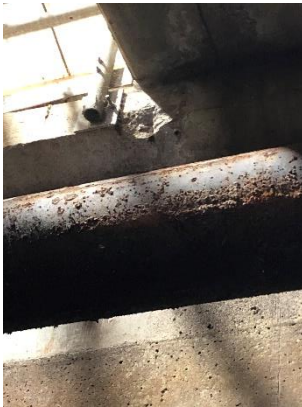
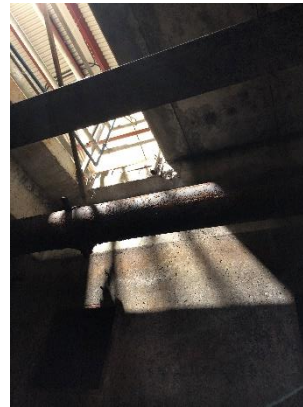
<p>Location Detail: Tank #3</p>

<p>Top View</p> <p>Side View</p> <p>Concrete Wall</p>	<p>Description:</p> <p>Concrete Deterioration – Leaching Action – Damage on Concrete – Corrosion on Steel Frame</p> <p>Required Action:</p> <ul style="list-style-type: none"> - NDT test to identify Cover and Possible steel corrosion. - Destructive test to find Alkalinity of concrete. - Fix Concrete. - Paint - Repair Steel Frame.
---	--

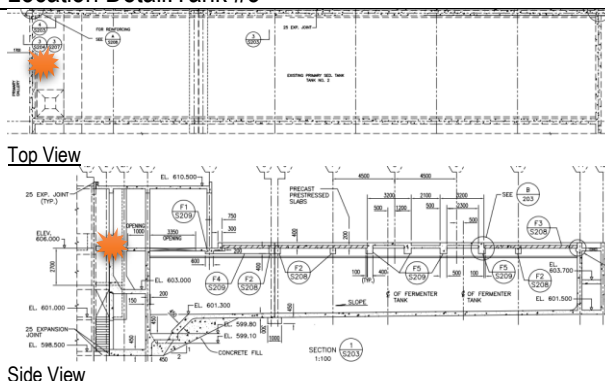
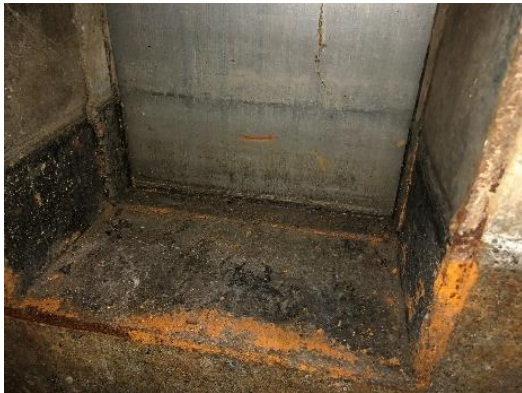
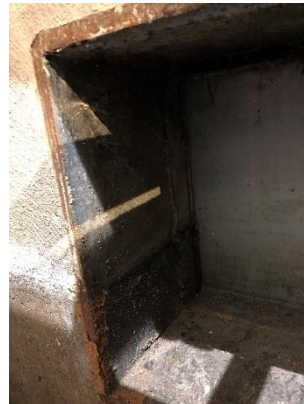
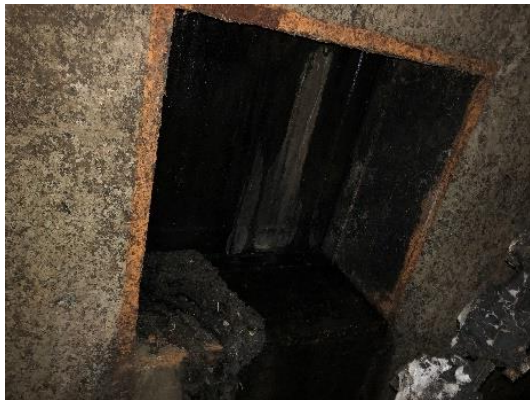
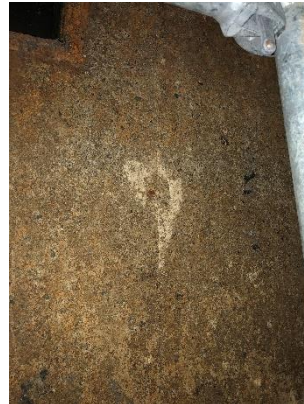
<p>Location Detail: Tank #3</p>

<p>Top View</p> <p>Side View</p> <p>Frame – Concrete wall</p>	<p>Description:</p> <p>Frame Corrosion Around inlet Concrete Deterioration – Abrasion damage, Etch Concrete</p> <p>Required Action:</p> <ul style="list-style-type: none"> - NDT test to identify Cover and Possible steel corrosion. - Destructive test to find Alkalinity of concrete. - Paint - Repair Steel Frame
---	--

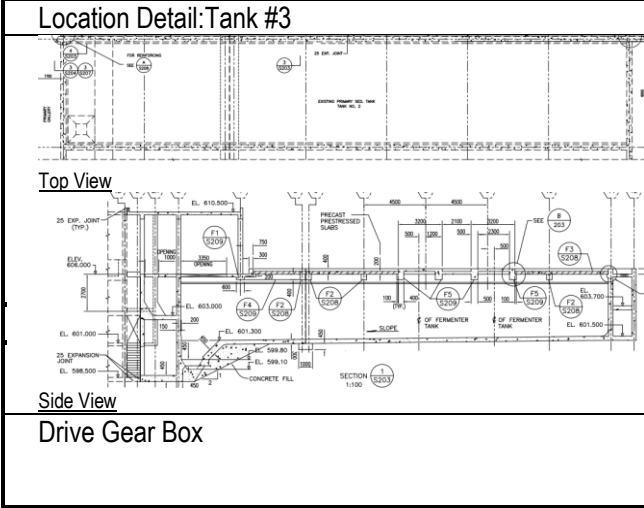
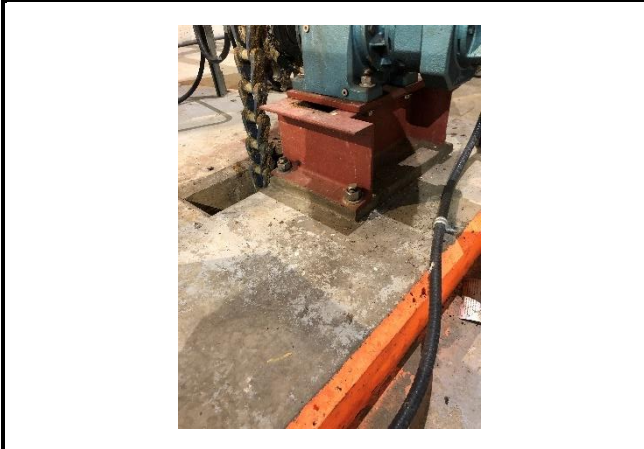
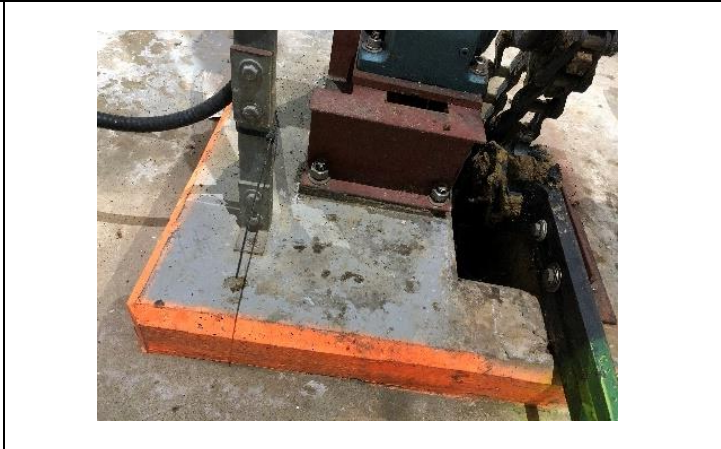
Item No:	S23
Action Plan & Resolution Timeline Required:	1 year
Repair Priority:	P2

Description:
Crack in Grout

Required Action:
- Repair Grout.

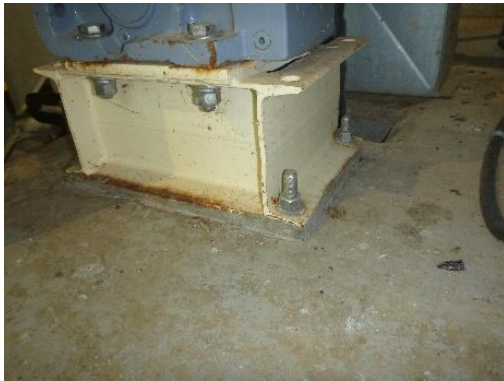
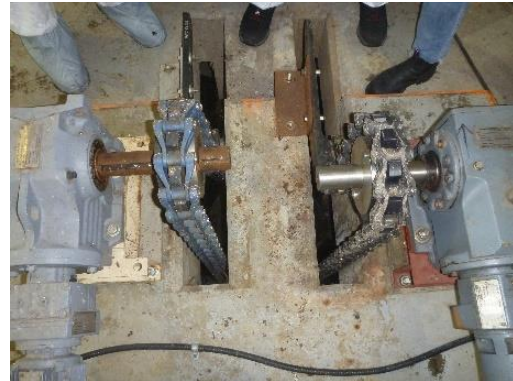
<p>Top View</p> <p>Side View</p> <p>Drive Gear Box</p>	<p>Description: Minor Corrosion</p> <p>Required Action: - Repair Steel Support- Paint.</p>
--	--

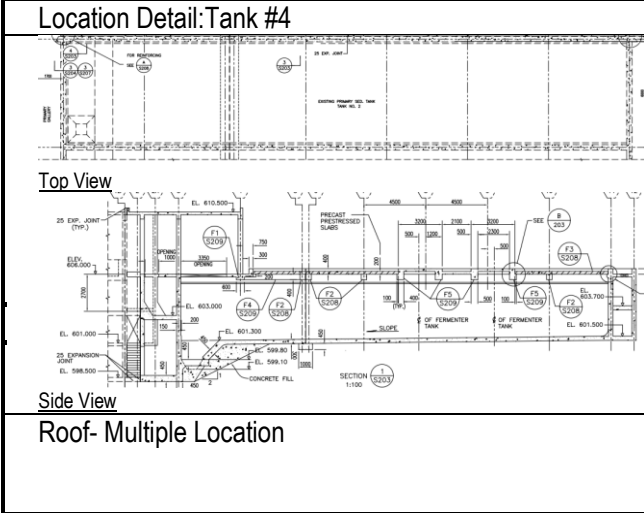
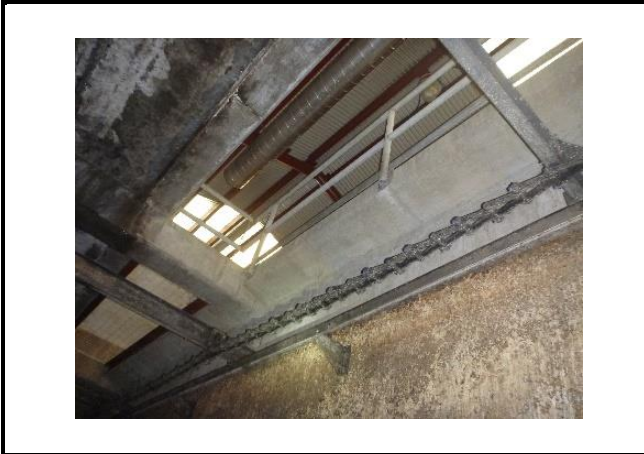
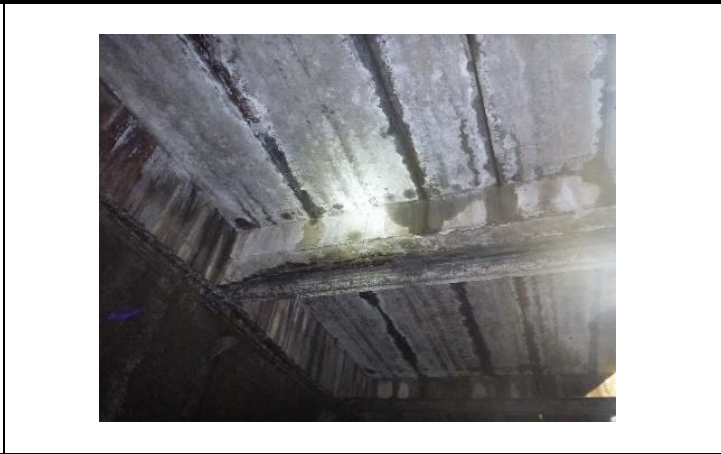
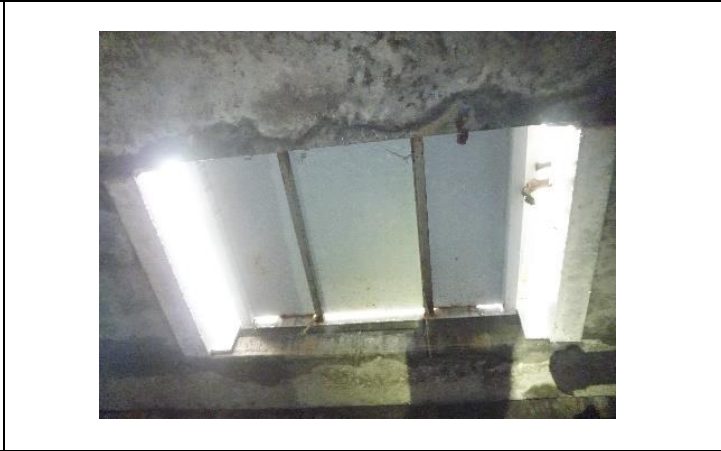
Item No:	S26
Action Plan & Resolution Timeline Required:	1 year
Repair Priority:	P2

Description:
Concrete Deterioration – Leaching Action

- NDT test to identify Cover and Possible steel corrosion.
- Destructive test to find Alkalinity of concrete.

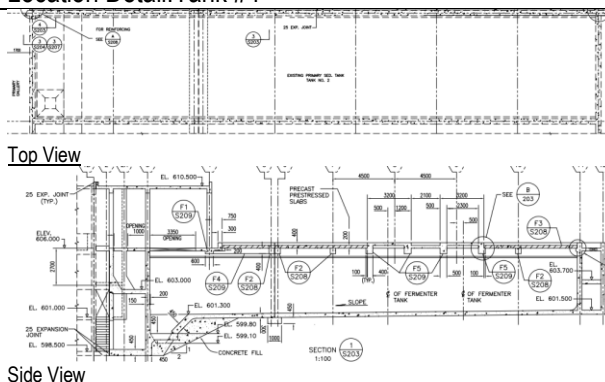
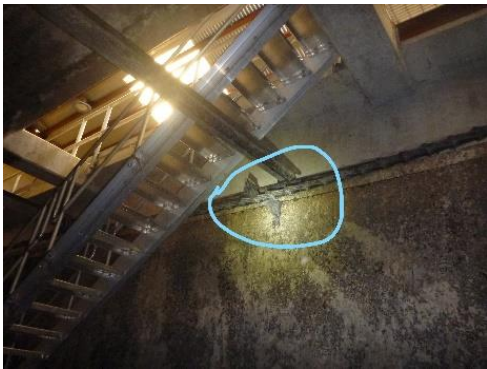
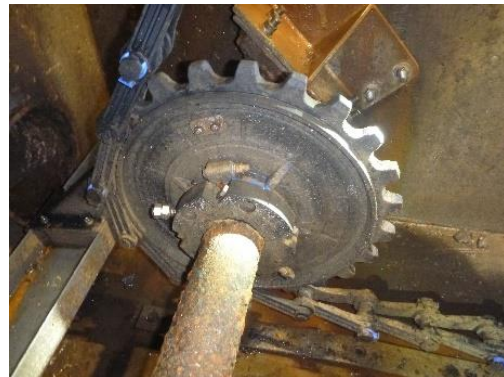
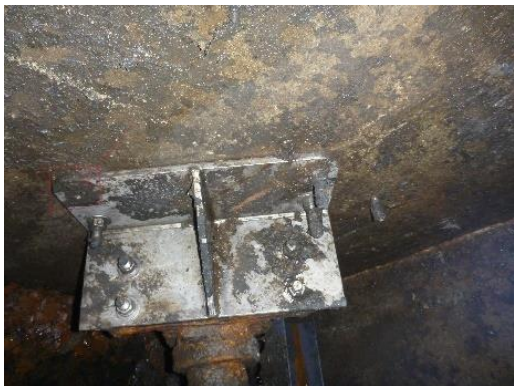
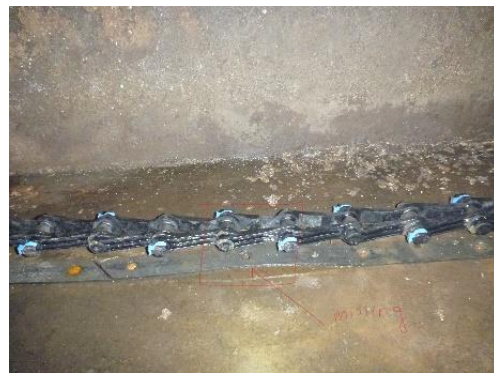
<p>Location Detail: Tank #4</p>

<p>Top View</p> <p>Side View</p> <p>Multiple Location</p>	<p>Description:</p> <p>Missing Bolts – Loosen Bracket- Loosen Bolts</p> <p>Required Action:</p> <ul style="list-style-type: none"> - Install New Bolts. - Fix Bracket. - Review Loosen Bolts.
---	--

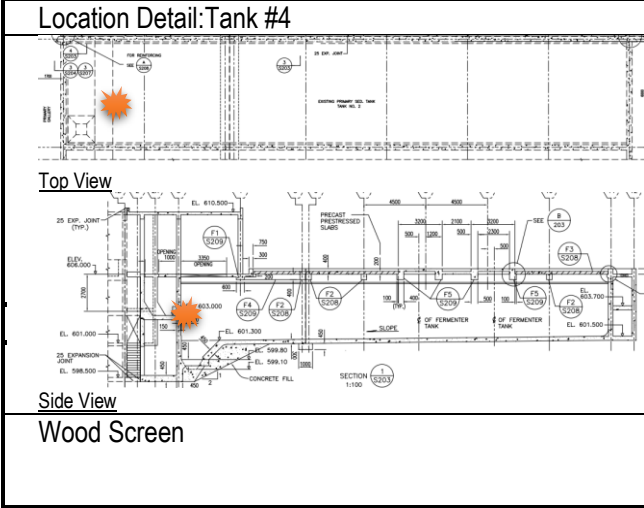
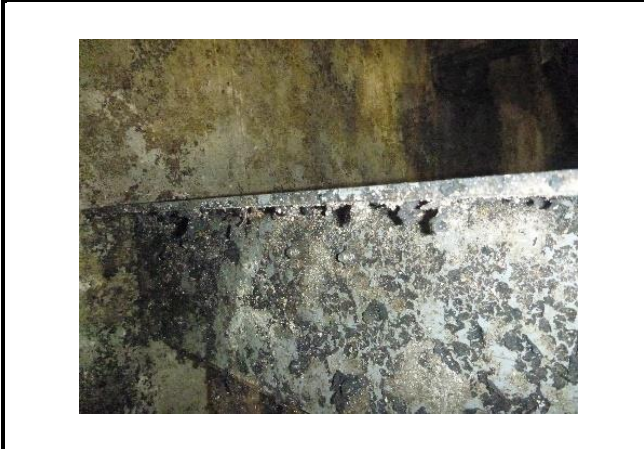
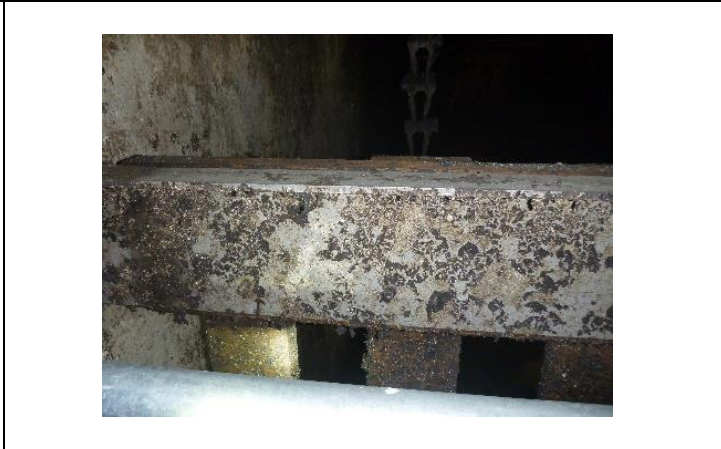
Item No:	S28
Action Plan & Resolution Timeline Required:	1 year
Repair Priority:	P2

Description:
Corroded screen and supports

- Replace wood screen and support.
