The Resort Municipality of Whistler

Annual Drinking Water report

2013

The following is the Resort Municipality of Whistler's (RMOW) 2013 Annual Water System Monitoring Report.

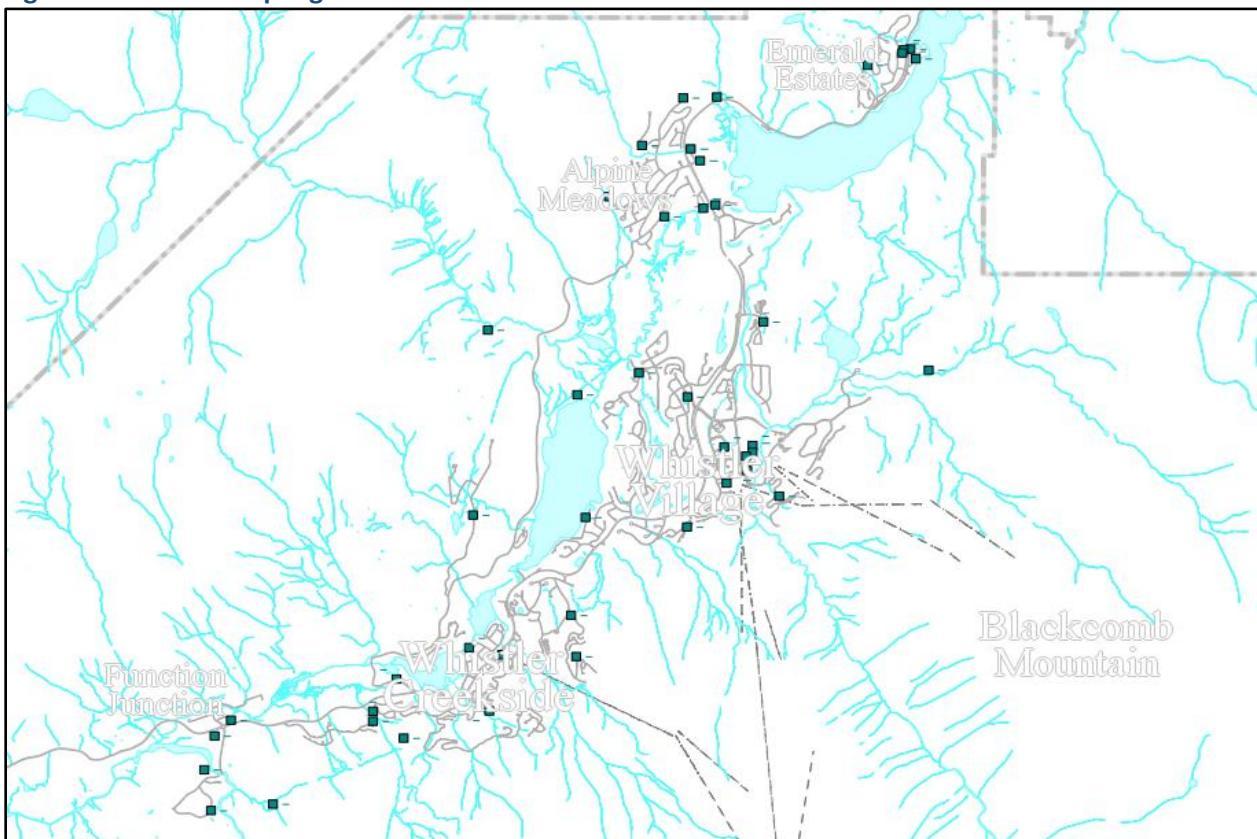
Figure 1 – Water Sampling Locations

W – Well

P – Pump Station

Sample Port – Sample port within the distribution system
